The Stones of Nidaros

An Applied Weathering Study of
Europe's Northernmost
Medieval Cathedral

Dr. Ing. (Ph.D.) thesis no. 1997:92
Department of Architectural History
Norwegian University of Science and Technology
Trondheim, Norway

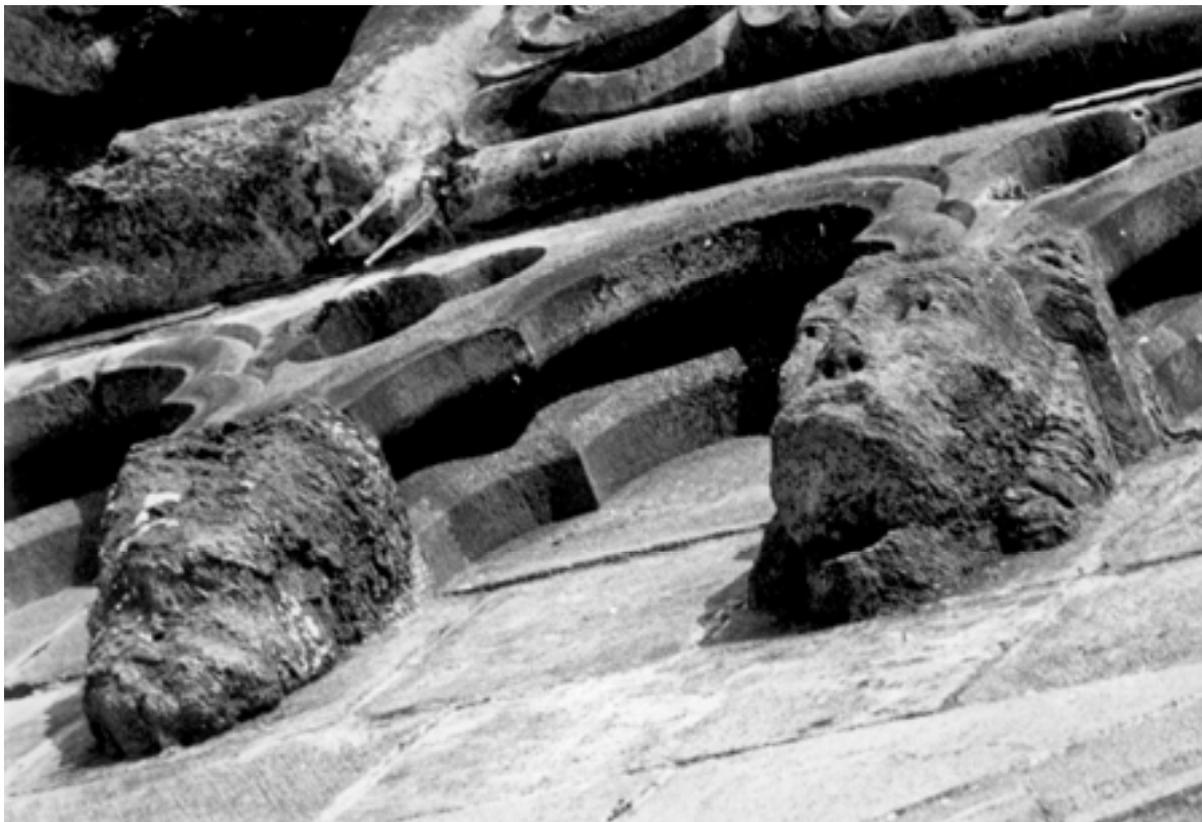
Fig. 1.7: Part of a frieze from the choir, made of Grytdal soapstone in the 1880s. The stone is notorious for its rapid weathering and presents serious conservation problems (photo: ARW 1992).

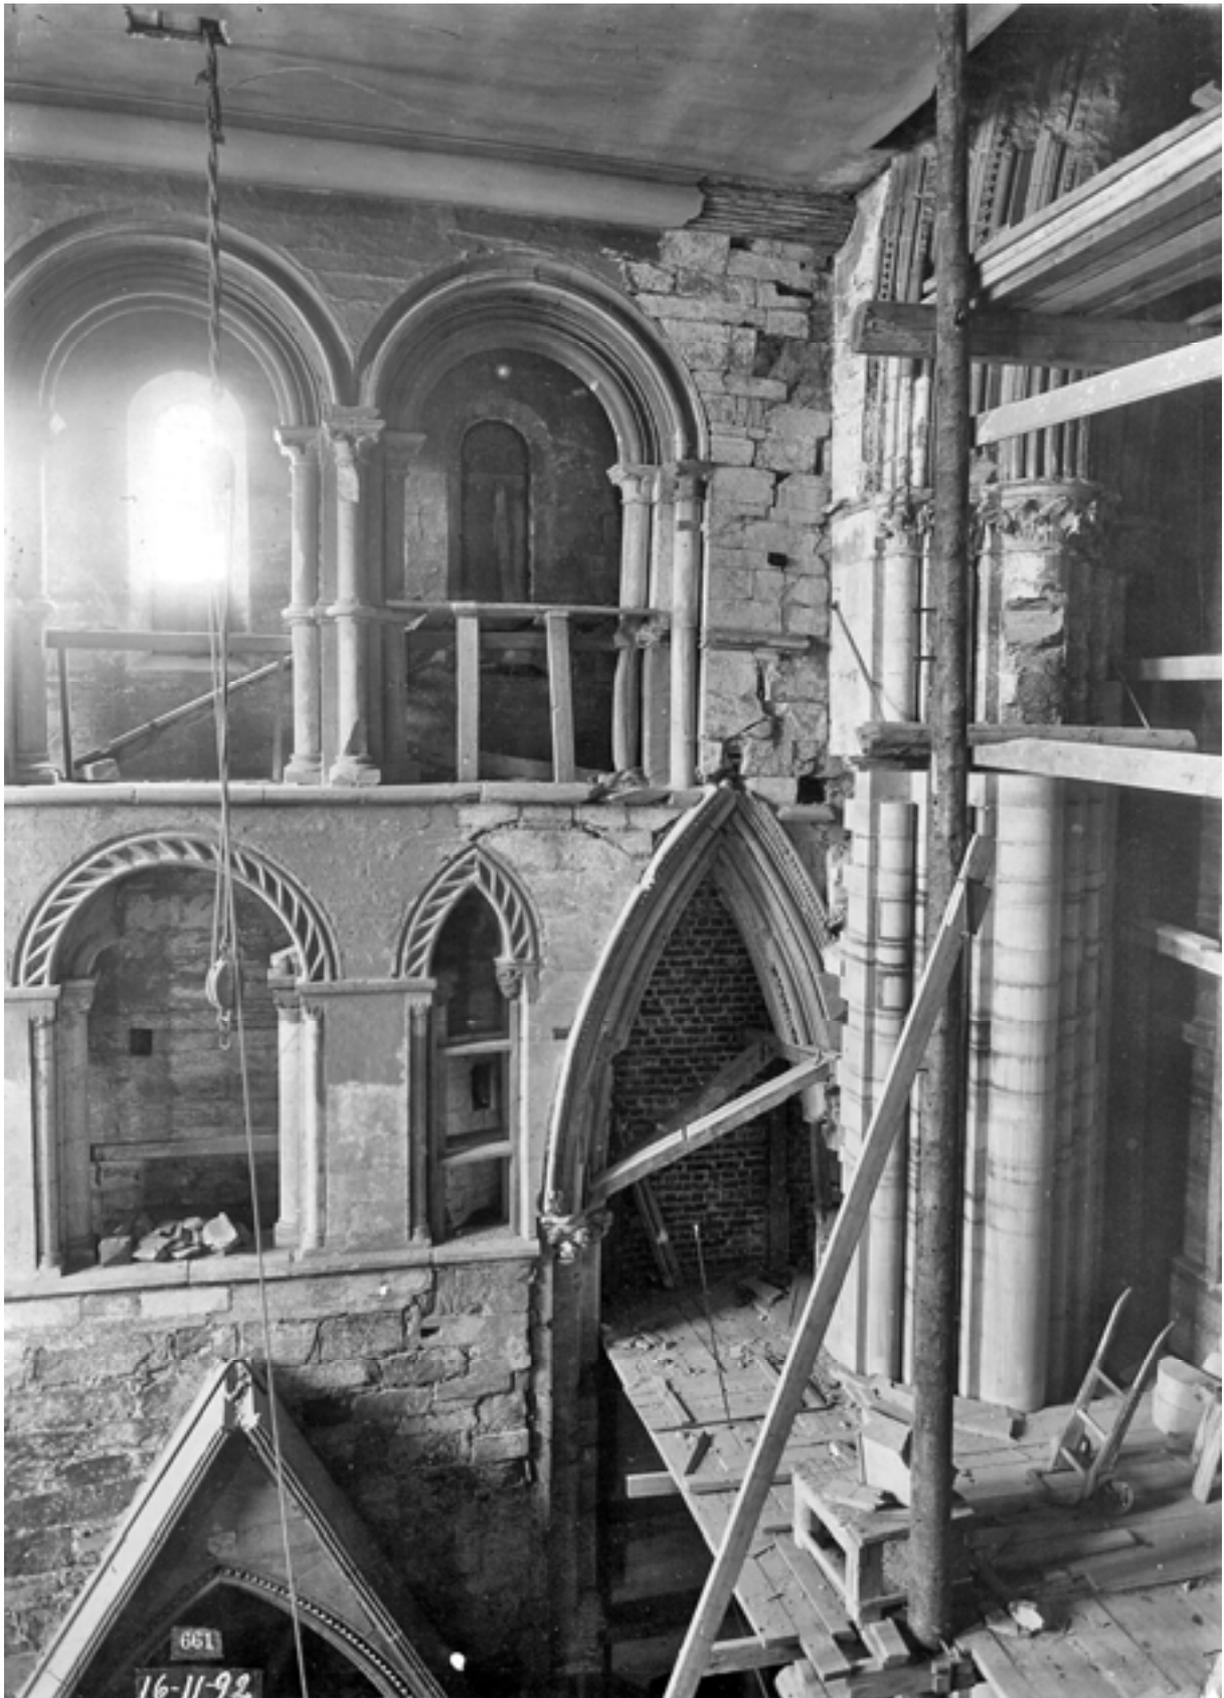
Fig. 5.1: East wall of the north transept during restoration in the 1890s. Note the cracks caused by differential settlement close to the arches of the central tower (photo: ARW, no. 661).

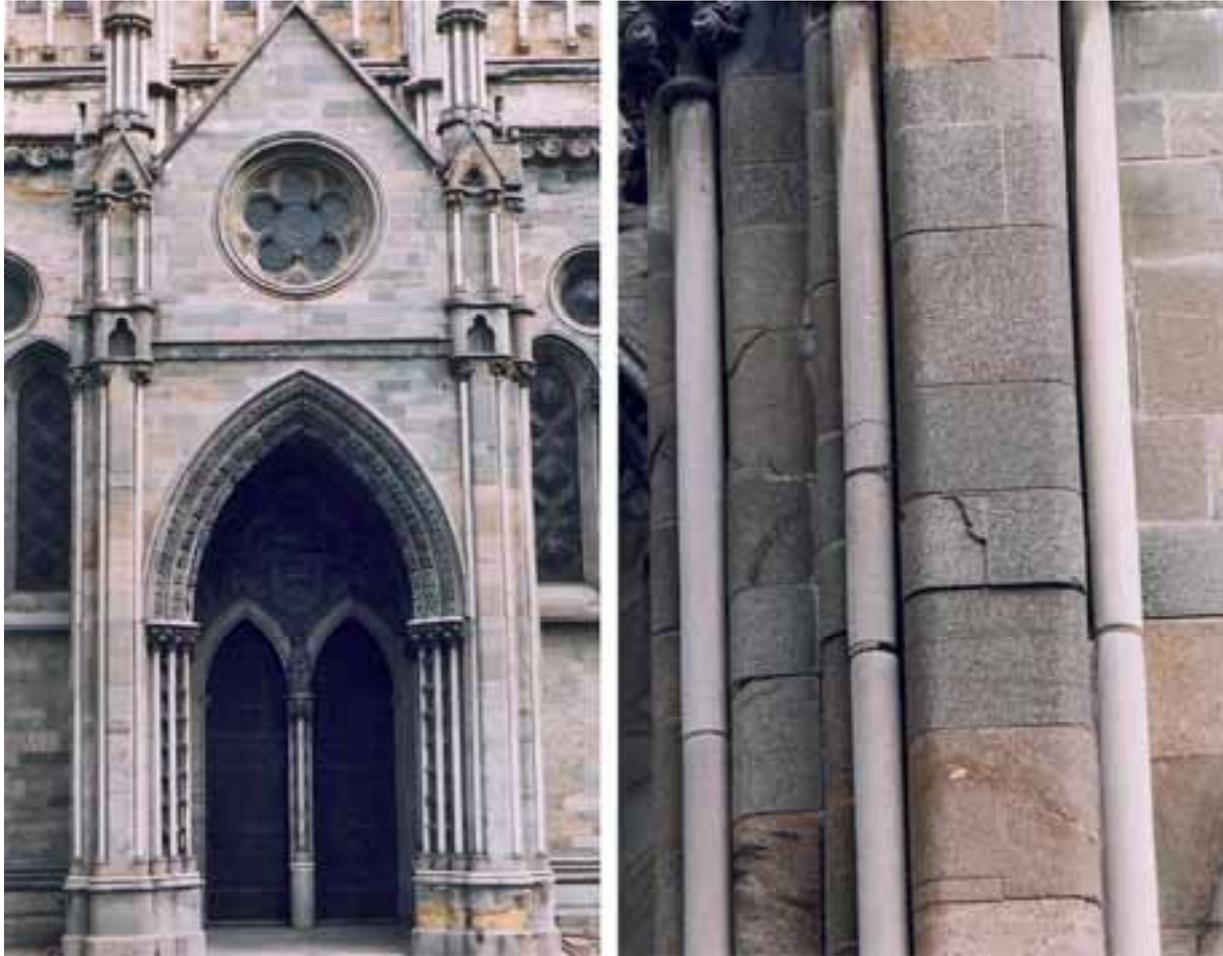
Fig. 5.7: The King's porch (above). The slender Gothic construction - thoroughly restored three times since 1878 - has developed extensive cracks since 1960. Note the bulging of the walls. Cracks preferentially follow joints, but also cut through stone blocks (photos: PS 6/96).

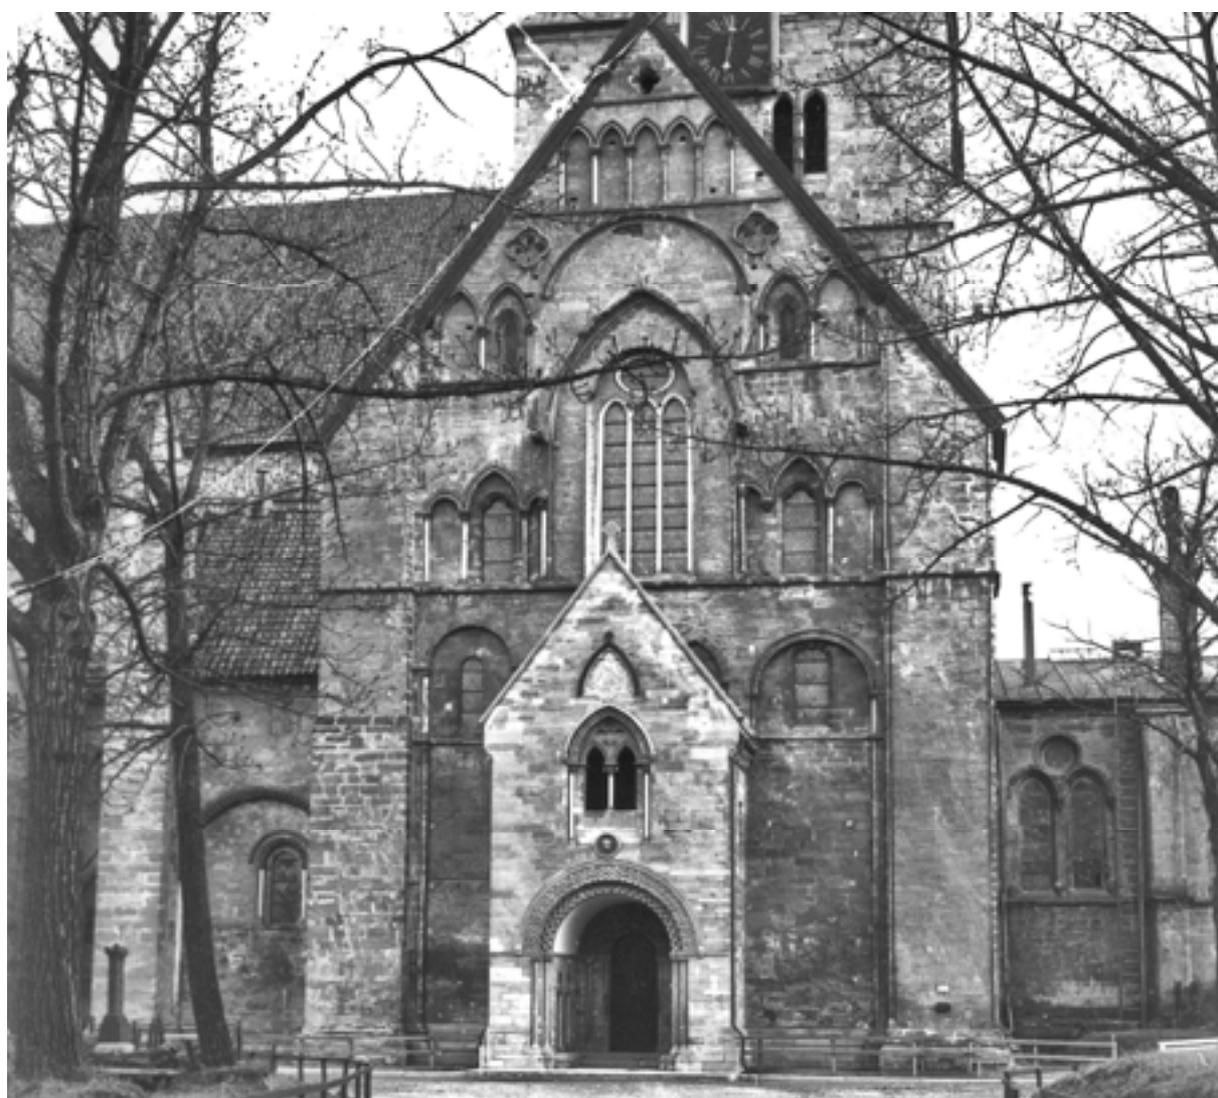
Fig. 7.13: The development of black crusts on the north porch of the cathedral. Above: c. 1881, just after the porch was restored. Next pages: 1905: There is a distinct line of black crusts along the wall. 1930: Black crusts are very widespread. 1993: The black crusts have largely disappeared, probably due to a combination of decreasing air pollution and rain washing (photos: ARW and PS).

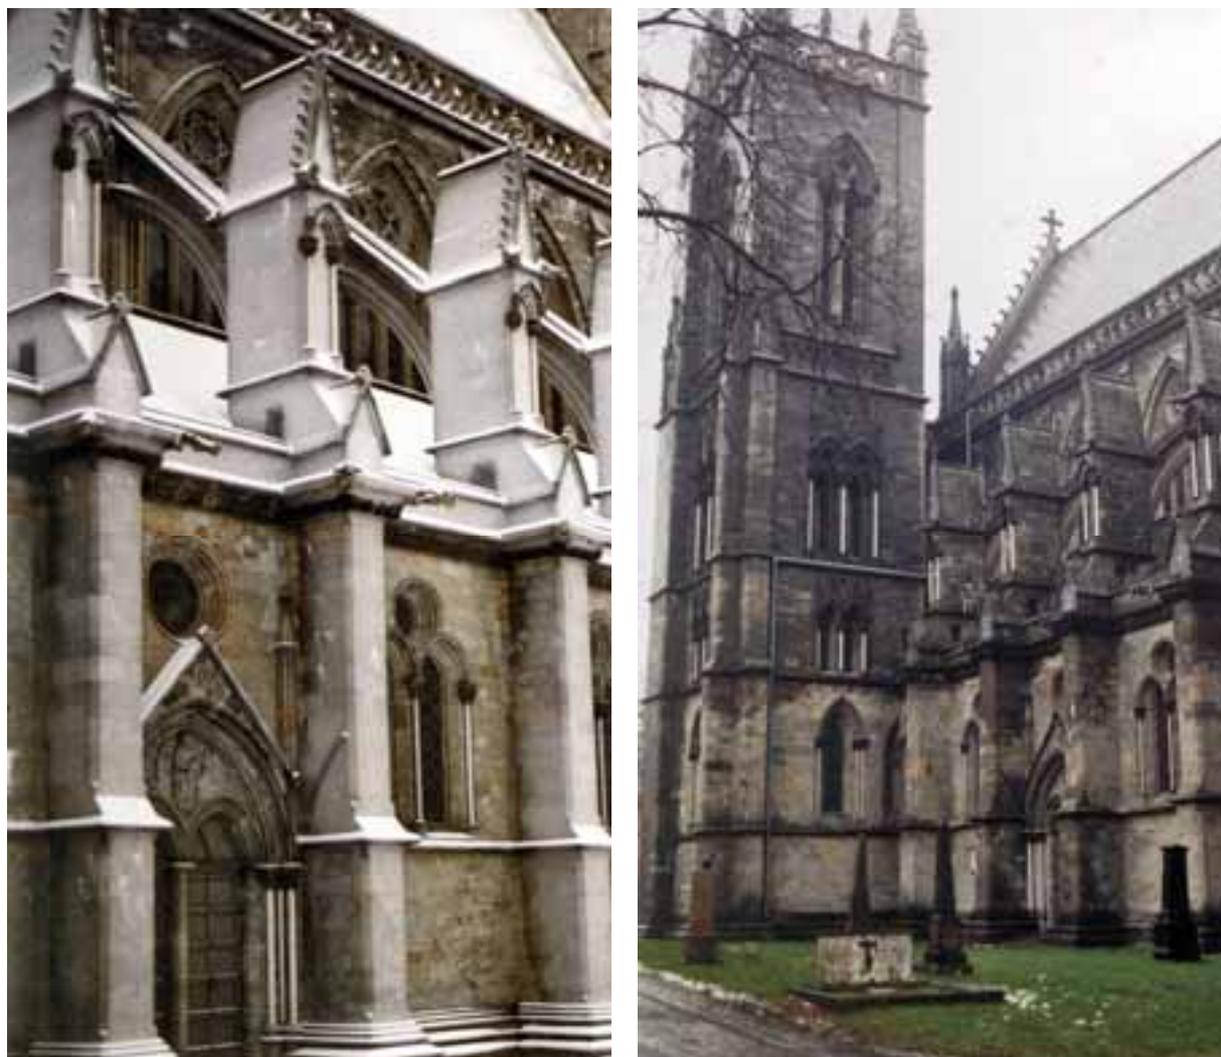
Fig. 7.20: Left: White frost has completely changed the architectural character of the cathedral. South side of the nave. Note the formation of white frost solely on unheated areas (photo: PS 12/96). Right: Autumn condensation on the south side of the cathedral in November 1995. Note that the heated, lower parts of the walls are not affected (photo: PS).

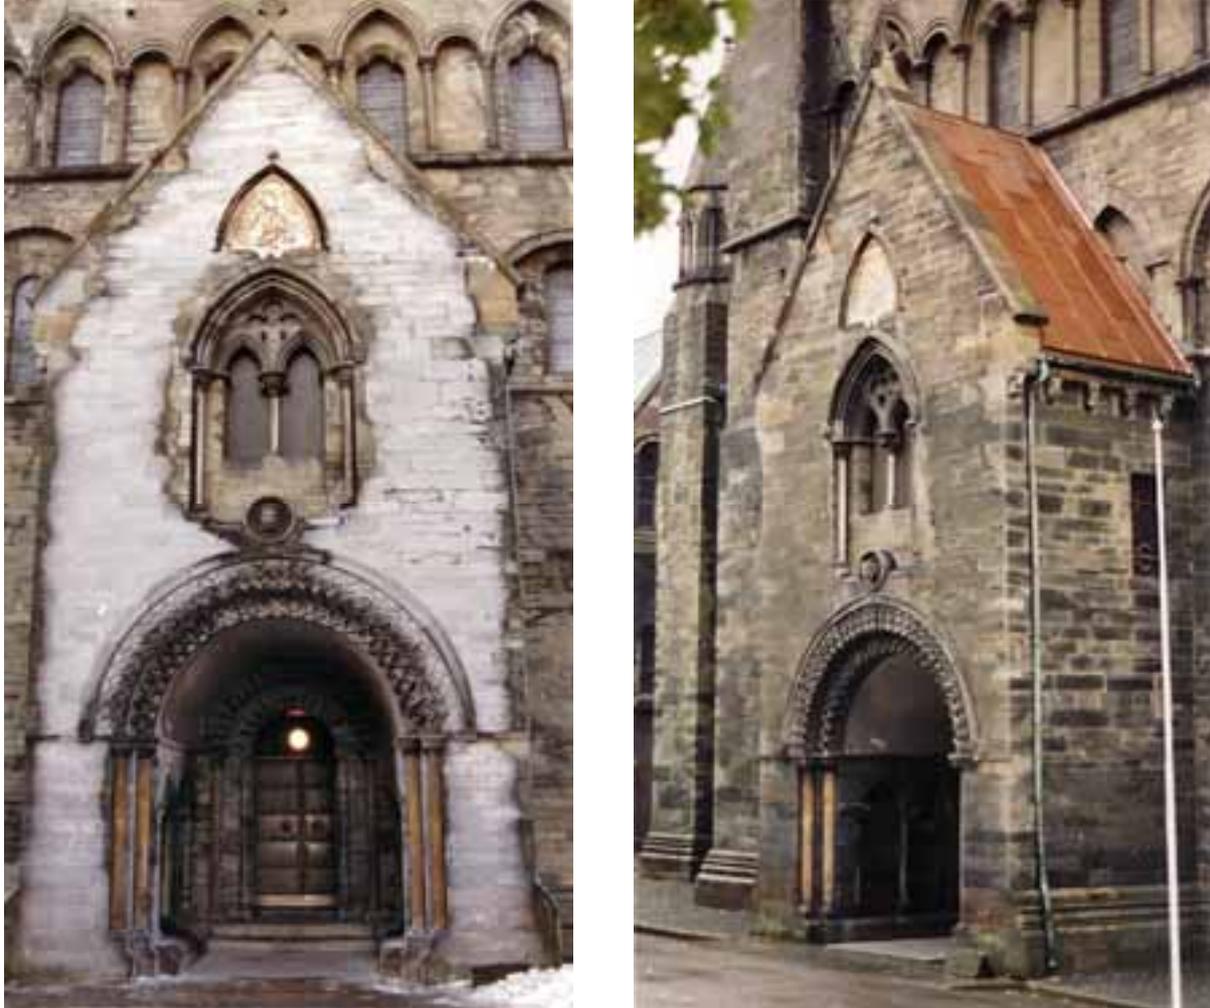
Fig. 7.21: Condensation events on the north porch and St. Michael's chapel. Left: White frost when mild weather broke a cold period in January 1996 (photo: Rune Langås, RWNC). Right: Completely wet because of condensation when mild weather broke a cold period in autumn 1995 (photo: PS).

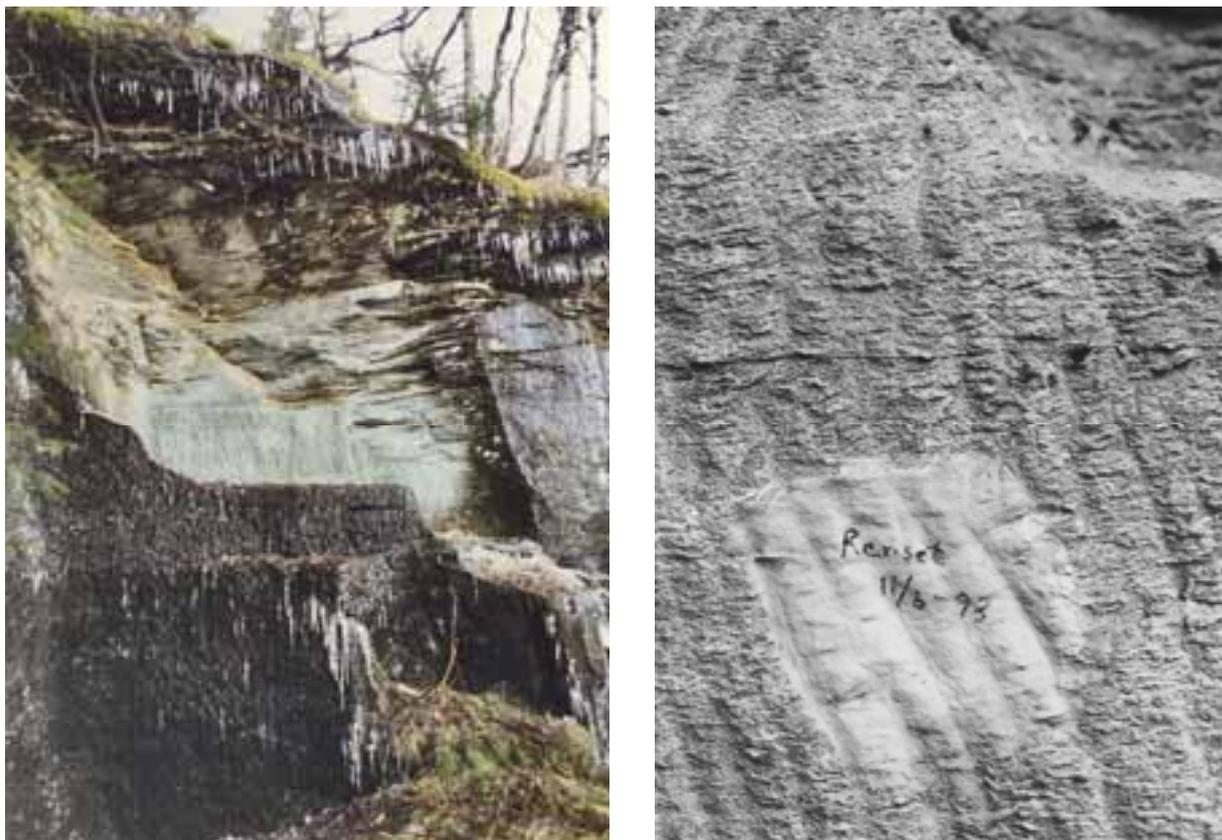
Fig. 8.5: Øye greenschist quarry. Left: Cliff in the western part of the quarry, The light (dry) area is protected from precipitation and weathers much more intensively than rock exposed to rain, snow and ice (dark areas). Right: Close-up showing that delamination is the main weathering form in the sheltered area. The disintegrated surface layer was removed on a test spot June 11th 1993. By 1996 flaking and delamination had made the test spot almost unrecognisable (photos: PS).

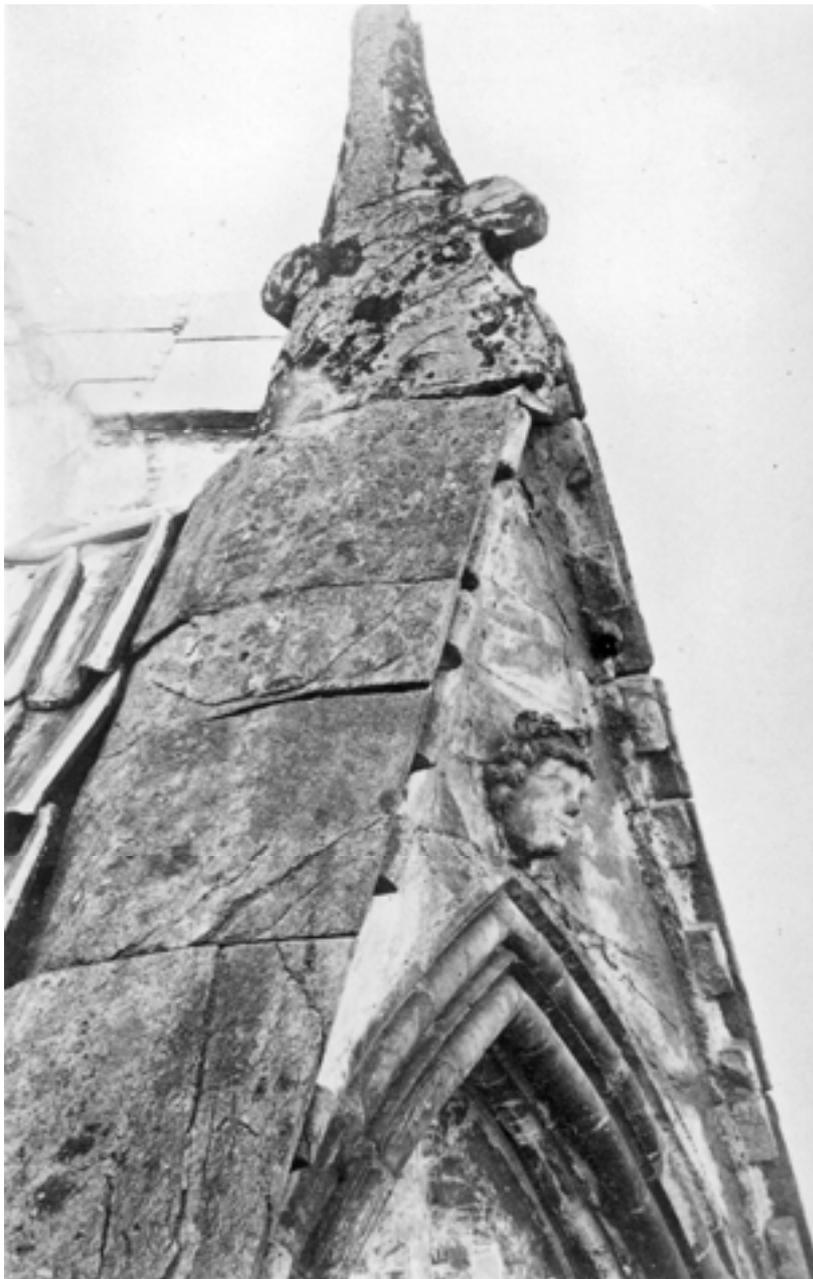
Fig. 8.14: The octagon's east chapel just before the restoration in the early 1870s. Note that gable copings made of Bakkaune soapstone have partly dissolved carbonate veins (photo: ARW).

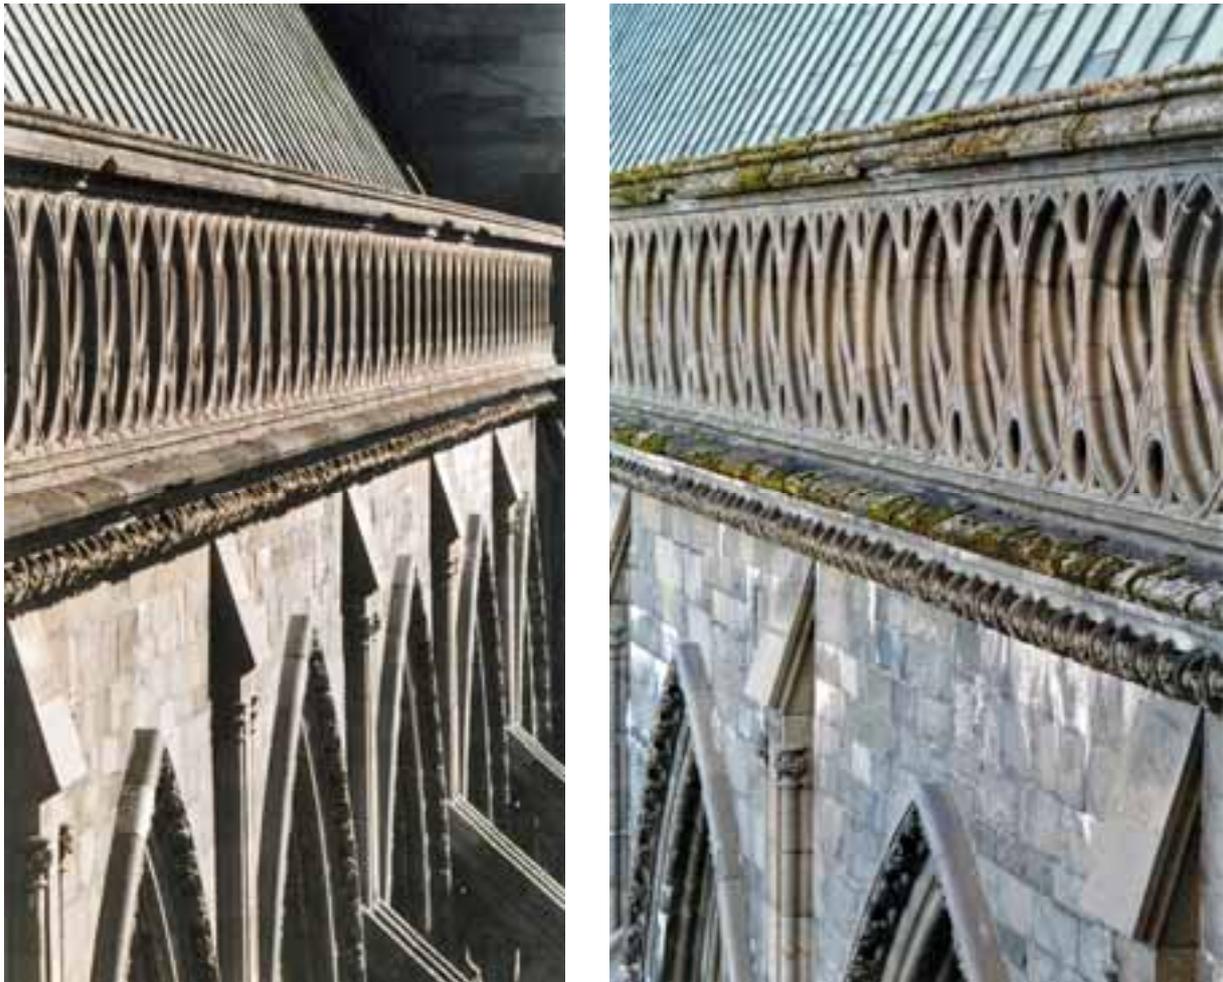
Fig. 12.4: The upper parapets of the nave in August 1995. Left: South side. Right: North side. Note that many deeply carved mouldings have been lost (photo: PS).

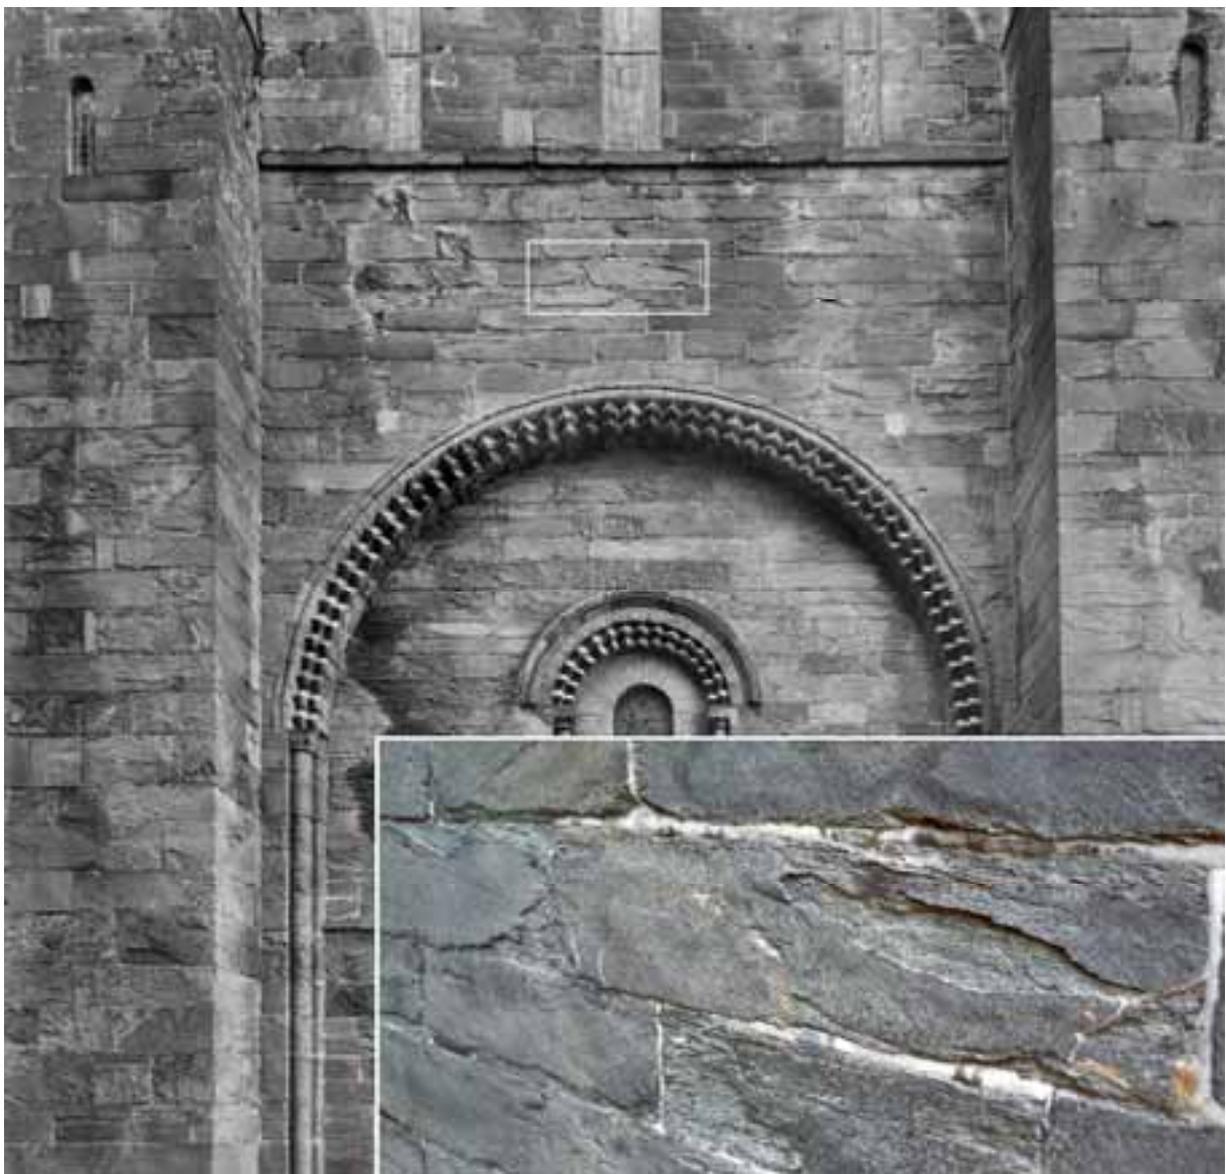
Fig. 13.6: East wall of the Lectorium and St. Mary's chapel. The most pronounced flaking of greenschist ashlars occurs between the main arch and the upper group of windows (photo: Svein T. Dahl 1990). Small picture: Detail of the exfoliation (photo: PS 9/90).

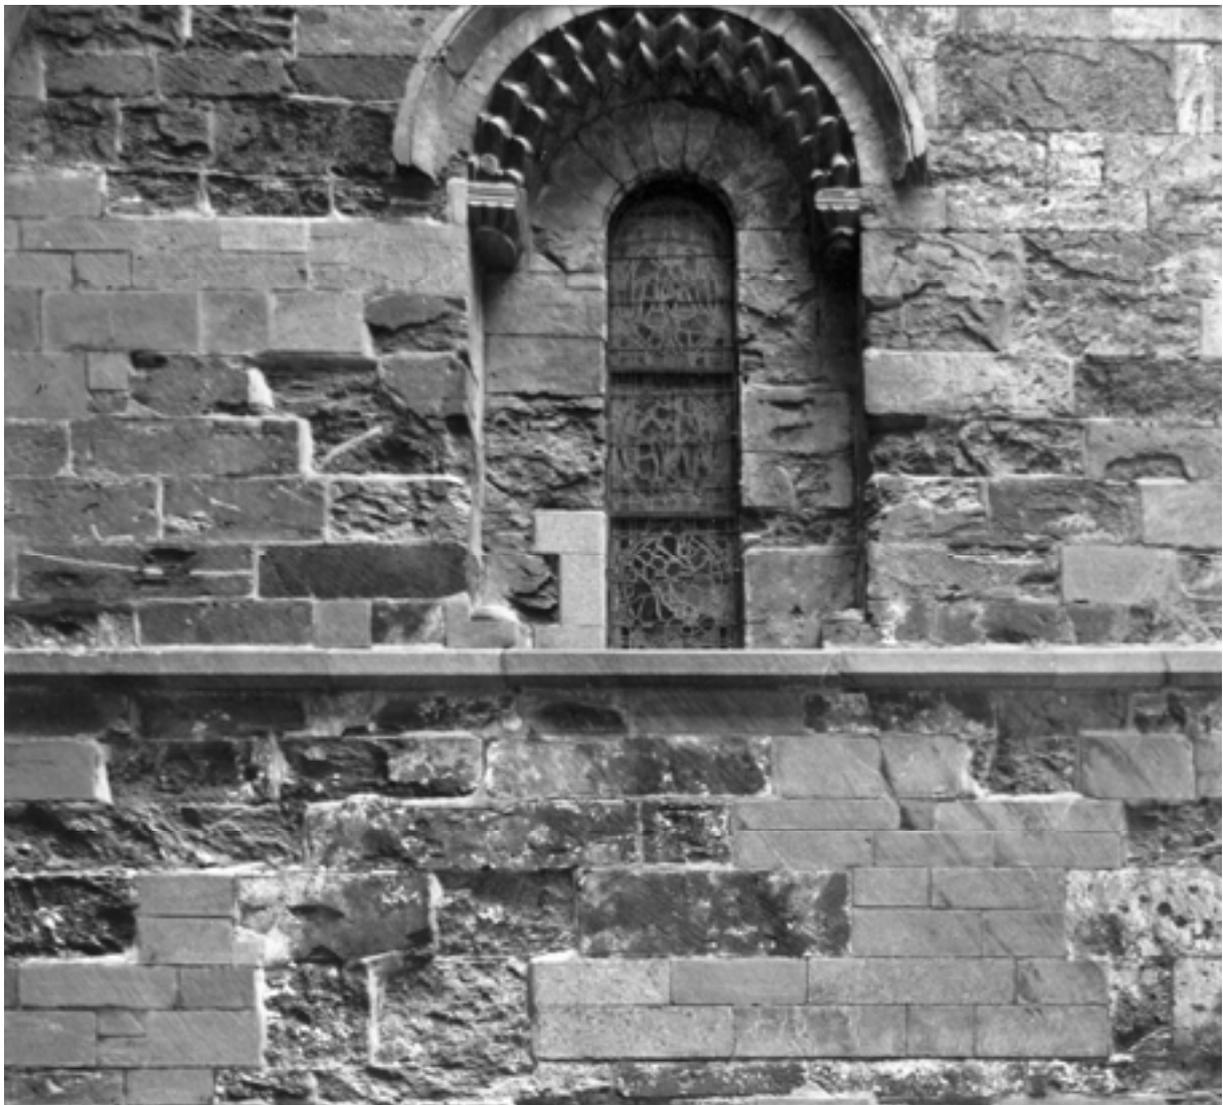
Fig. 13.10: *Narrow space between the Lectorium and choir. Fire has caused severe spalling of ashlars, but the situation is at present quite stable. The most severely damaged ashlars were replaced during the restoration (photo: Svein T. Dahl 1990).*

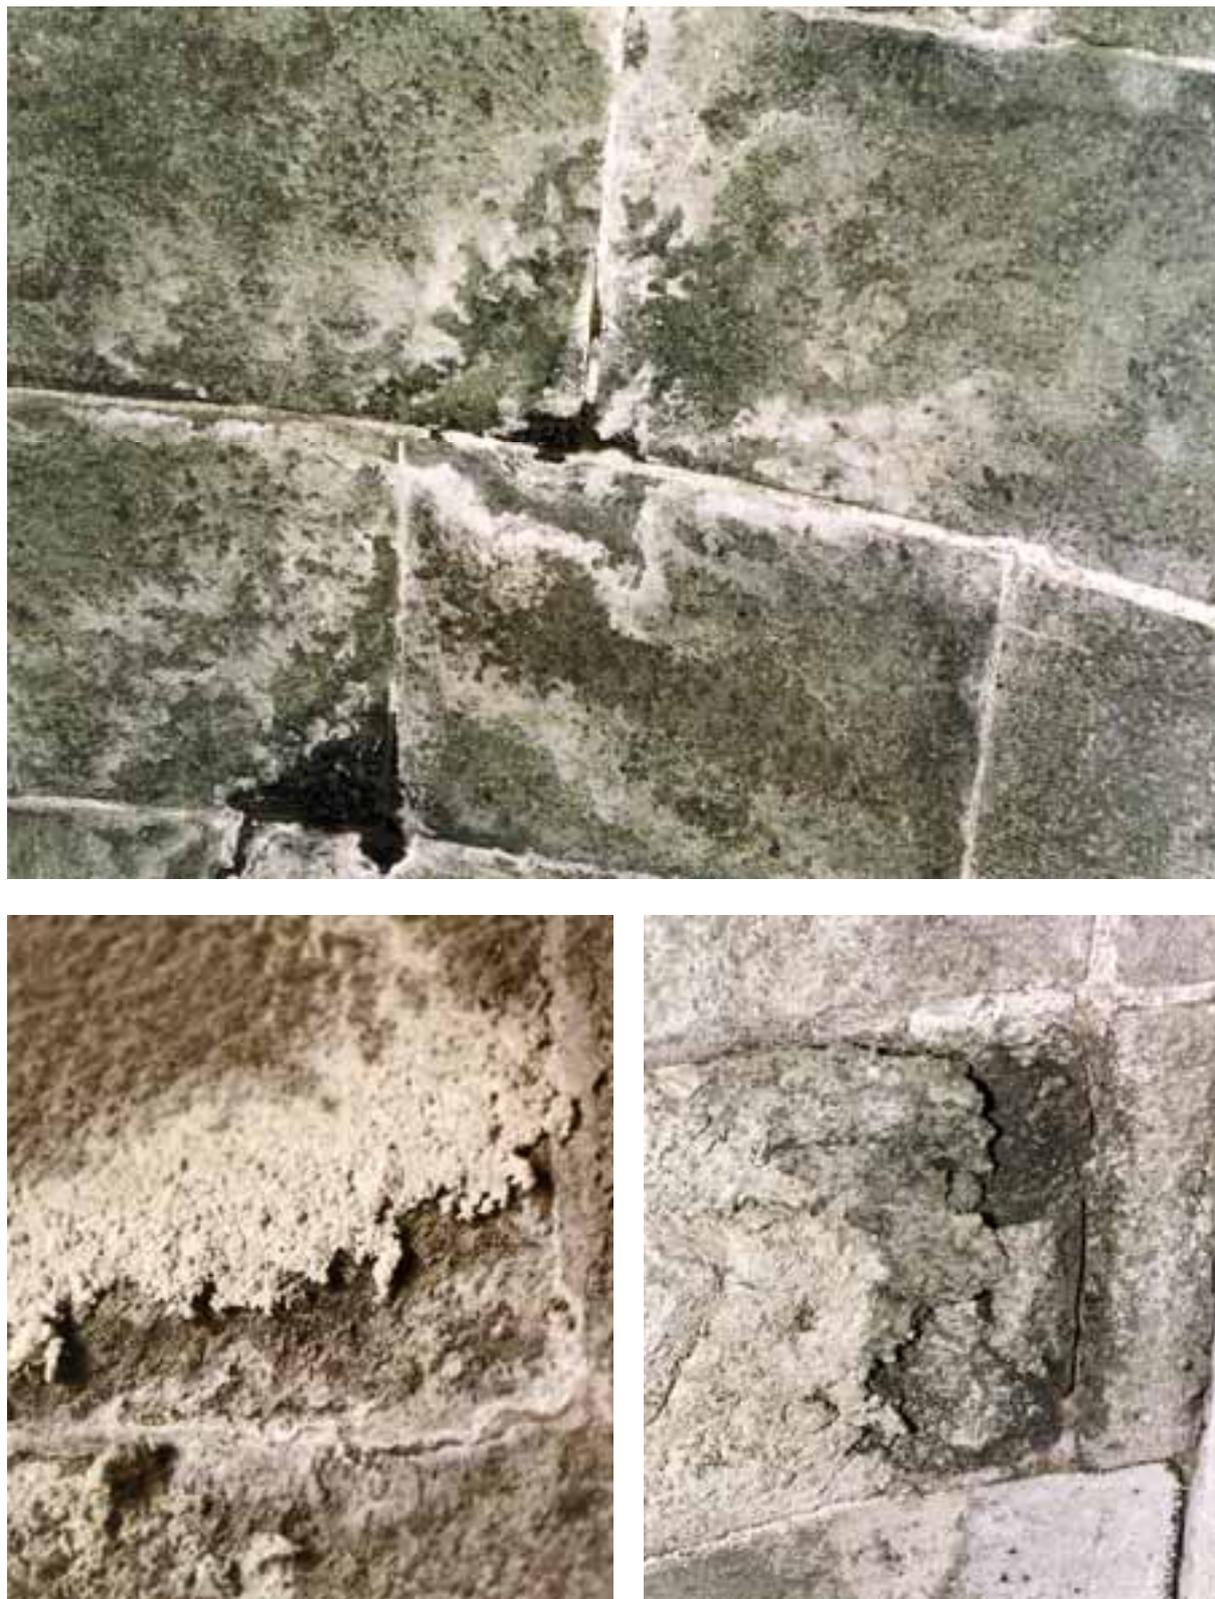
Fig. 14.8: Weathering due to alkaline salts on the walls of the staircase of the southern west tower. Top: Efflorescences of natrite forming around the joints. The dark areas represent leaks coming to the surface (photo: PS 6/91). Left: Loosely bound crust of thermonatrite dehydrated from natrite (photo: PS 5/96). Right: Large flake about to fall off. Note the salt efflorescences on the surface (photo: PS 2/91).

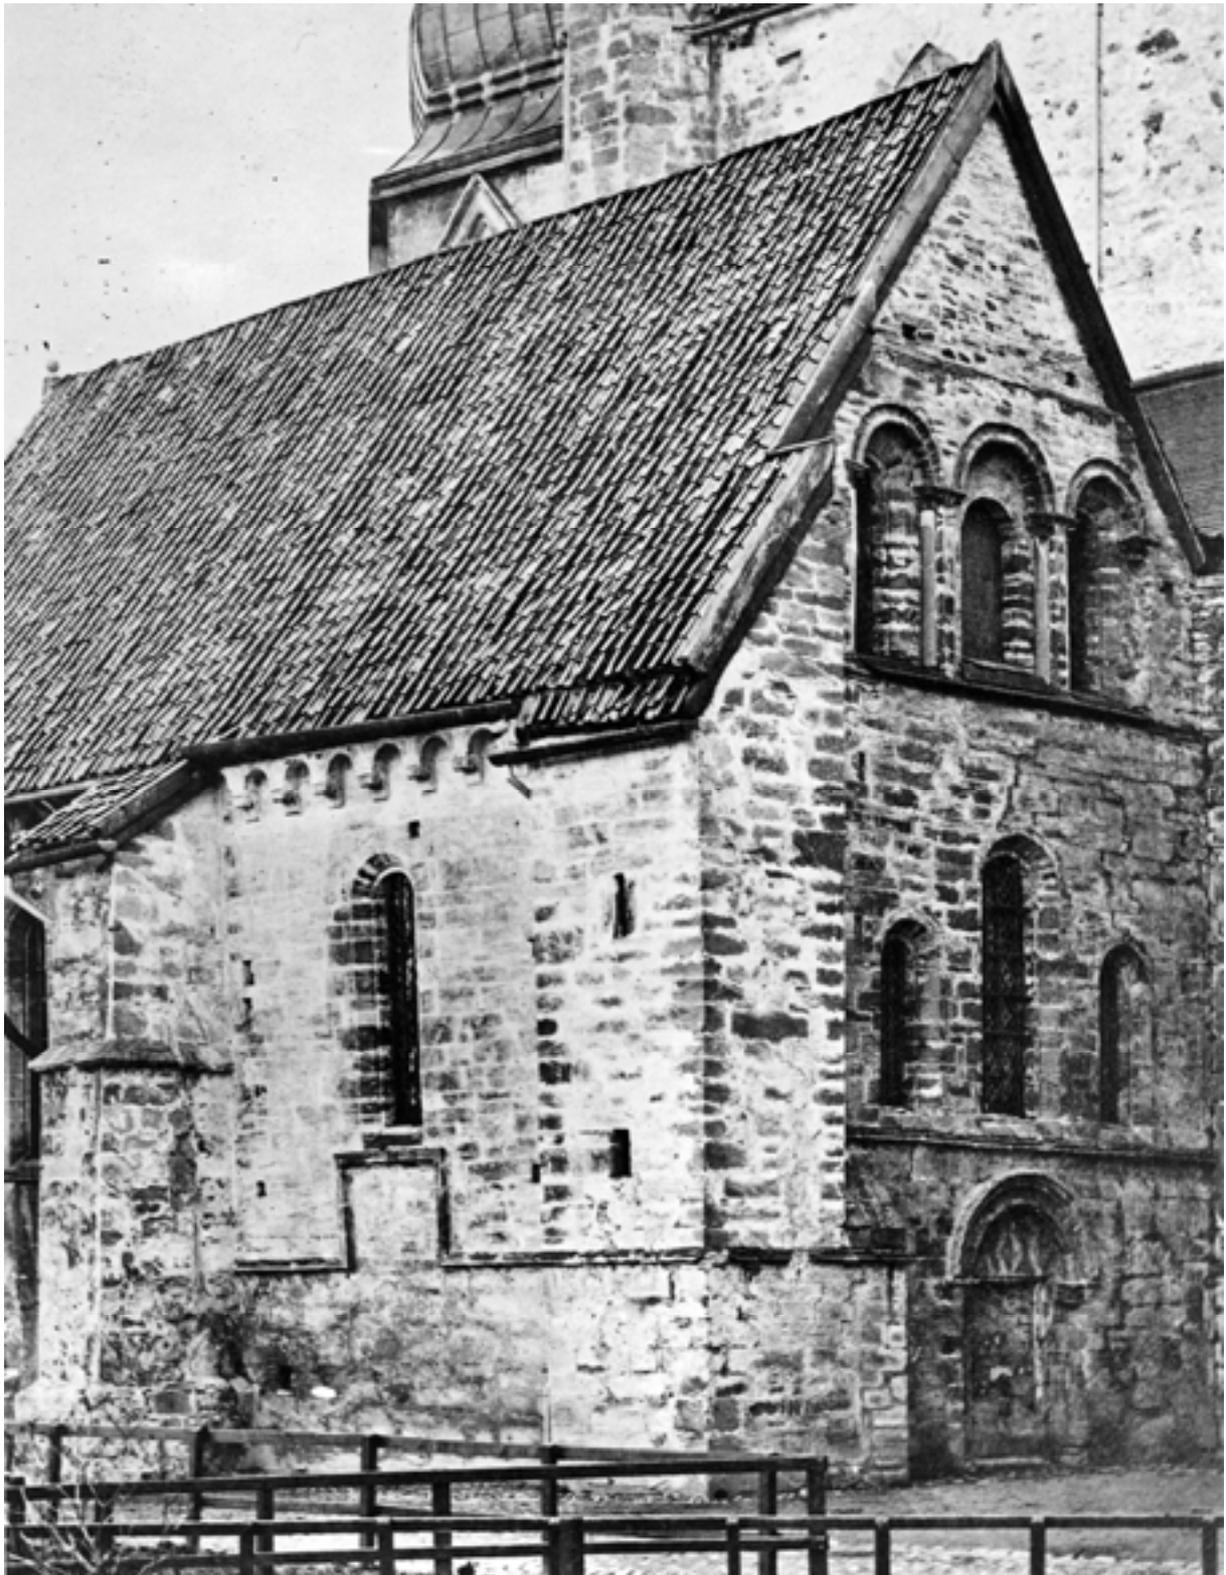
Fig. 15.1: The poor condition of the chapter house before architect Schirmer's complete restoration in 1869-71 (photo: ARW, no. 738).

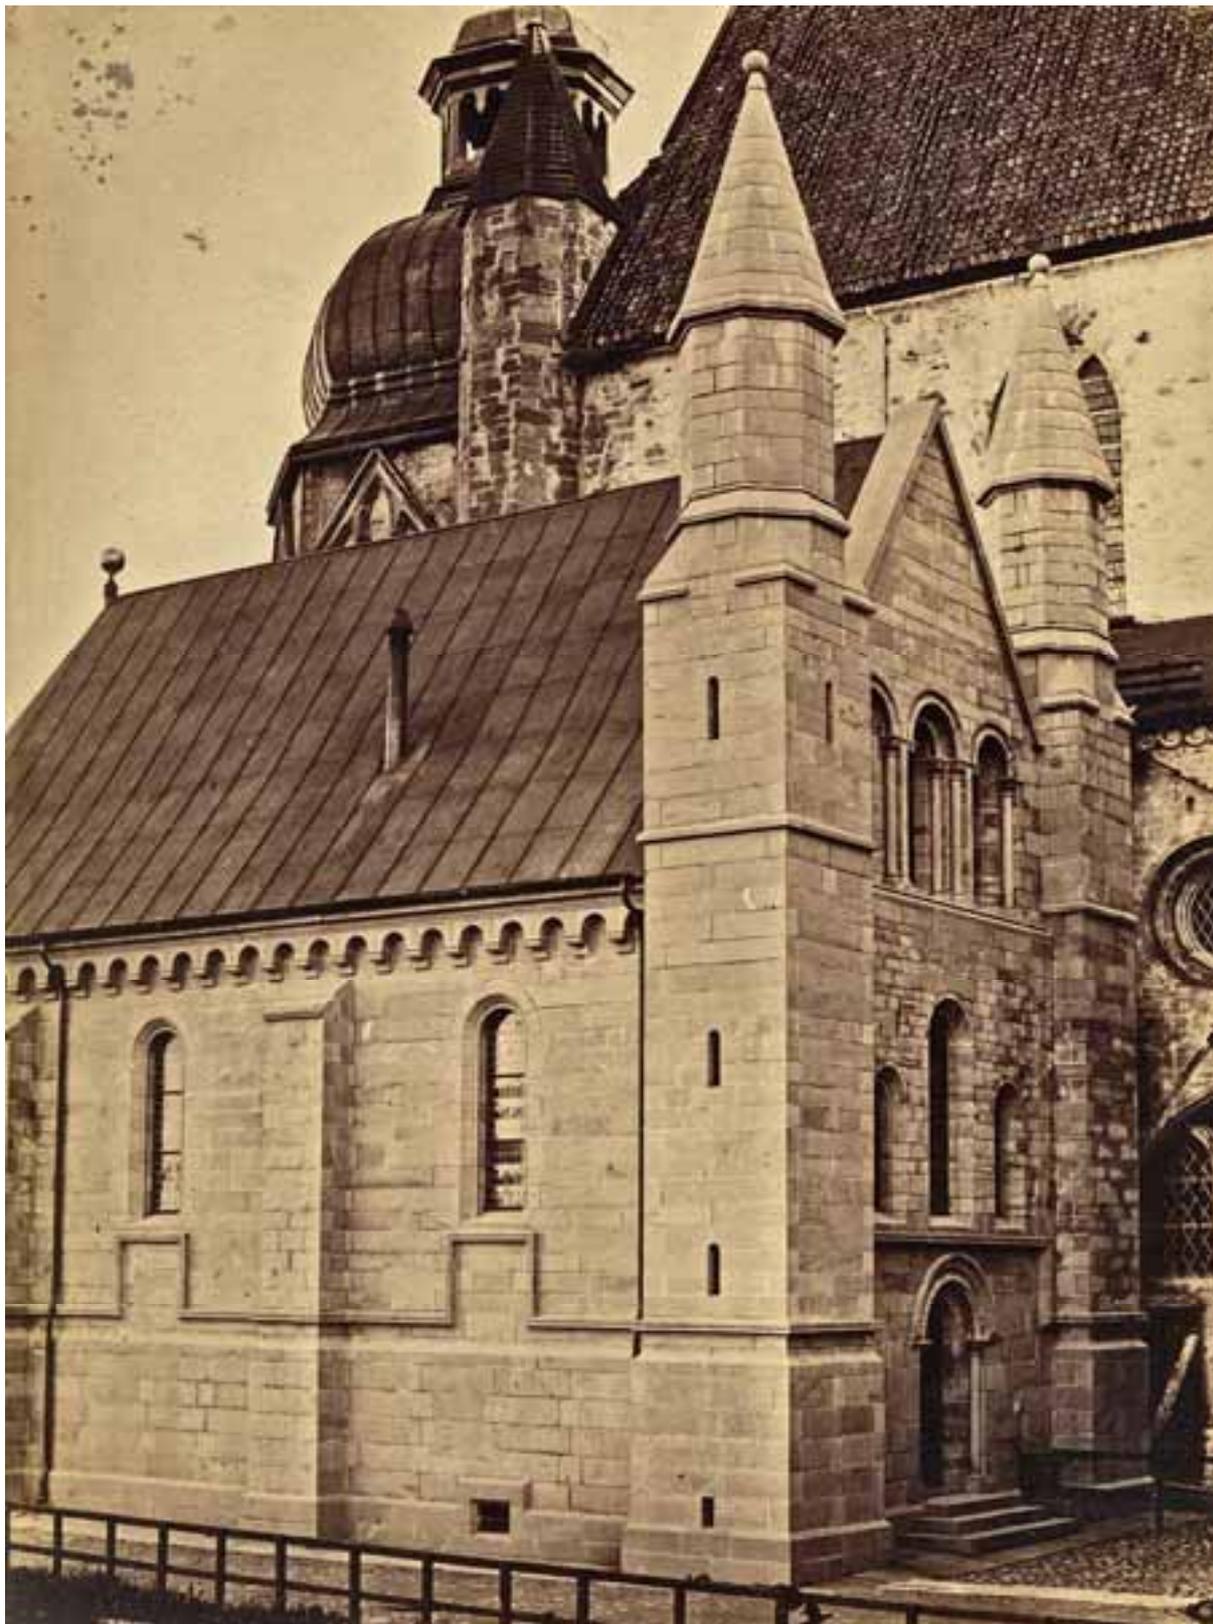
Fig. 15.2: The chapter house just after the completion of Schirmer's restoration in 1871. It is almost a completely new building! Note the wet spots on areas with reused stones. The spots are probably caused by hygroscopic salts, maybe from cleaning with acid/lye (photo: ARW).

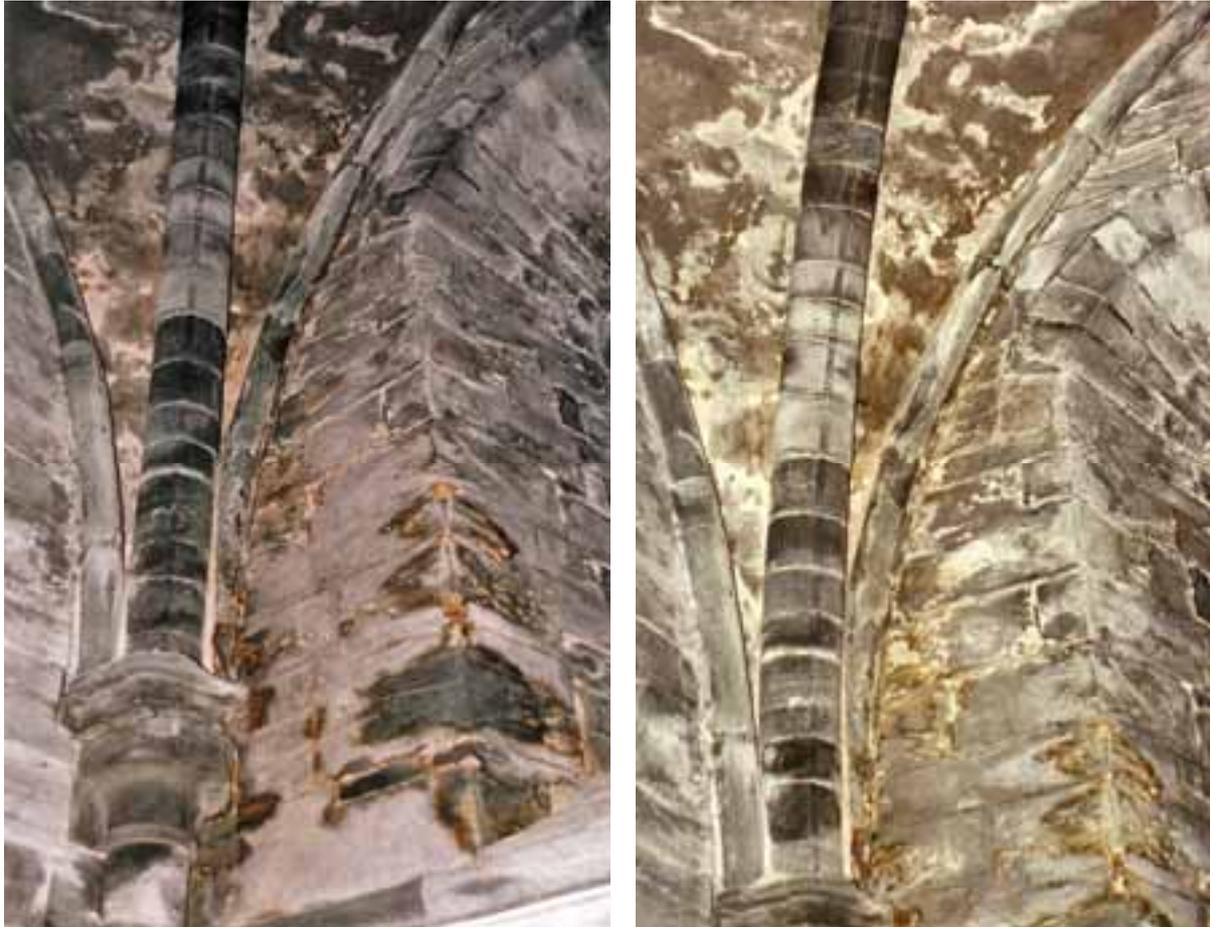
Fig. 15.11: *Left: The south west corner of the west wall of the chapter house during an event of summer condensation. Note the wet (dark) spots which are caused by dissolution of hygroscopic salts, mainly mirabilite (photo: PS 8/95). Right: The corner in the winter time when the cathedral is heated. The wet spots have disappeared (photo: PS 1/95).*
