The Stones of Nidaros

An Applied Weathering Study of
Europe's Northernmost
Medieval Cathedral

Dr. Ing. (Ph.D.) thesis no. 1997:92
Department of Architectural History
Norwegian University of Science and Technology
Trondheim, Norway

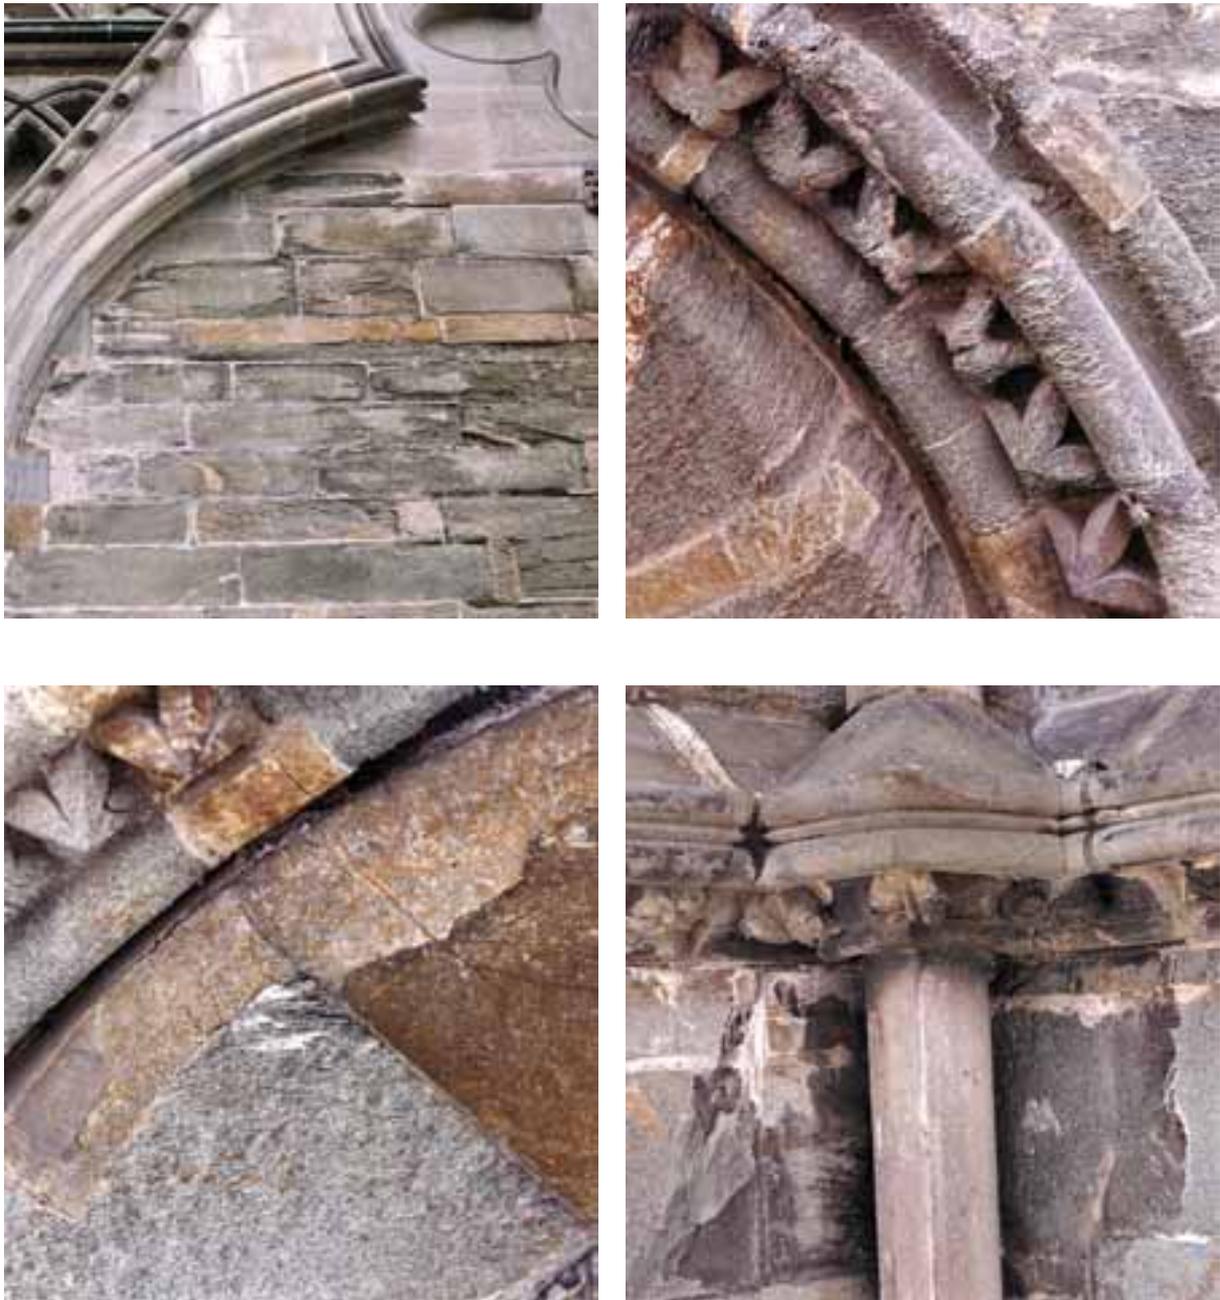
Fig. 16.9: Details of the east wall of the east chapel in 1993. Top left: Condition of the upper section. Note the new stones (from 1974-76) and how the weathering of the medieval greenschists is concentrated along joints. Top right: Arch of the southern window. Note the small stone pieces which were inserted in 1871-73 and the delamination of medieval dog tooth ornamentation (greenschist). Left: Arch of the southern window. Note the salts in a small delaminated zone (thenardite) and underneath the dog teeth (trona). Right: Area below the string course on the southern side. The string course is not in order. There are joint fissures leading to water infiltration, and a lot of black crusts (photos: PS).

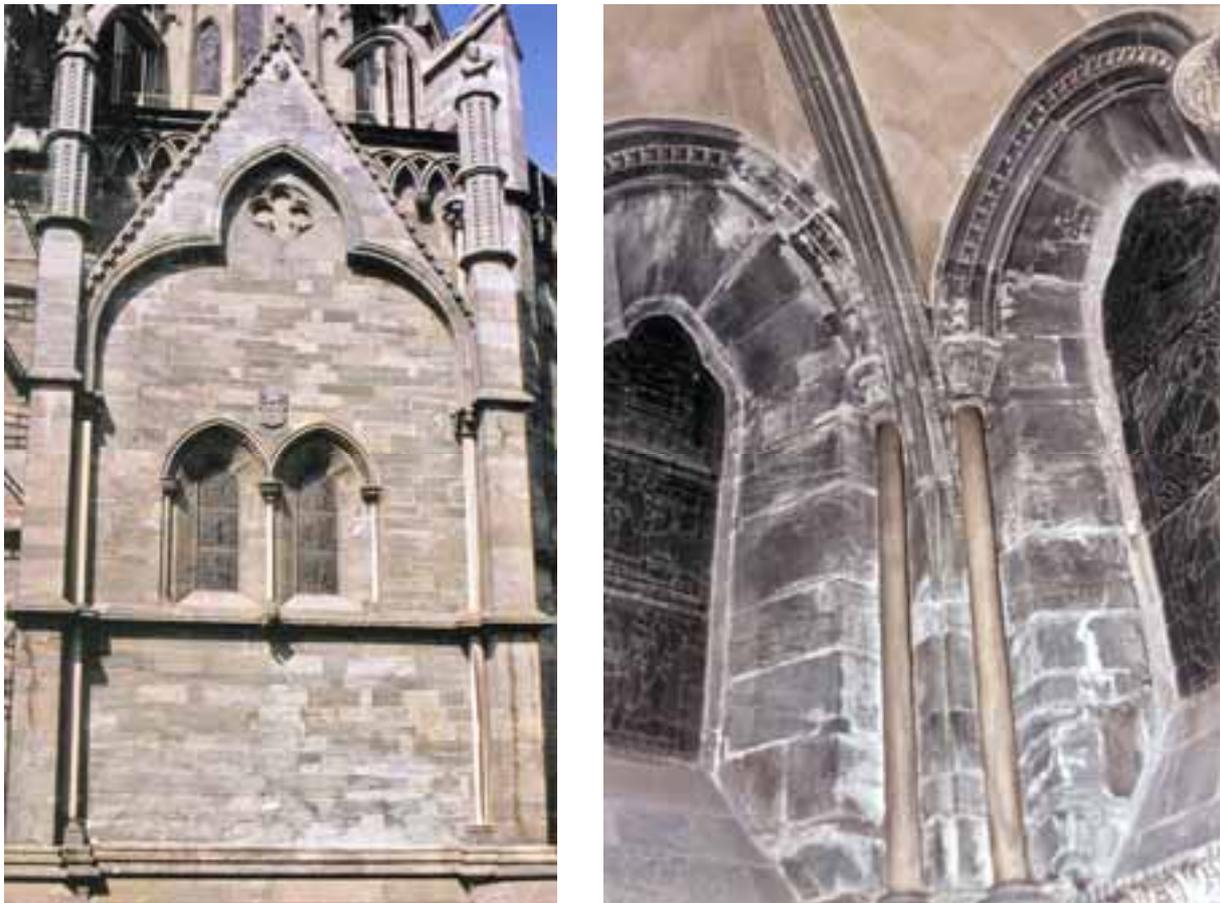
Fig. 16.14: The south chapel of the octagon. Left: The area below the trefoil arch is exposed to rain and therefore in a rather good condition today. Right: The interior of the chapel is characterised by rapid salt weathering (alkaline salts) (photos: PS 1992-93).

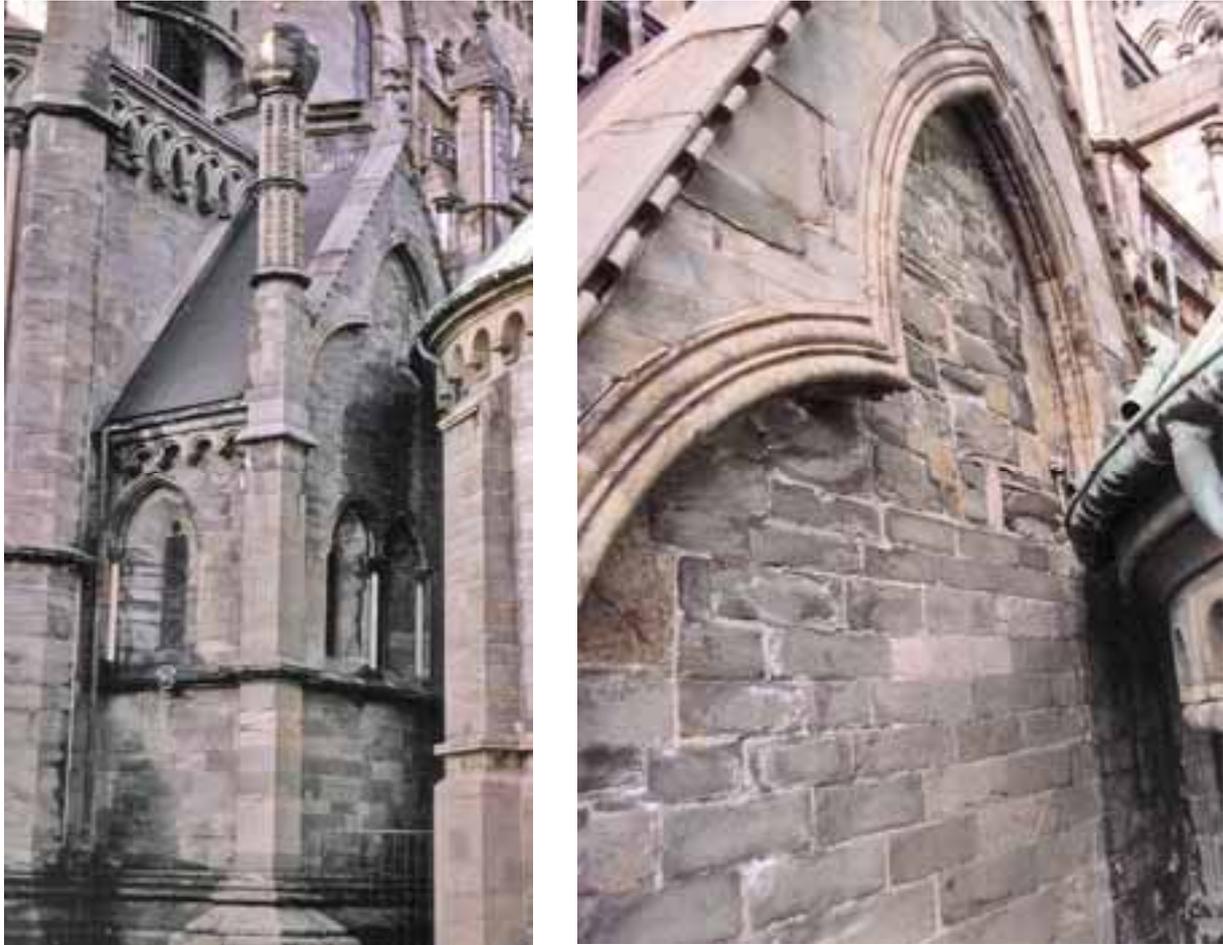
Fig. 16.15: *The north chapel of the octagon. Left: Situation after a downpour in October 1992. Observe the wet area just above the windows of the north wall. Right: Water is provided from a downpipe coming down from the upper parapet of the choir! Observe that masonry affected by the run-off is sound while the adjacent stonework is characterised by salt weathering along joints. The salts mostly originate from lime cement mortars due to water infiltration through large joint fissures in the gable (June 1993) (photos: PS).*

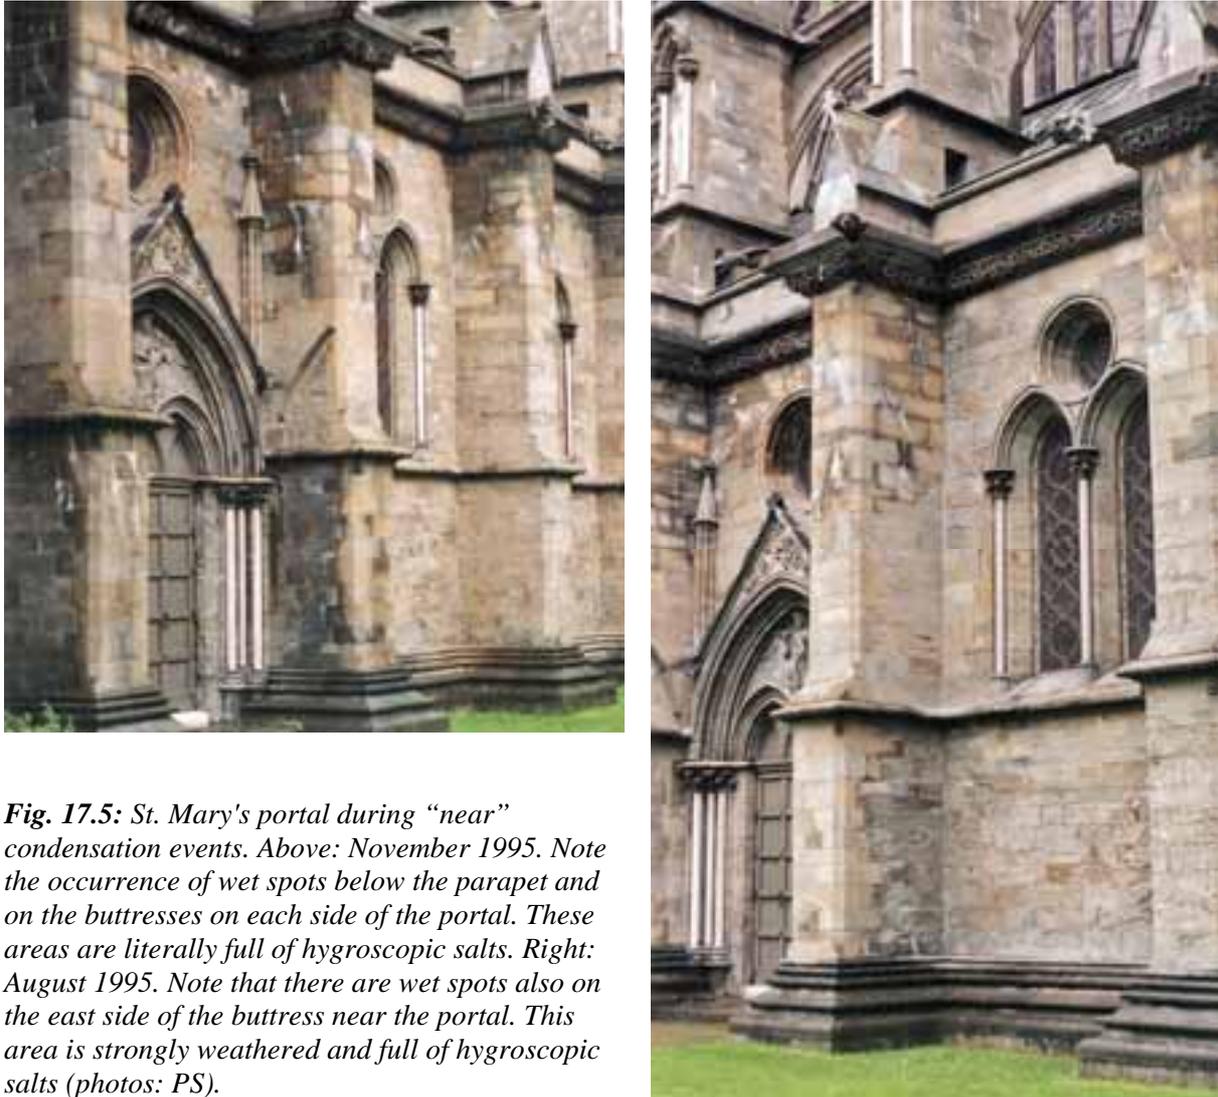
Fig. 17.5: St. Mary's portal during "near" condensation events. Above: November 1995. Note the occurrence of wet spots below the parapet and on the buttresses on each side of the portal. These areas are literally full of hygroscopic salts. Right: August 1995. Note that there are wet spots also on the east side of the buttress near the portal. This area is strongly weathered and full of hygroscopic salts (photos: PS).

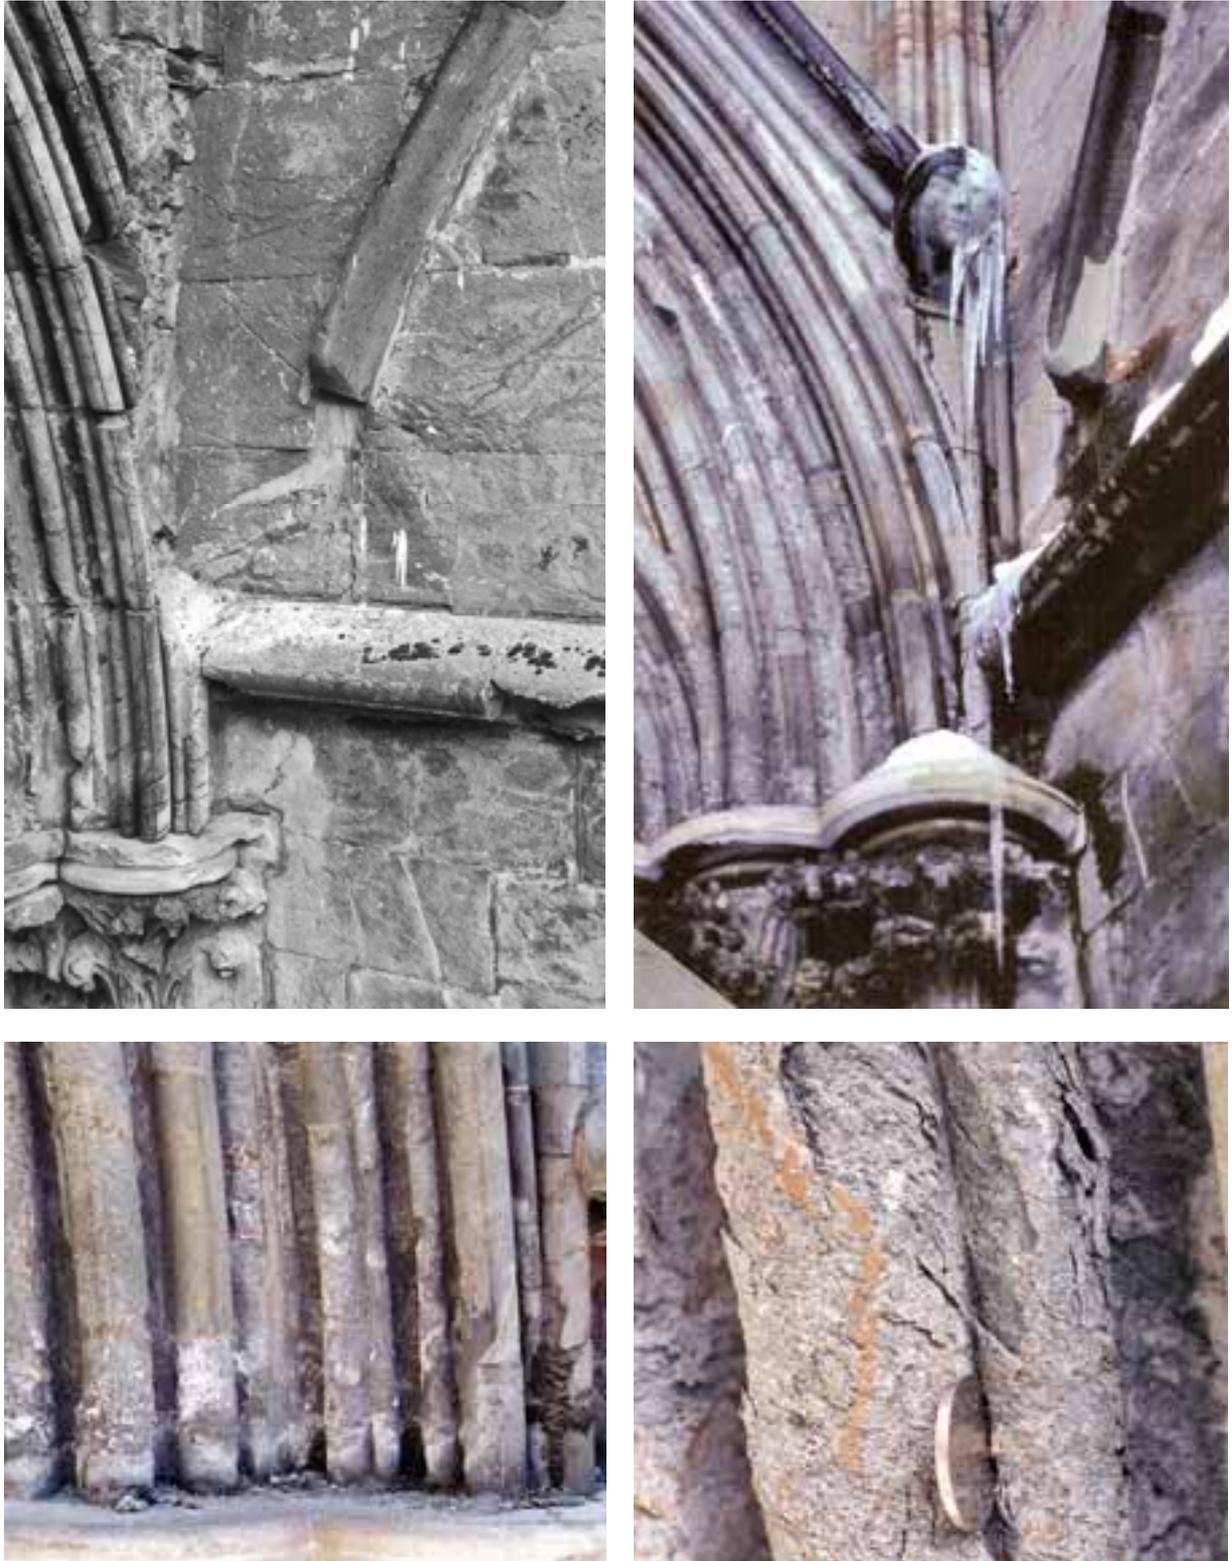
Fig. 17.8: Weathering of St. Mary's portal, east corner. Top left: Condition before the restoration (c. 1900). The head between the gable and the pinnacle is missing (photo: ARW, no. 1188). Top right: Ice formation in February 1995. The partially reconstructed capitals have lost several pieces after the restoration, probably due to frost. Left: Salt weathering in the moulded arch just above the marble plate. Right: Detail of the moulded arch (April 1994). The cracked moulding was initially "weak" due to the 1531-fire - since c. 1900 it has been destroyed, mainly due to alkaline salts (photos: PS)

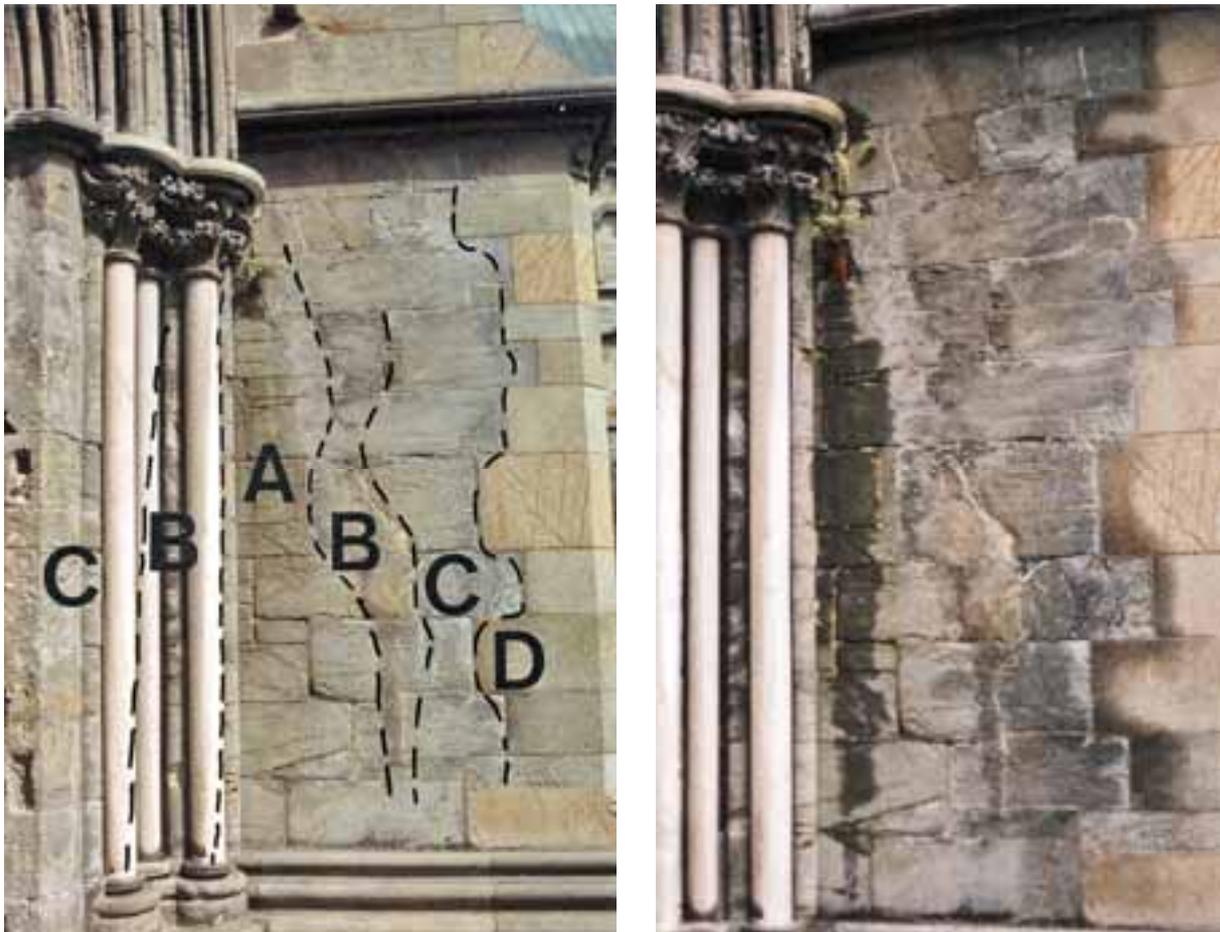
Fig. 17.9: The lower, east part of St. Mary's portal and the adjacent buttress during fine weather in June 1993 (left) and very humid weather after slight rain in August 1995 (right). Observe run-off from the marble plate above the capitals. The distinct run-off pattern has developed because water from several sources collects in the corner by the marble plate. Ashlars in the actual run-off area (A) are sound. Beside the main waterway (on the buttress) there are three different zones: B) a narrow zone with black crusts which are associated with flaking of the stones; C) a broader zone characterised by granular disintegration and salt efflorescences (in dry weather); D) a zone with highly hygroscopic salts (seen on the "new" stone from c. 1900). The particular zoning has developed because of the different solubility products of the salts. Note that the salts close to the door cannot be washed away by rain (photo: PS)

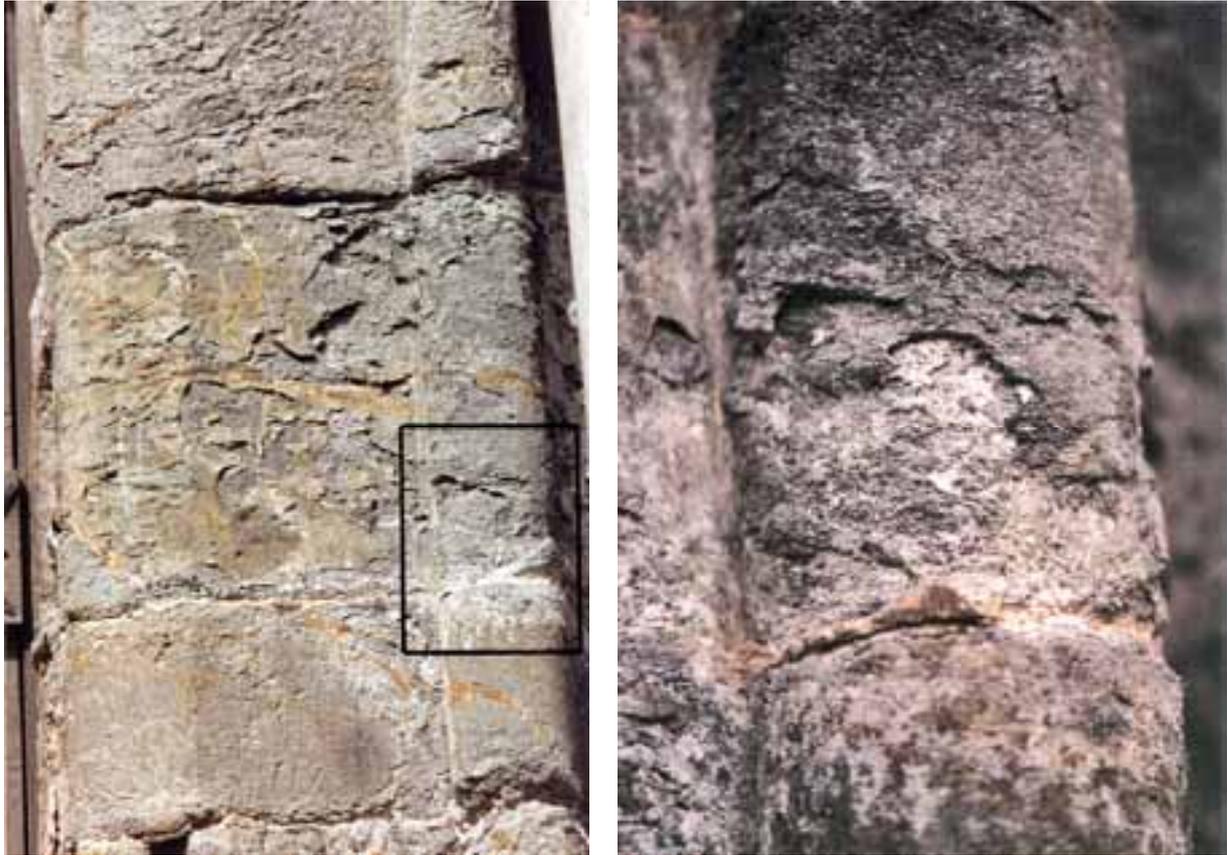
Fig. 17.10: The east flank of St. Mary's portal is affected by “horizontally” migrating salts because of the run-off system in the corner (fig. 17.9). Left: Extensive flaking and granular disintegration in June 1993. Right: Detail in March 1990. Note all the salts and that the weathering has proceeded rapidly between 1990 and 1993 (photos: PS).

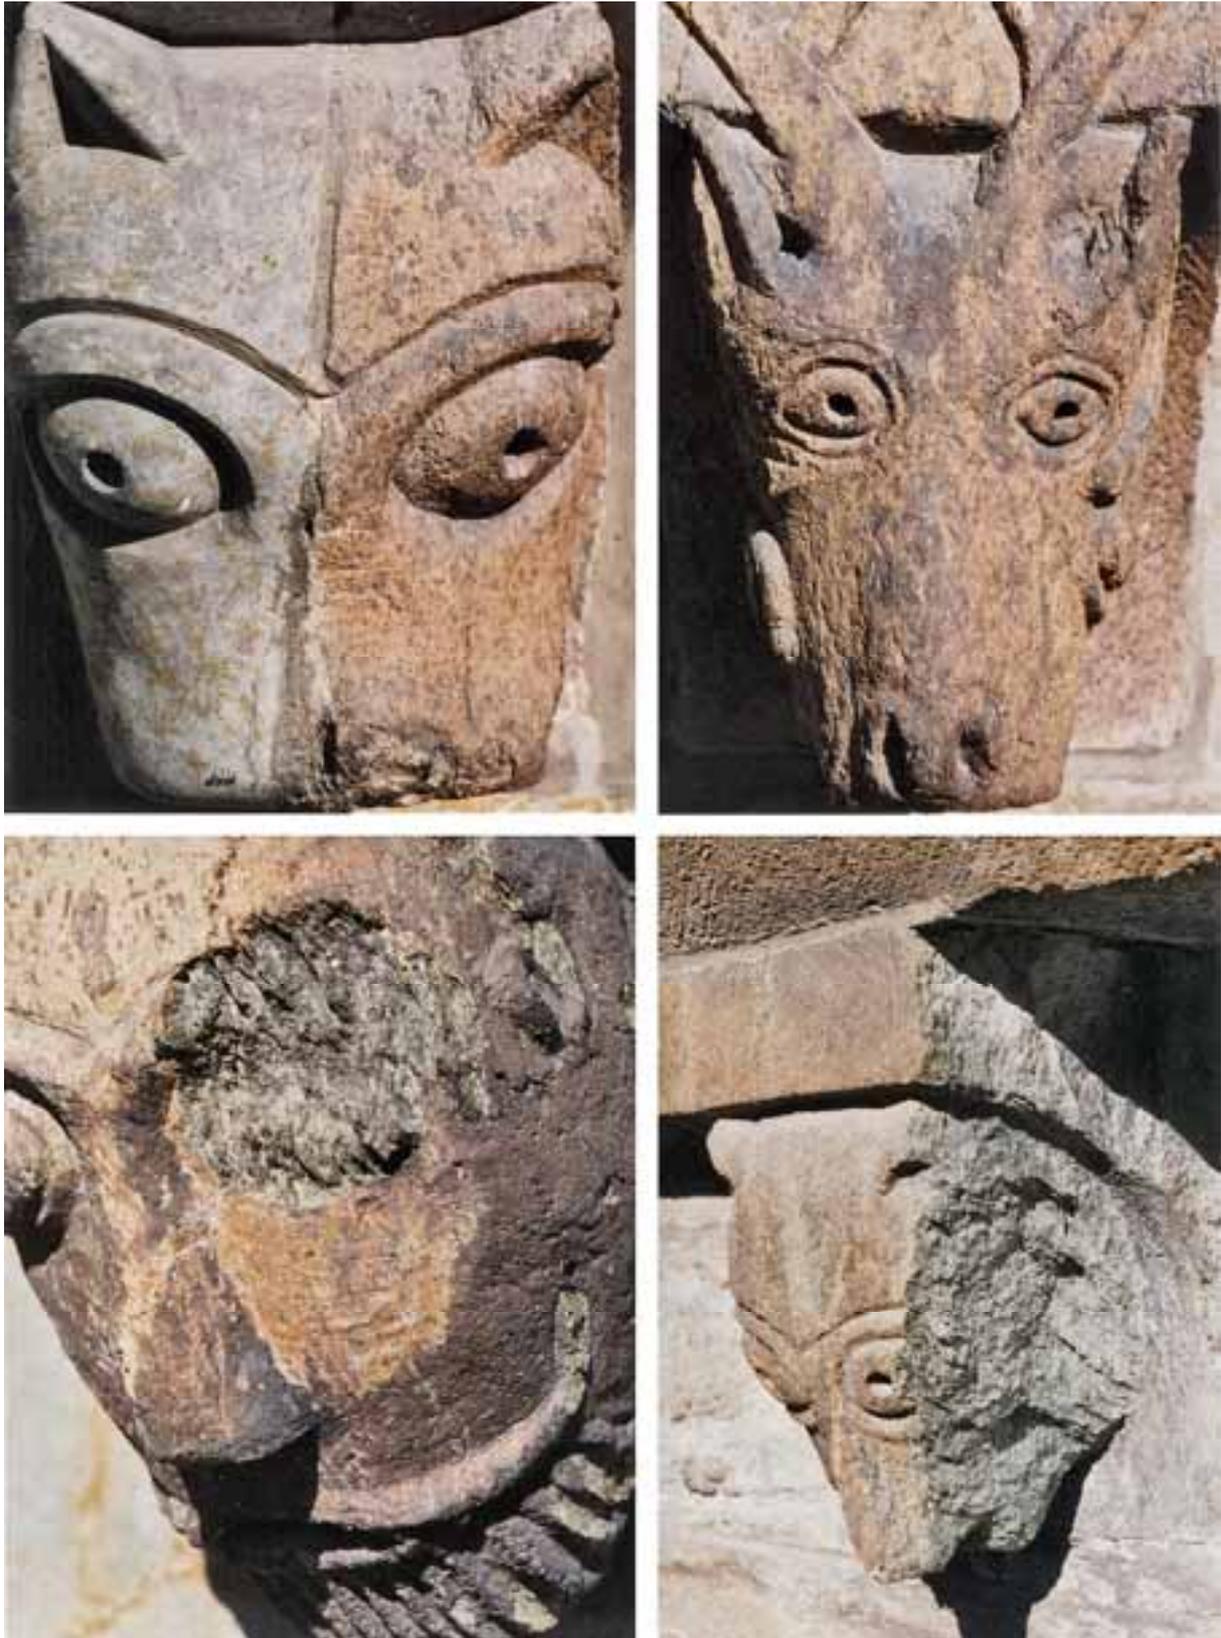
Fig. 18.1: Four corbel heads in St. Olav's chapel in September 1995. Top left: Half the face lost before 1870, probably due to fire, reconstructed in the late 1870s. Top right: No particular change since 1870. Left: Eye lost before 1870. Note the paint layer partly covering the face. Right: East side lost between 1960 and 1990 (photos: PS).

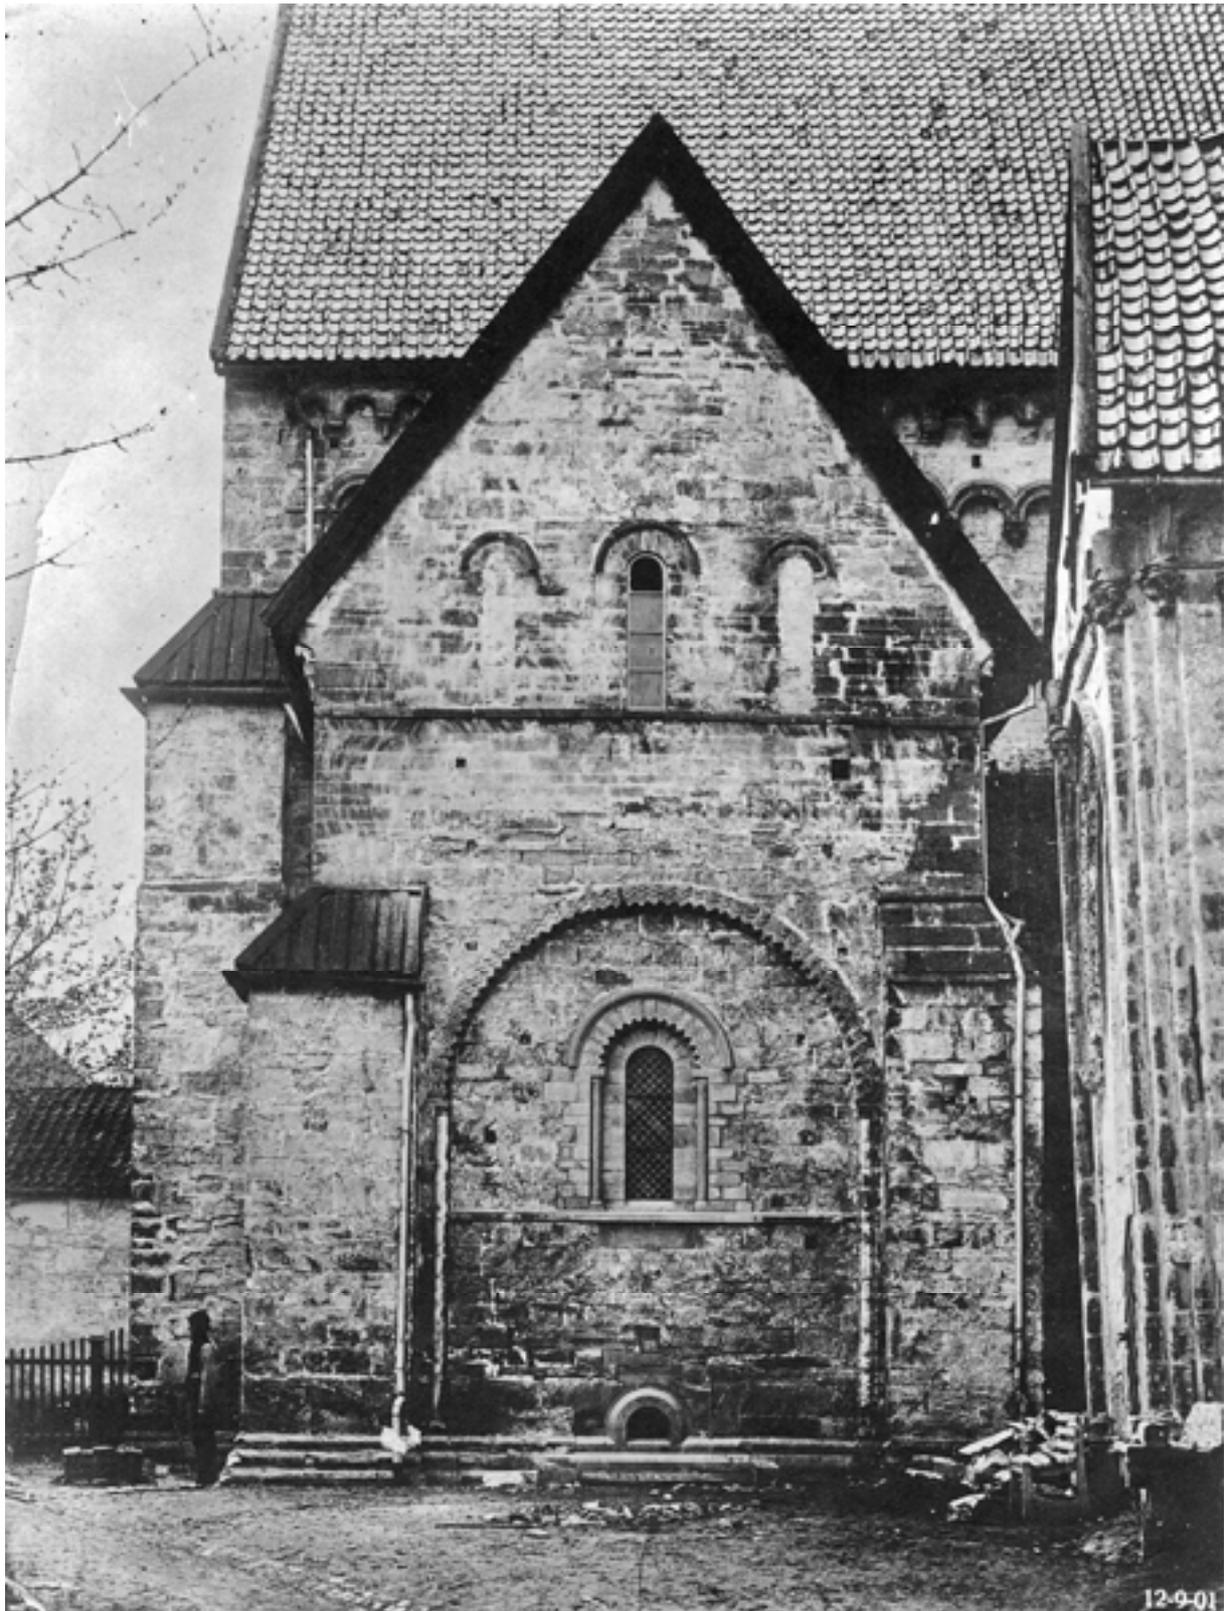
Fig. 18.2: *St. Olav's chapel, looking west. Condition in c. 1870, before the restoration. Note that gableboards and eaves protect the corbels in the cornices (photo: ARW, no. 997).*

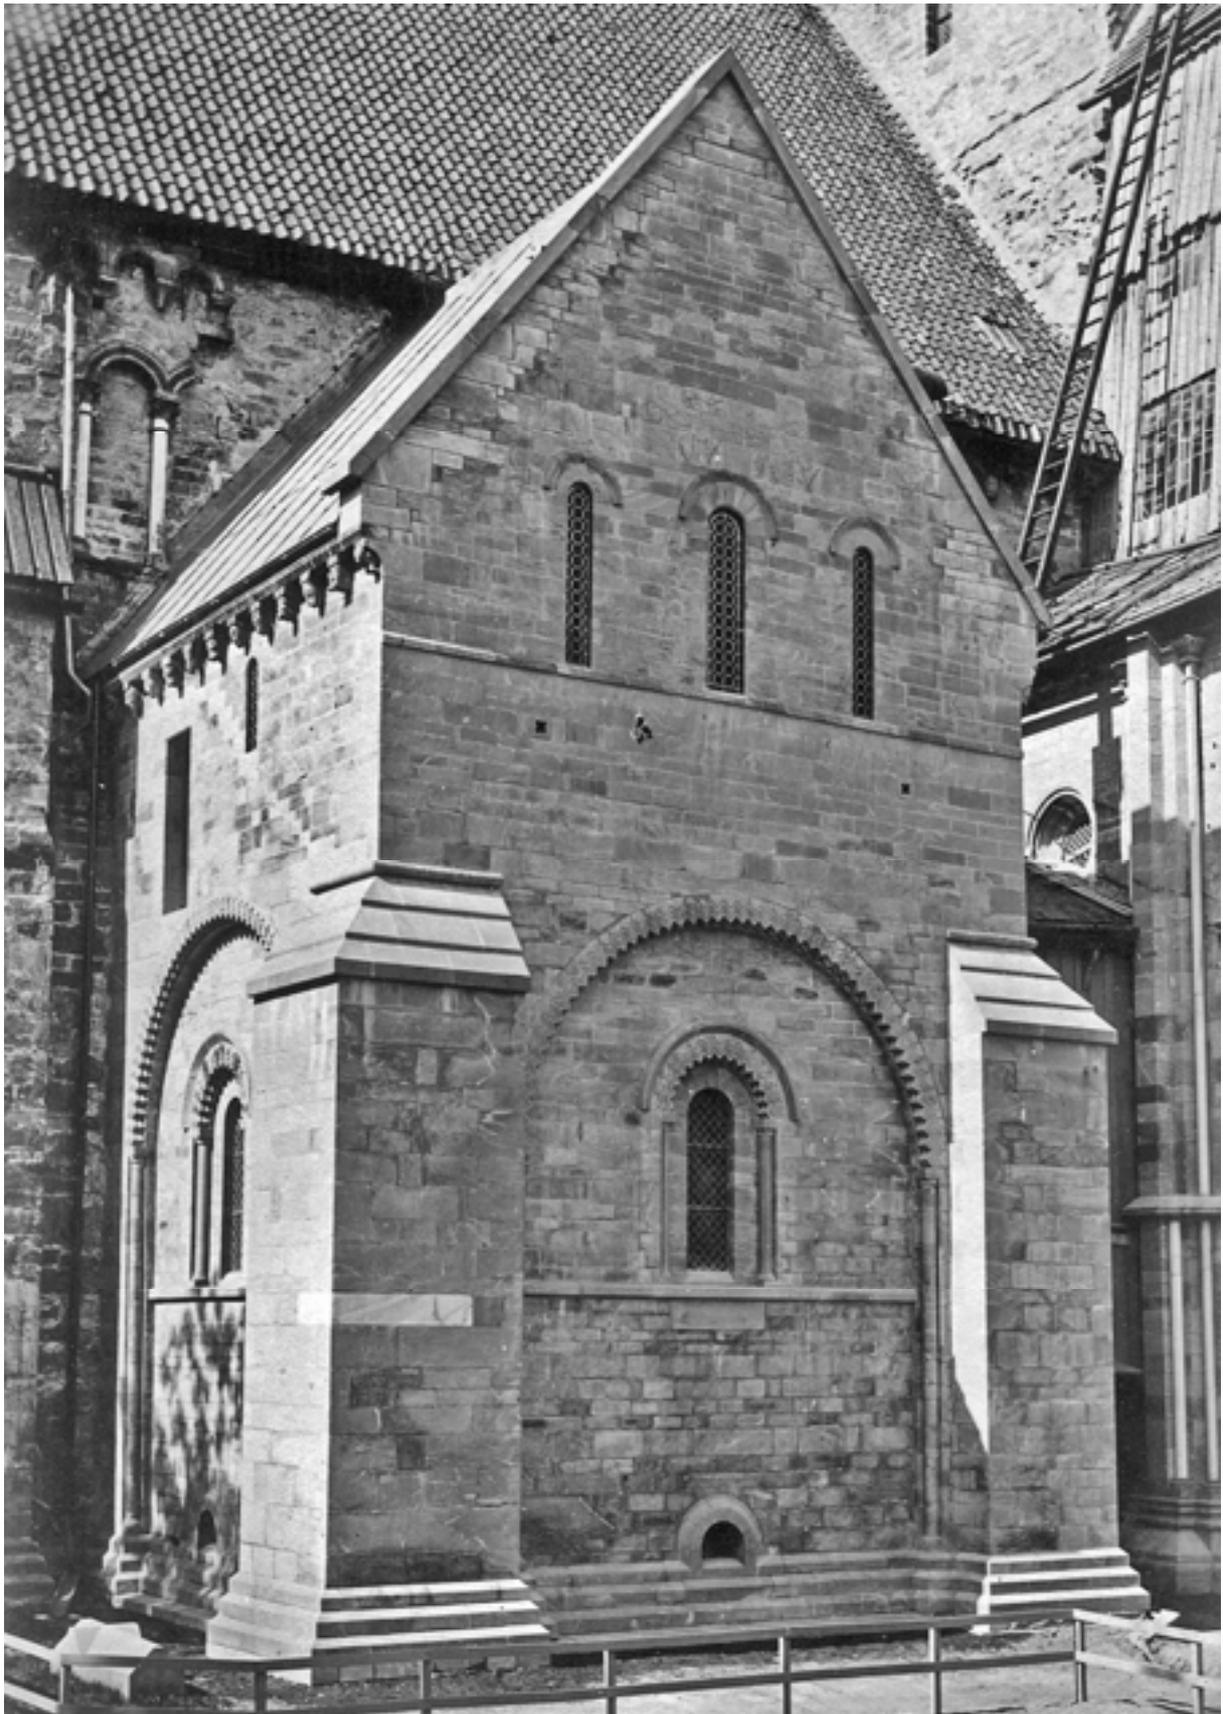
Fig. 18.3: St. Olav's chapel around 1880, after the restoration during which the gable and the roof were changed. Note that the corbels are less protected than before the restoration (photo: ARW).
