A STUDY ON THE WEATHERING OF NORWEGIAN GREENSCHIST

STOREMYR, PER

The Restoration Workshop of Nidaros Cathedral

**INTERNATIONAL CONGRESS
ON DETERIORATION
AND CONSERVATION OF STONE**

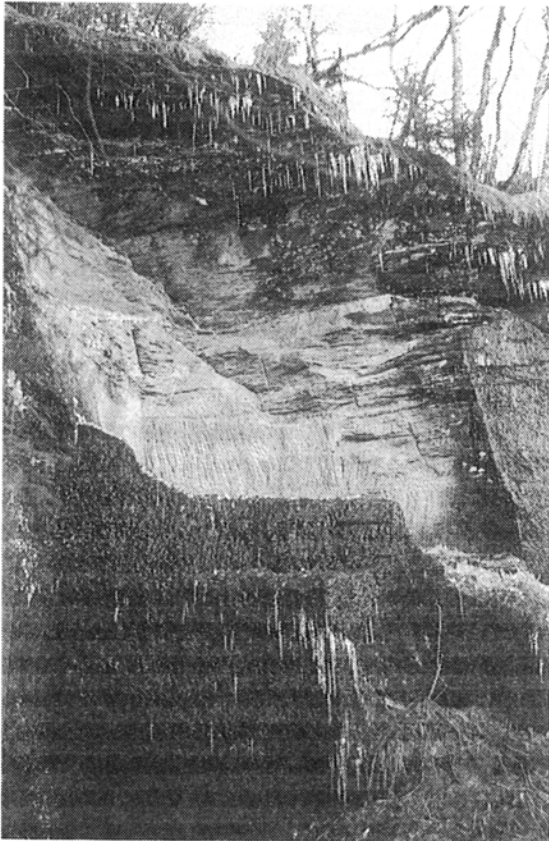
Figure 2:
Part of the Öye greenschist quarry. The stone is sound when exposed (dark areas) and rather disintegrated when sheltered (light area).

Whereas semi-sheltered cliffs are strongly delaminated/disintegrated and have lost most marks of medieval quarrying operations, the exposed rock-faces are, although sometimes overgrown by lichens and moss, usually very sound. In this way hundreds - if not thousands - of square metres with quarrying marks have been preserved.

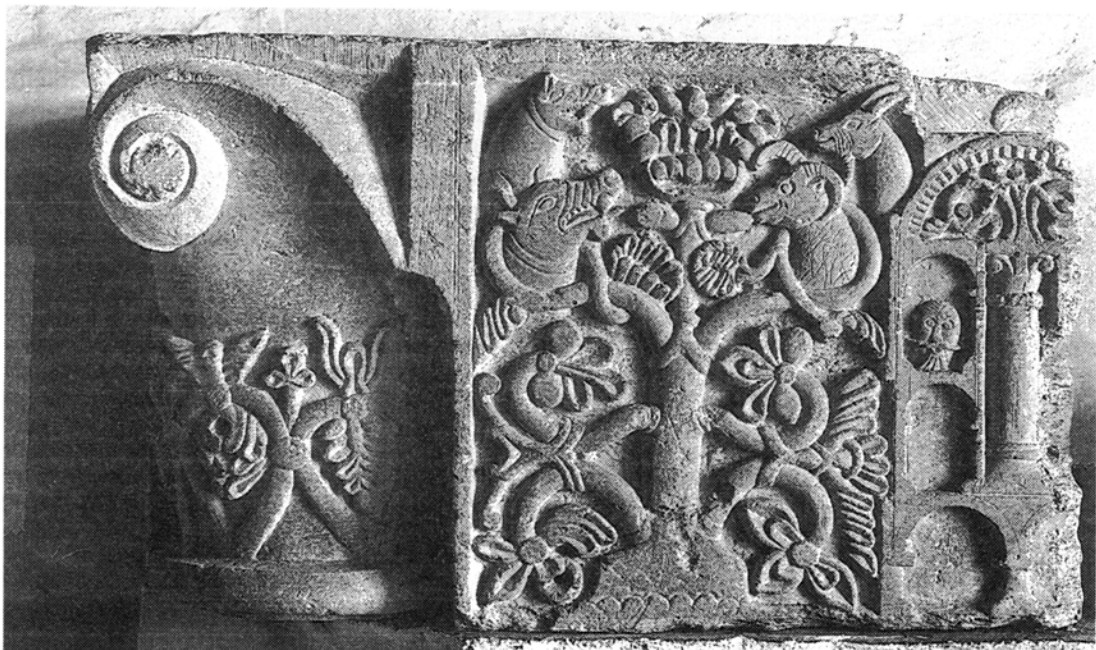
Figure 4:
Early Romanesque capital (late 11th century), now in the museal collections of the Nidaros cathedral. The delicate carving shows that medieval stone carvers were able to make beautiful art of the very foliated greenschist (photo: RWNC).

In addition to problems connected with the use of gunpowder, main reasons why the 1934-campaign (and a very minor experiment in the 1950s) failed, seem to have been the large difficulties encountered when dressing the stone, and that more easily workable soapstone could be obtained elsewhere. Masons who have tried to work the greenschist maintain that it "always" tends to delaminate when faces perpendicular to the foliation planes are to be dressed - and that the stone is difficult to saw. Hence, except from a few ashlar, nothing has been produced from the stone after nearly 100 years of infrequent experimentation - an enormous contrast to what was achieved during a similar time-span in the Middle Ages (fig. 4).

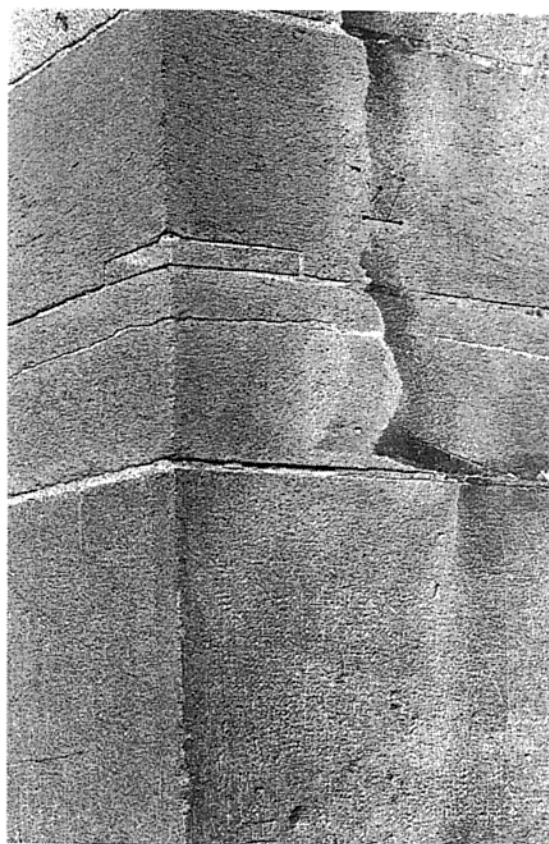
Figure 8:
Very sound greenschist ashlars on a pillar of the south chapel of the Nidaros cathedral. The pillar have been slightly redressed (1872). Note the preserved mason's mark from 1180-90.

Ashlar masonry (with stones bedded horizontally), buttresses, string courses and sculptures exposed to precipitation, but not influenced by leaks, rising damp and soluble salts, are usually very sound (fig. 5, 8). Some of the elements were redressed in the last century, but whitewash and paint were more often removed by mallets or hydrochloric acid. Hence, medieval dressing and masons's marks are beautifully preserved - just like in the quarry.
