## Selected works undertaken with various institutions *prior* to the establishment of Per Storemyr Archaeology & Conservation Services in 2010

Over the years I have worked for several institutions and directed or taken part in about 100 consultancy and research projects within conservation of monuments and sites, and archaeology. In this note selected projects in Norway, Switzerland and Egypt, as well as EU-projects are presented (1990s-2010). Most links will lead you to documents on my website - [www.per-storemyr.net](http://www.per-storemyr.net)

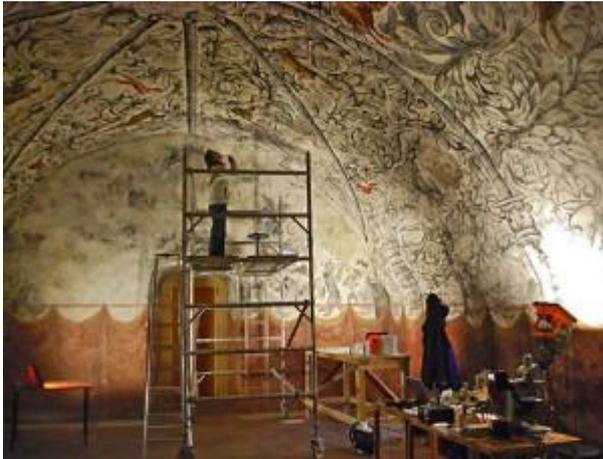
The early 17th century mural paintings in the Regalia room of the Archbishop's palace are some of the finest in Norway. In 1996 I initiated a project to elucidate their heavy weathering and undertake conservation measures, in cooperation with [conservator Andreas Franz](#). We could show that water infiltration, soluble salts, a warm indoor climate, static problems and poor previous restorations were responsible for most damages. Conservation was carried out in 2000-2001 (and again recently) and detailed climate and damage monitoring since then has shown a significant drop in weathering rate.

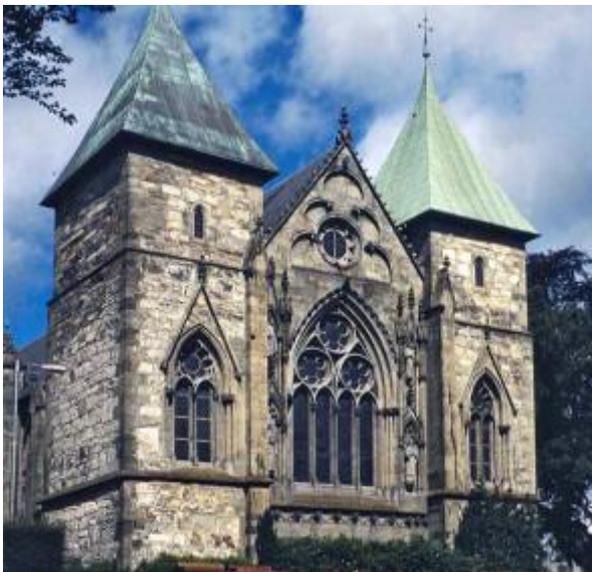
My tasks were mapping of materials and decay phenomena, as well as compiling, writing and editing the final documentation report, which was also published as a CD-ROM.

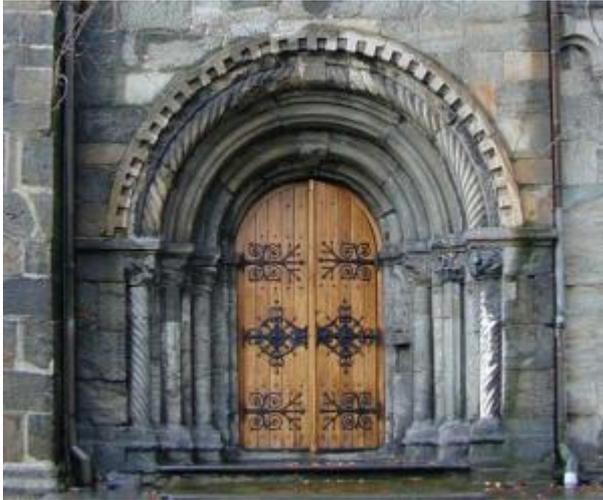
Bergen has many medieval and later portals made from soapstone. The rainy climate in the city as well as (previous) air pollution have generally been considered the most important causes of the heavy weathering of some of the portals.

However, studies of three portals in the late 1990s showed that air pollution were of much less importance than rusting iron cramps, poor previous restorations and, in particular, architectural designs that facilitate water infiltration and, thus, salt weathering.

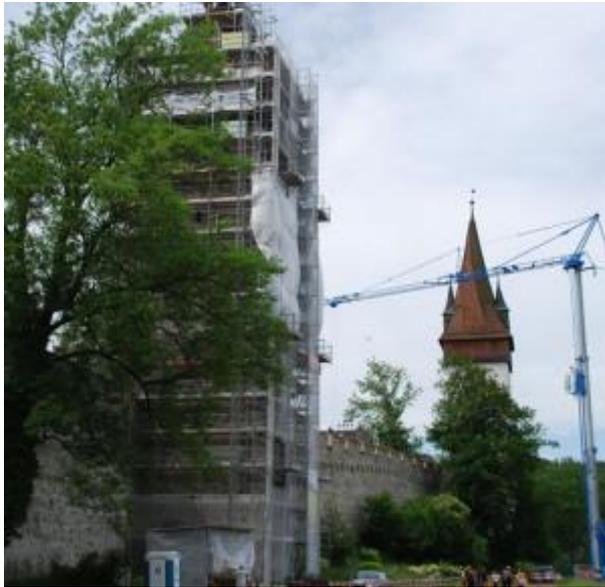
Museggmauer, or the City Wall of Lucerne, is currently (2010) under restoration. In 2005-2006 I was responsible for mapping of damages and risk analysis of the whole 870 m long medieval wall with its nine towers. The analysis formed the basis for the conservation concept now implemented. For the mapping of such a large monument a Geographical Information System (GIS) based on a measured survey by photogrammetry was developed. This system allowed the mapping and presentation of numerous interdependent themes, and also quantification of damages, which was used for risk assessment and the setting of priorities for conservation. Moreover, the GIS was used by other collaborators, e.g. for mapping and presentation of valuable fauna on the wall (birds' nests).

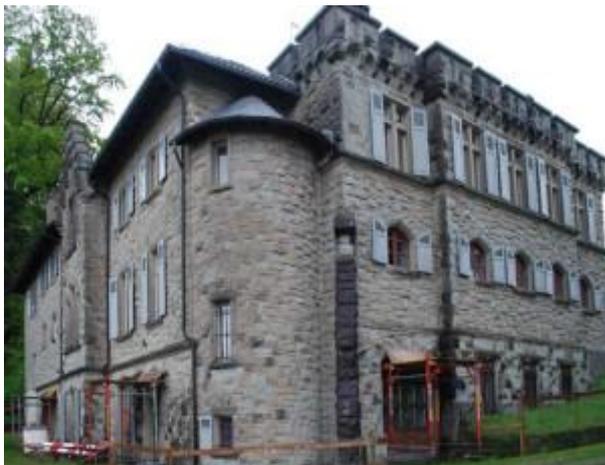
The Dreilinden estate constitute three stone buildings forming part of a late 19th century English landscape park in Lucerne. The condition of the façades has since long been poor, in particular since the local Molasse sandstone used develops thick scales at exposed locations. The buildings were completely mapped in terms of materials and weathering in 2009 and a conservation concept drawn up according to a risk analysis. Also in this case maps were produced using GIS, which proved time-consuming, but very useful since damages could easily be quantified and thus applied for setting priorities for conservation.

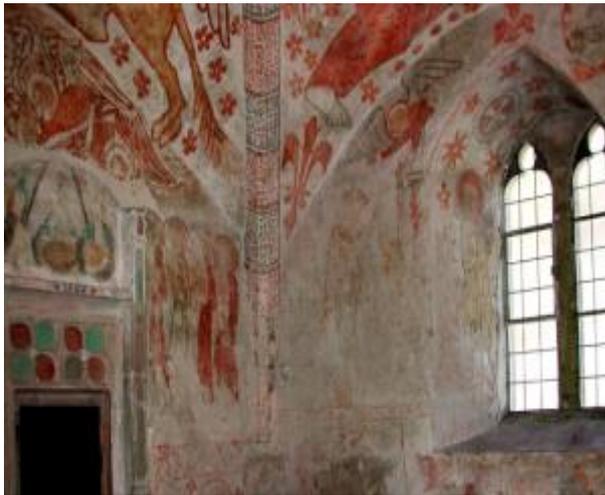
The small church at Zell in canton Zurich comprises a chapel entirely decorated with medieval murals. They provide an exemplary case for misguided, previous intervention: The murals were sealed with wax in the late 1950s and electric heating was simultaneously installed to improve comfort. Only 20 years later large parts of the murals were gone due to salt crystallisation in the warm indoor climate. As soon as the heating was turned off in the early 1980s weathering rates dropped dramatically. Together with Atelier Andreas Franz, our task was to aid in developing a conservation and maintenance concept. Conservation was undertaken in 2002-2005.
