The Stones of Nidaros

An Applied Weathering Study of
Europe's Northernmost
Medieval Cathedral

Dr. Ing. (Ph.D.) thesis no. 1997:92
Department of Architectural History
Norwegian University of Science and Technology
Trondheim, Norway

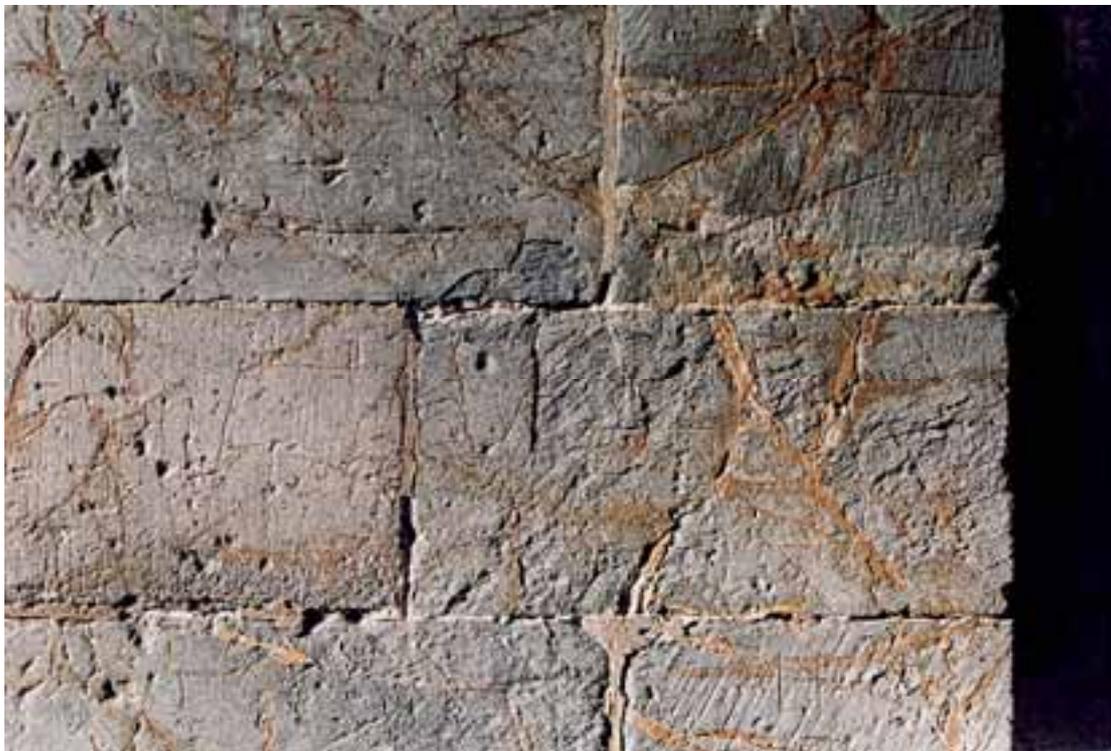
Fig. 1.6: Typical appearance of the nave's medieval soapstone ashlars. The green-grey, dense and soft matrix of talc and chlorite is intersected by carbonate mineral veins (photo: PS 8/95).

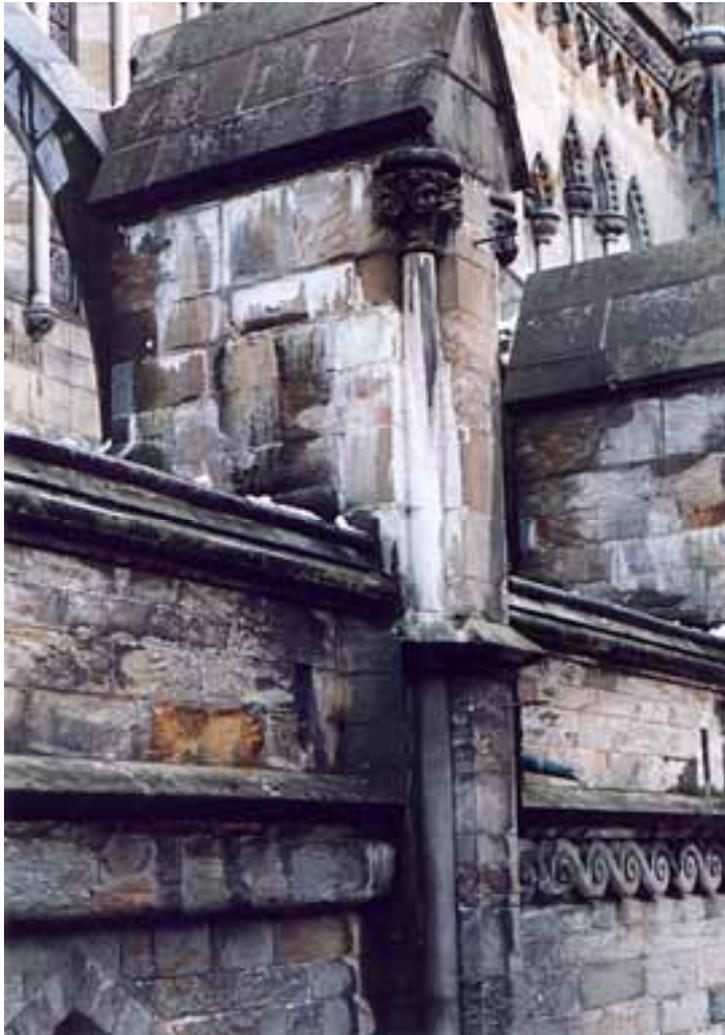
Fig. 1.8: Large salt deposit (calcite crust) on a flying buttress, north side of the choir. Salts represent a major problem at the cathedral (photo: PS 1990).

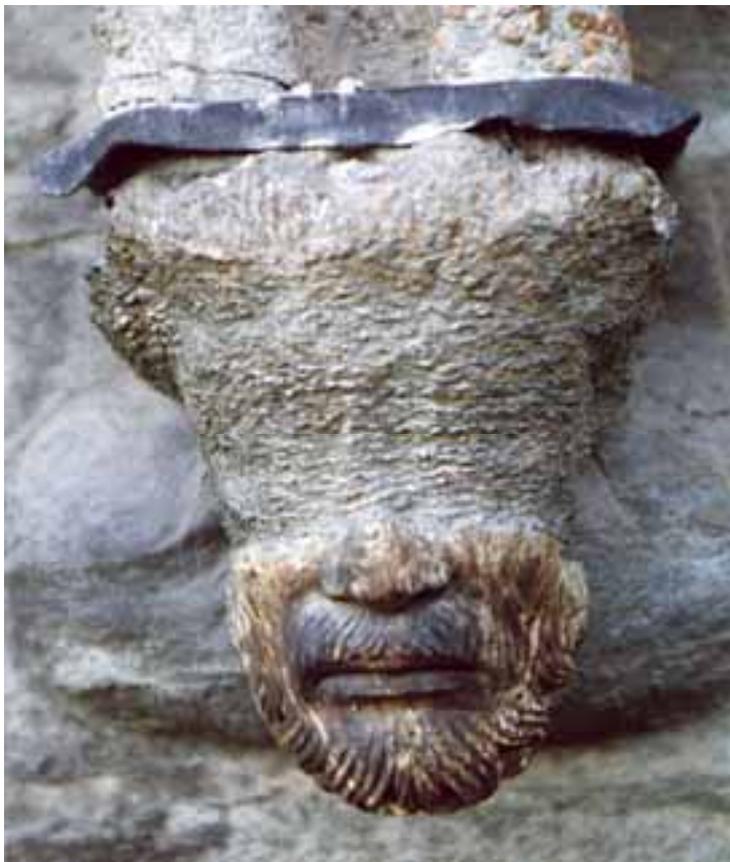
Fig. 1.10 One of the most difficult problems of the cathedral is rapid weathering of medieval sculpture. The picture shows a Gothic mask on the octagon. Why is the weathering taking such a peculiar form? Only combined historical and scientific investigation may give the answer (photo: PS 1990).

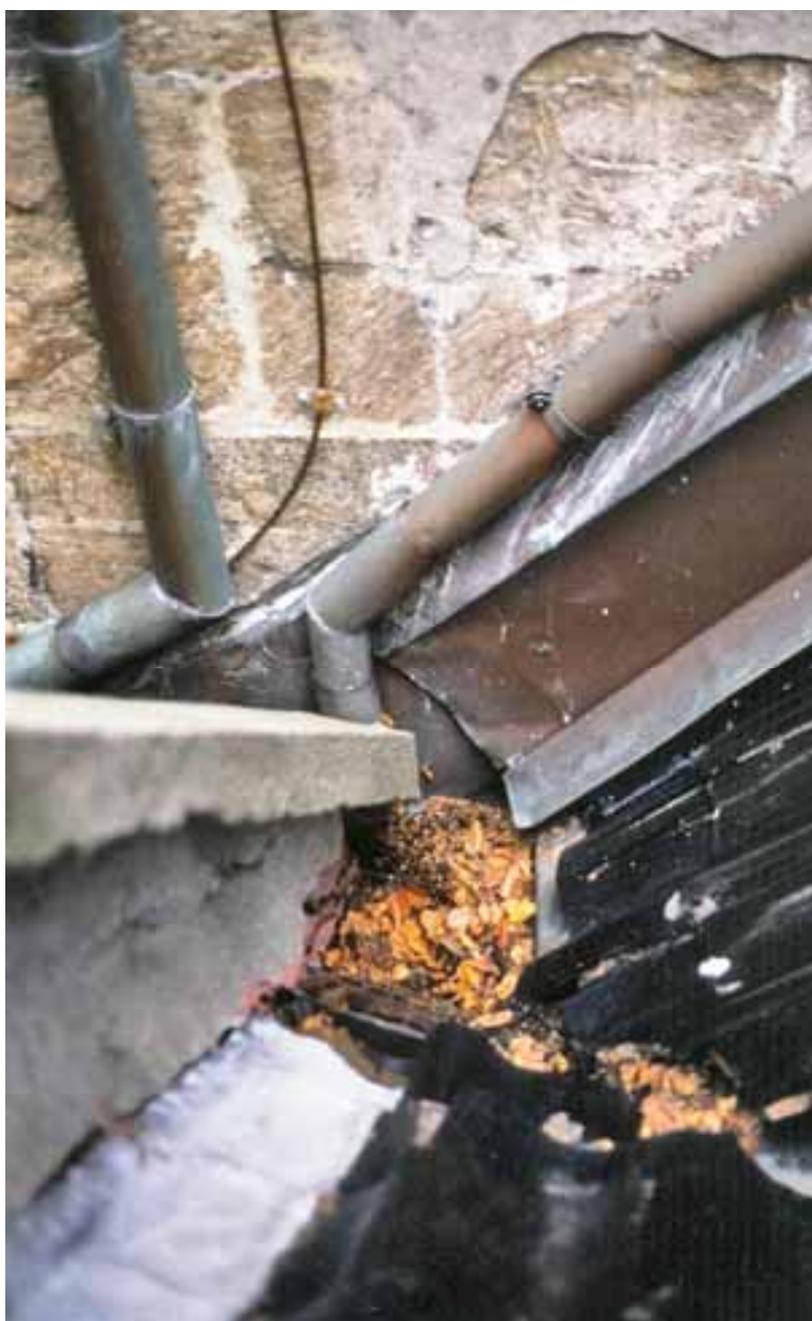
Fig. 2.2: Extremities of contemporary conservation. Left (opposite page): Rebuilding of Frauenkirche in Dresden 50 years after it was destroyed by allied bombing in the Second World War (photo: PS 1996). Right (this page): Leaves that clog up a downpipe at St. Mary's church in Bergen and cause water infiltration in a valuable Romanesque portal just below (photo: PS 1993)

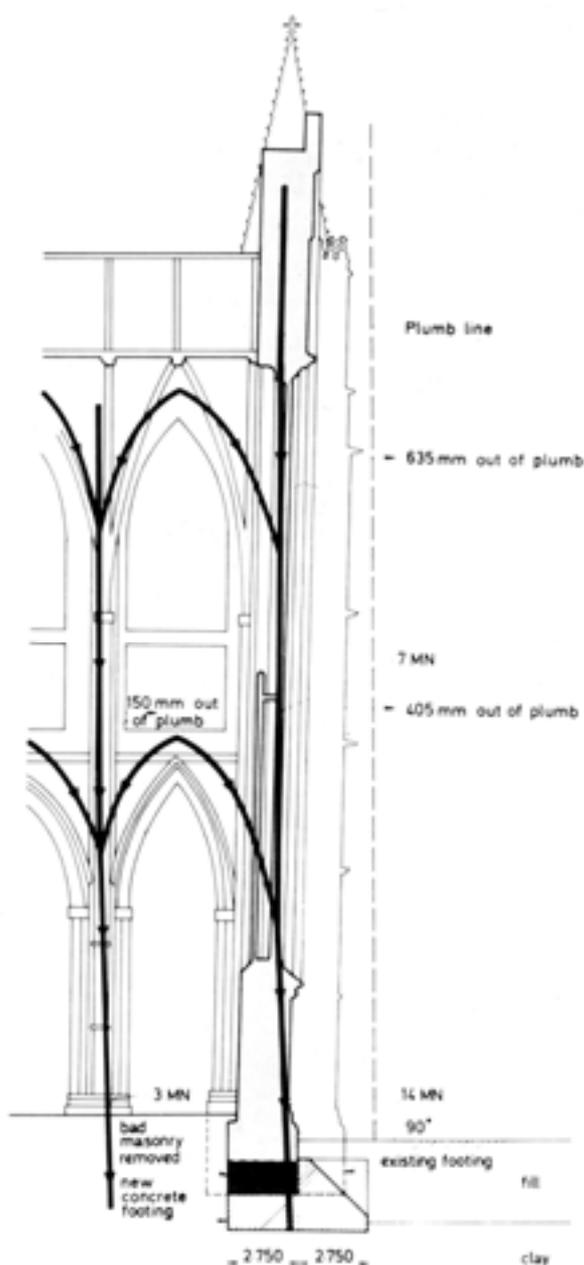
Fig. 2.4: Diagram of thrusts and movements, east end, York Minster, England. The diagram shows the line of thrust dangerously close to the outside face of the wall and indicates eccentric loading on the foundations. New reinforced concrete foundations were designed to give concentric loading. Diagram from Feilden (1982), after Ove Arup & Partners.

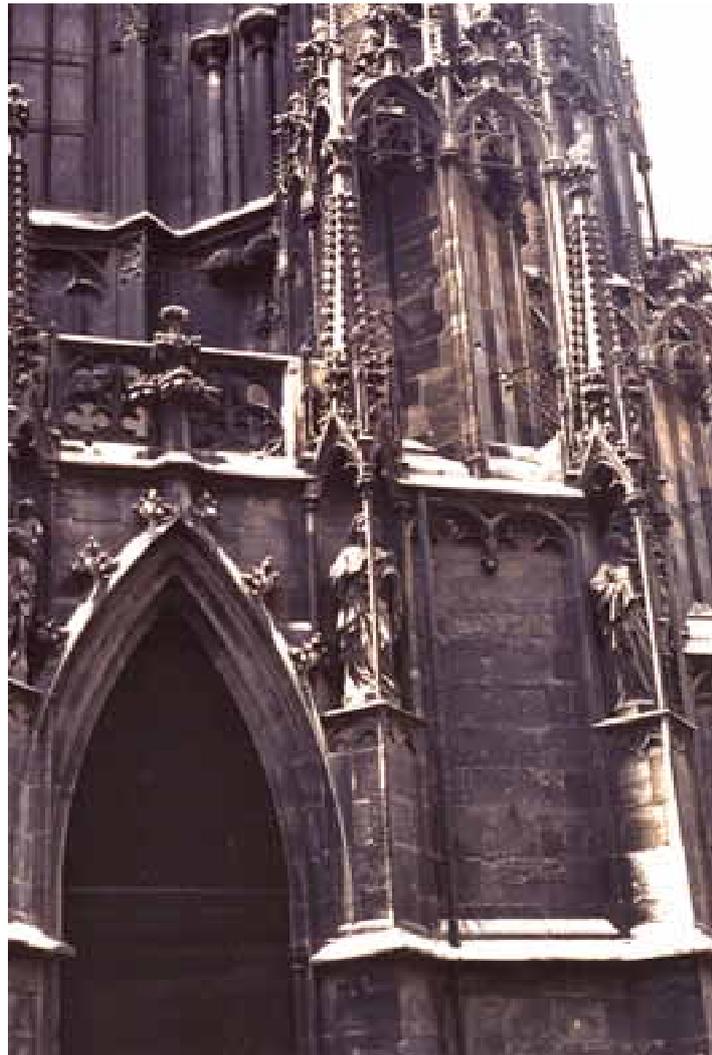
At places where lashing rain affects buildings from one main direction only, it is often possible to observe whole façades covered by black crusts. This is the case in Vienna where the overall wind direction is westerly.²⁵ The cathedral of St. Stephan (fig. 3.6) is consequently “black” on most sides facing north, east and south, as well as on the lower parts of walls facing west (because these walls are protected by nearby buildings). All projecting elements are, however, “white” on their upper surfaces (fig. 3.7), and it is usually possible to observe a few “white” lines on otherwise “black” walls as well. The latter phenomenon is caused by run-off from elements upon which rain water accumulates.

Fig. 3.7: *Cathedral of St. Stephan in Vienna. The snow-white projecting elements of limestone make a great contrast to the walls which are covered by black crusts (photo: PS 4/94).*

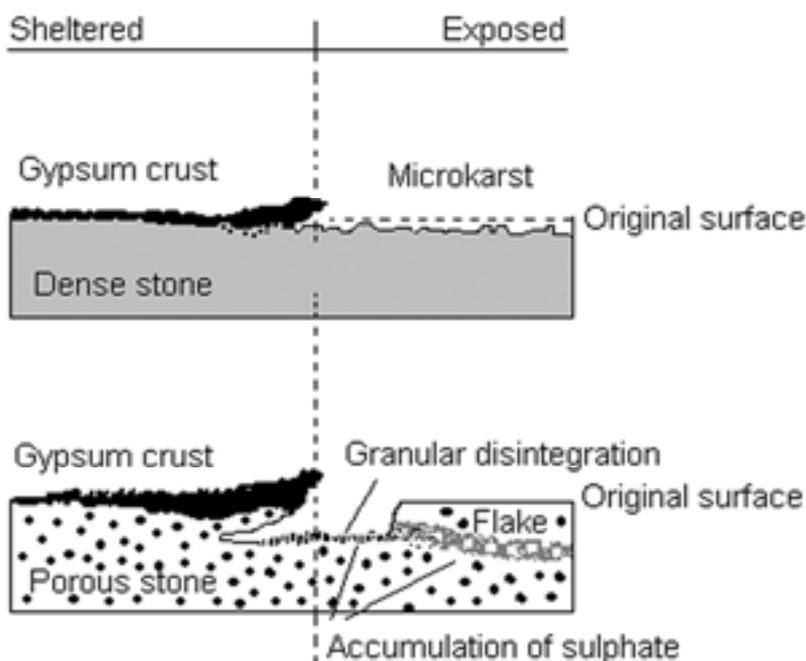
Concerning weathering mechanisms, it is very important to be aware of the difference between dense and porous stone (fig. 3.8). Sulphate/gypsum is not able to penetrate deeply into dense stone, implying that black crusts usually can be observed as mere layers on the surface - rarely doing any specific harm to the fabric of the stone.²⁷

Fig. 3.8: Different weathering phenomena observed on porous and dense stones as a result of air pollution (chemical dissolution, black gypsum crusts and accumulation of gypsum) (after Arnold 1984b).

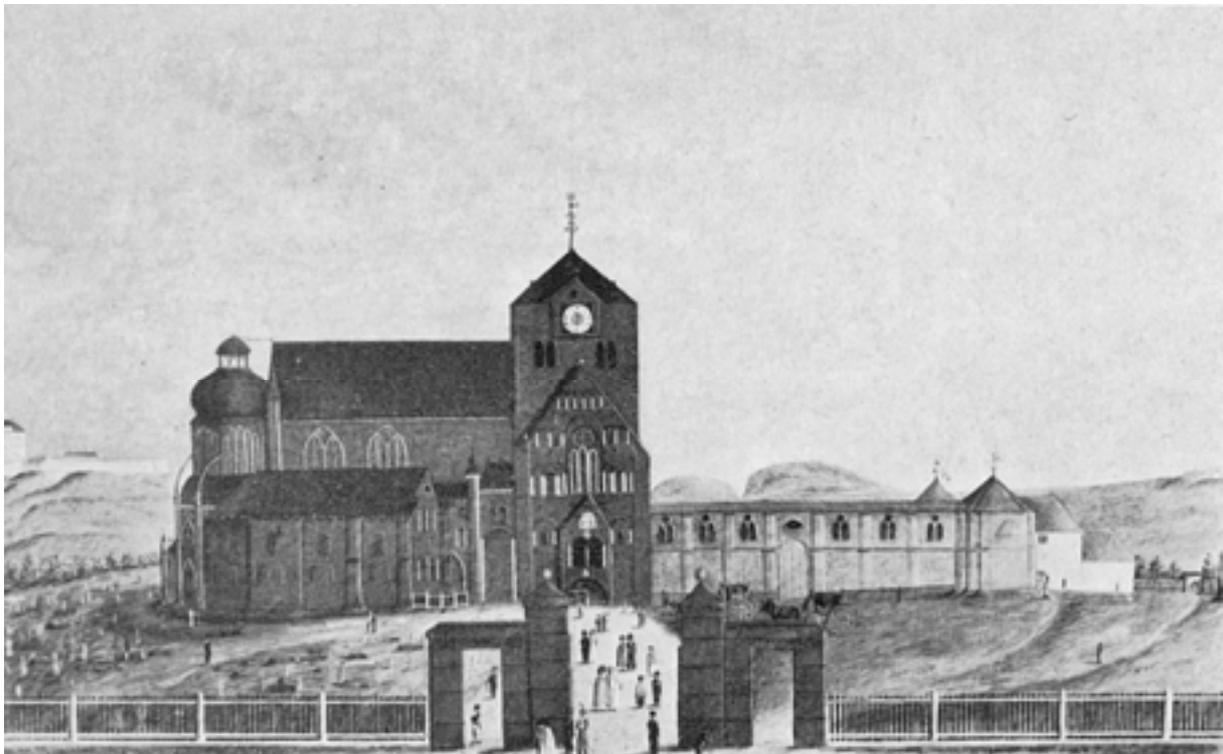
Fig. 4.4: *The north façade of the cathedral, probably in 1818. The dark colour of the church (except the nave) represents the paint applied before the coronation in 1818. Note also that ornaments and columns are painted white. Drawing by P.H. Kriebel.*

A very important repair operation took place before the coronation of King Karl Johan in 1818 (see fig. 4.4). Marble columns were whitewashed, and exterior masonry, including some decorations, painted with a grey glue paint,⁷¹ presumably some kind of lime- and glue-based distemper with dark pigments. This repair is important insofar as there are remains of the paint on the cathedral even today. Otherwise, almost every sign of post-reformation plaster and whitewash was removed during the restoration from 1869. The different removal techniques will be described in chapter 6.4.

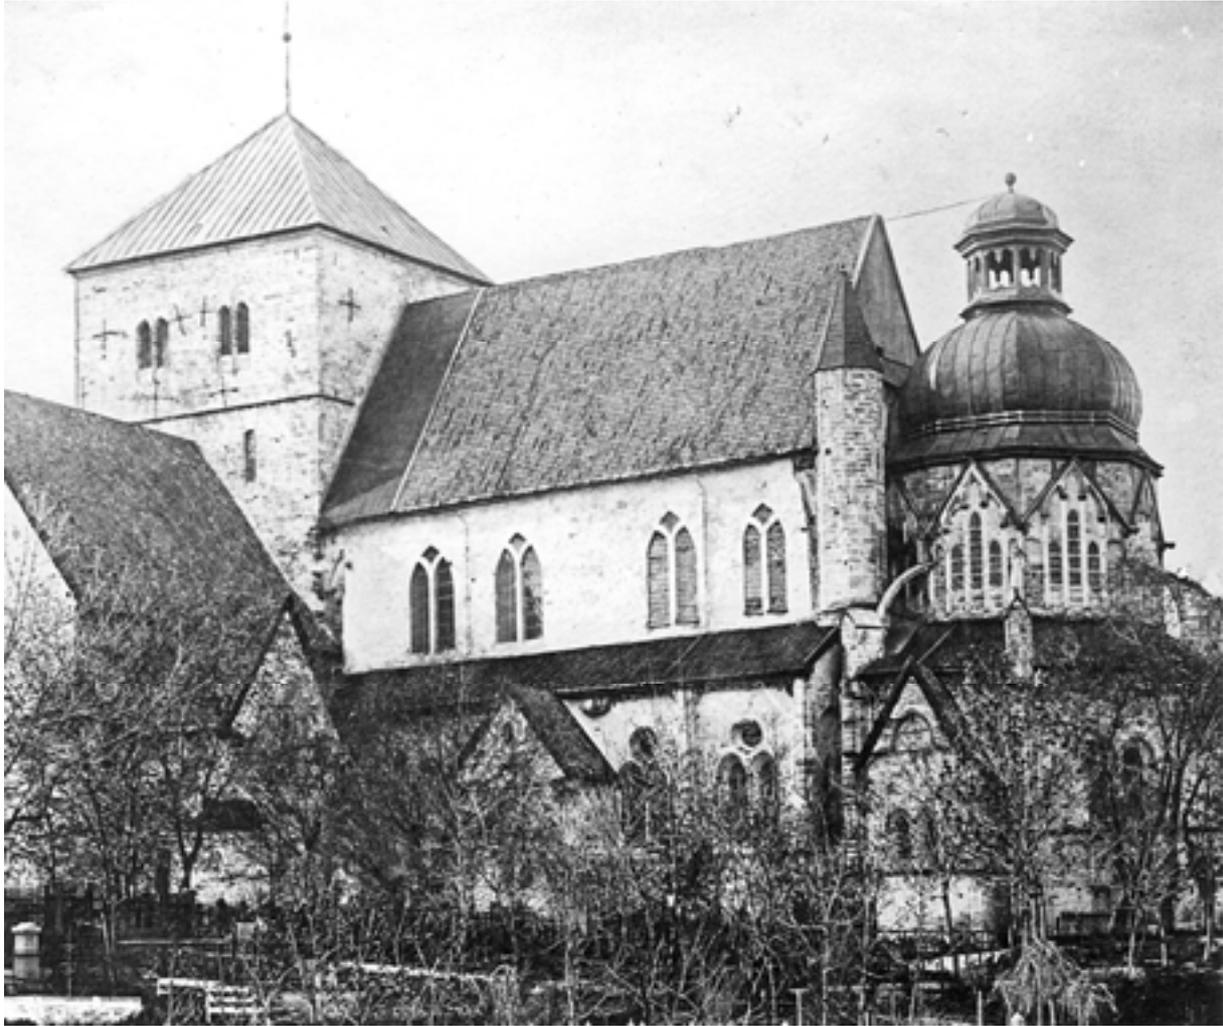
1860-1869: Awaiting a final decision about the restoration, Schirmer started work on the new furnishing of the church in 1861. In that year the church also got its first real heating system - a coal fired central heating plant located in the corner between the north transept and the nave. Then - in 1862 - experts examined the ground conditions below the church and the stability of the walls. They established that most of the walls inclined outwards considerably

Fig. 4.5: The cathedral from SE in the 1860s (photo: ARW, no. 3593).

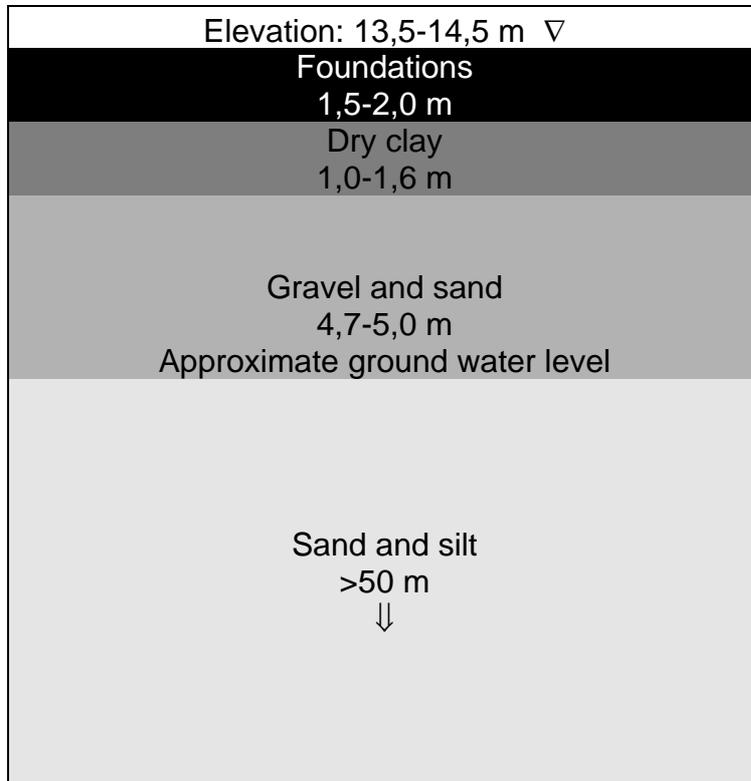
Summarised, the ground below the cathedral consists of some 2 m of clay and anthropogenic material, a 1-2 m thick layer of highly compacted, dry clay, a few thin layers of sand and silt, a 5 m thick layer of extremely compact sand/gravel and more than 50 m of sand and silt. Hence, the cathedral rests on some 6 m of good, stable soil - compact clay and compact sand/gravel. One should nevertheless be aware of possible future problems as a result of changing ground conditions, especially if *major ground water changes occur or if the layer of compact clay becomes too wet.*

Fig. 5.2: Schematic representation of the building ground below the cathedral (from Finborud 1967).

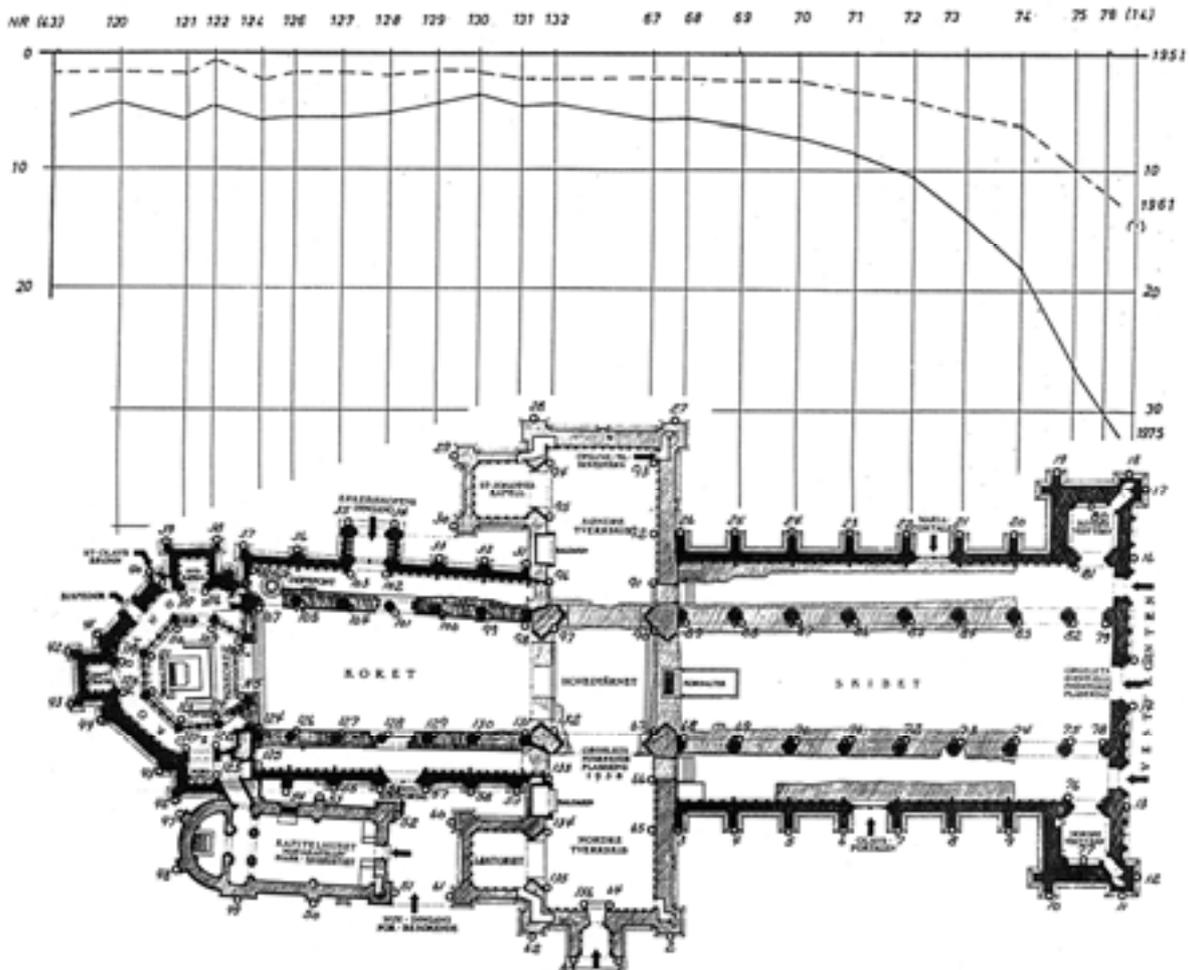
Fig. 5.3: Settlement (in mm) along the northern side between 1951 and 1975. Note the relatively large settlement in the western part of the cathedral (from Rye 1976).

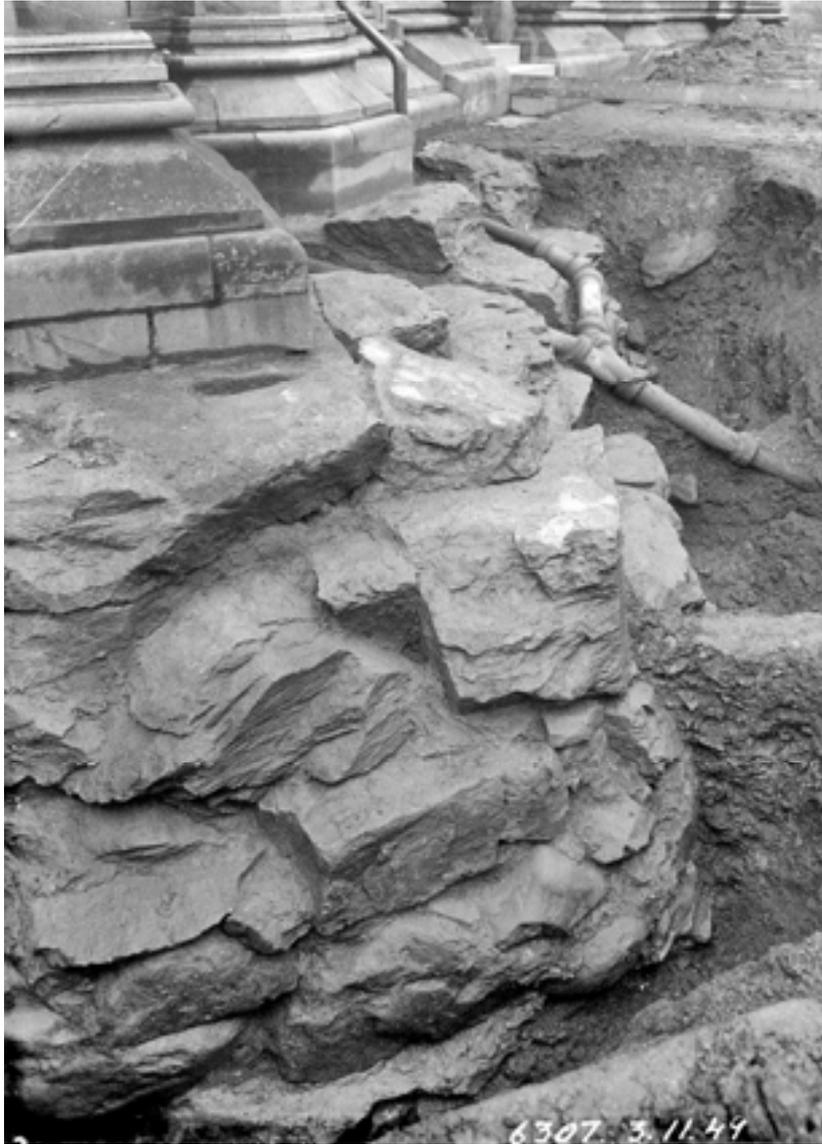
Fig. 5.4: Example of the consolidated foundations. South side of the octagon during archaeological excavation of the late 1940s. Note the closed water drainage system. The gutters are no longer connected to the system (photo: ARW, no. 6307).

Hence, until the turn of the century, supporting stone foundations (fig. 5.4) were laid next to interior and often also adjacent to exterior parts of the old ones. The supporting foundations were generally made some 2 m deep, 1 m wide and were often constructed on top of a layer of concrete. Moreover, voids in the old foundations were filled with Portland cement mortar, which was also utilised as jointing material in the new foundations.

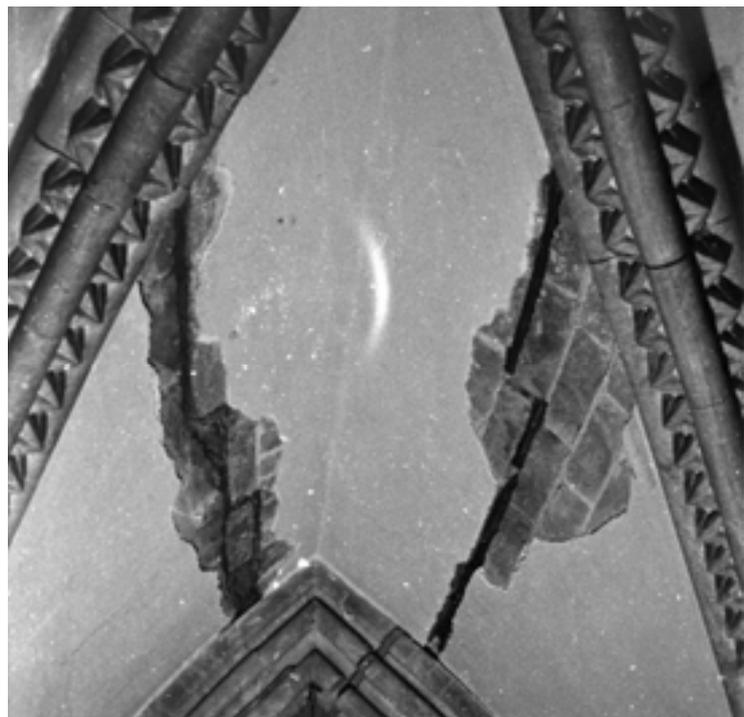
Fig. 5.8: Example of cracks in a vault of the aisle (choir). Photo probably taken in 1982 (ARW).

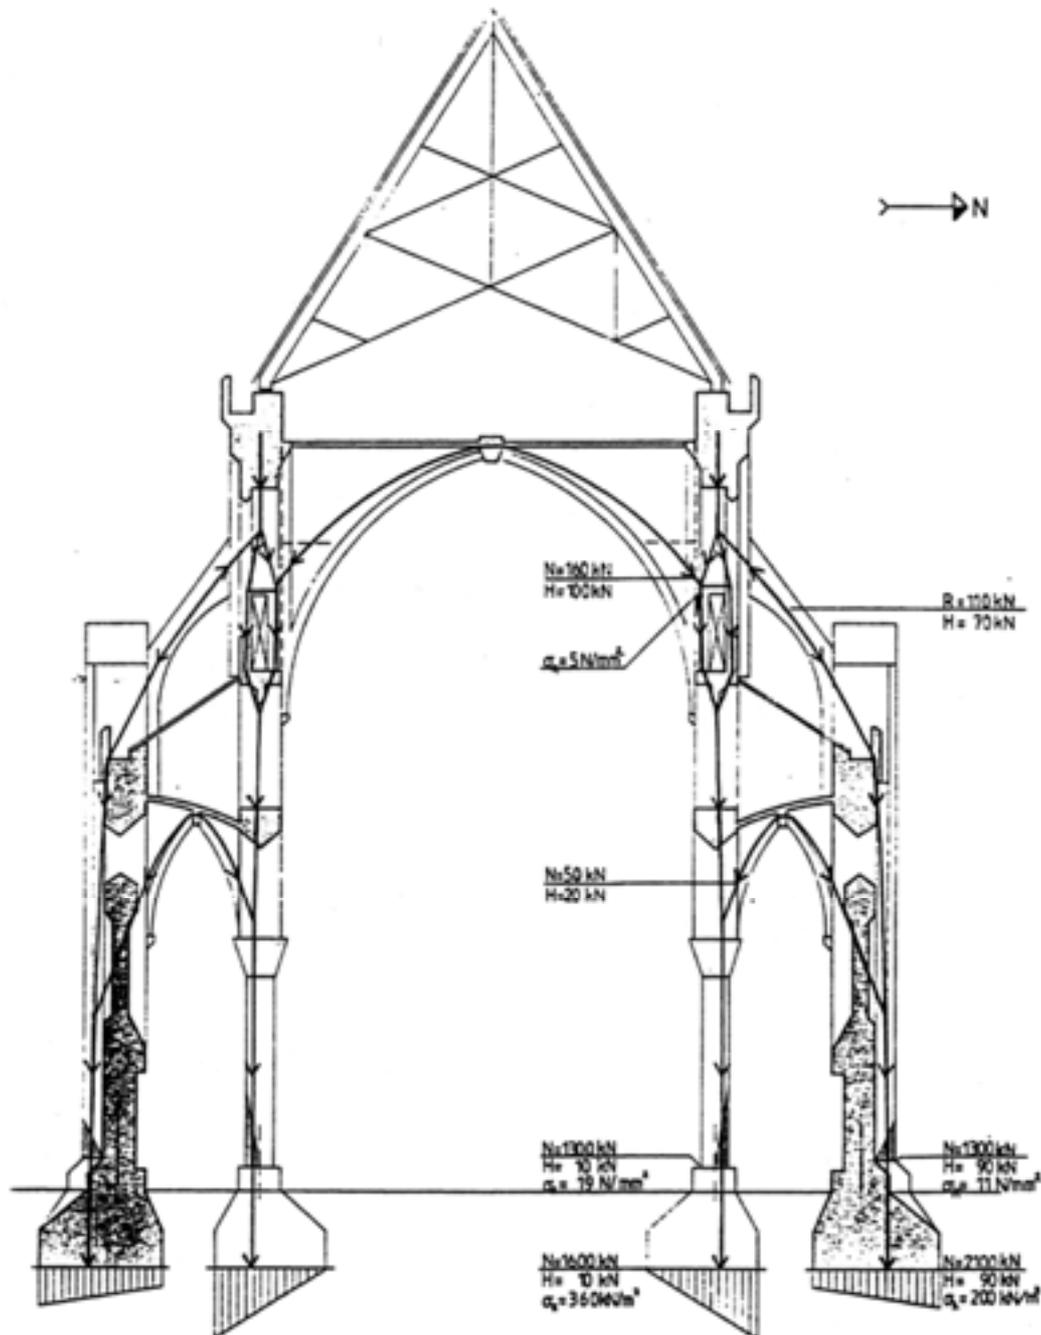
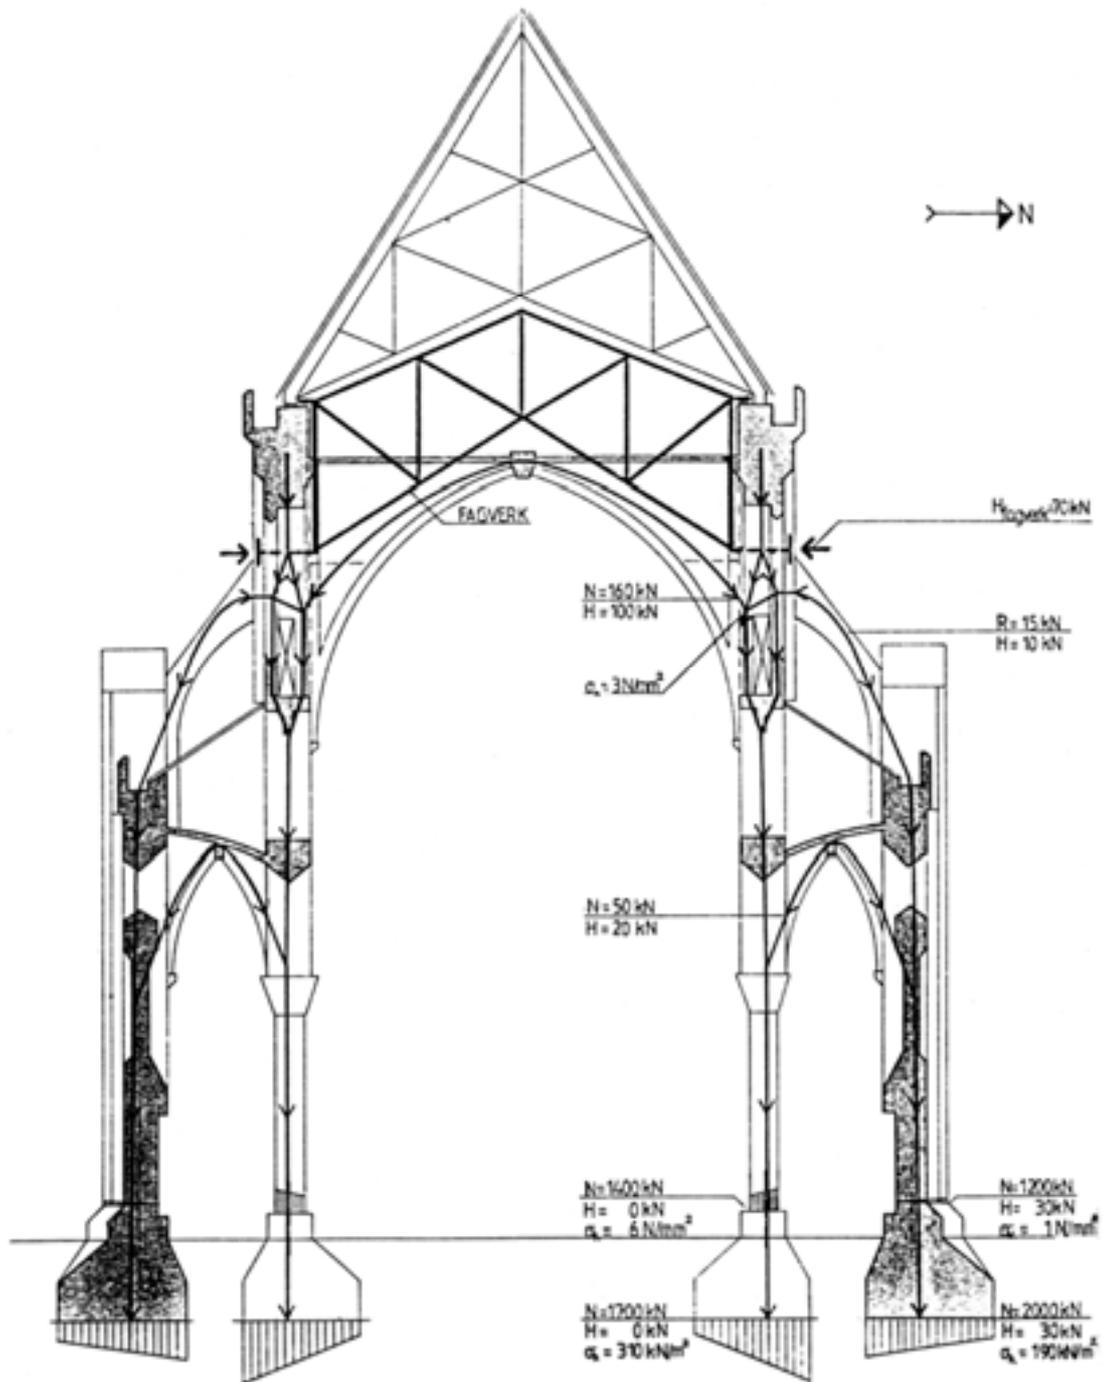
Fig. 5.9: Above: Schematic representation of the pressure lines in the choir before the construction was secured in 1986. Next page: Similar representation (hypothetical) after the application of a hidden steel construction on the loft (from Løvås 1984).

above the vaults would be the best solution (fig. 5.9) - a work which was undertaken in 1986.¹⁹ Until 1996-97 it was the view of The Restoration Workshop that the problems in the choir had largely come to a halt, although outward inclination (deviation from plumbline) showed an increasing tendency in 1989 (fig. 5.10). After 1989, no regular measurements of inclination, crack development and settlement have been undertaken. Such measurements are absolutely necessary in order to understand the behaviour of the choir, not least since it has recently (April 1997) been discovered that several columns and capitals in the triforia are in danger of collapsing.²⁰

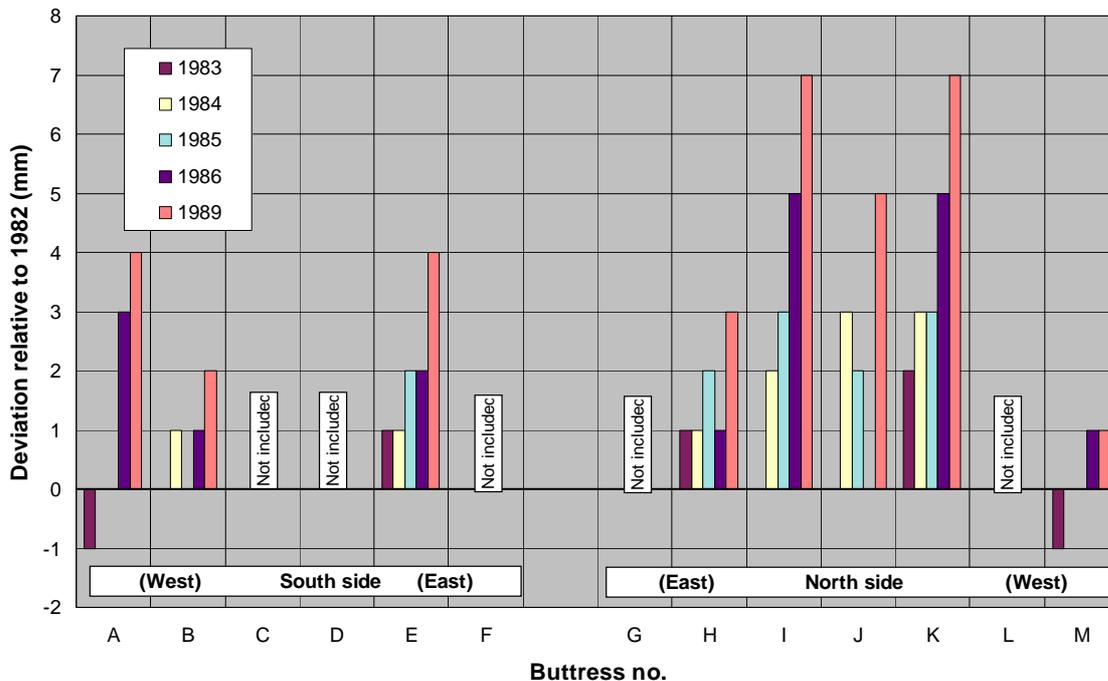
Fig. 5.10: Aisles of the choir. Development of deviation from plumbline 1983-1989. Note that this deviation did not halt after 1986 (measurements undertaken by The Restoration Workshop).

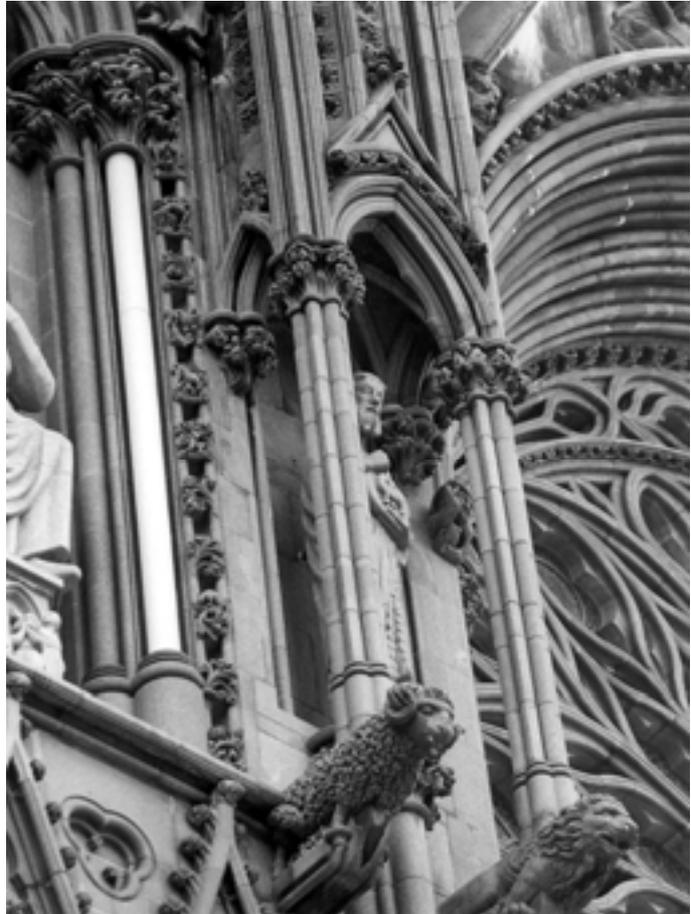
Cracks have also continued to develop in two frail canopies of the west front (fig. 5.11). Put in place just before 1930, the corbels bearing the canopies have been replaced by copies several times (1932, 1935, 1947). Whether large-scale stability problems or - as maintained in 1935 - thermal dilatation due to strong sunshine in particularly warm summers can explain the problem is uncertain as it has not been investigated further.³¹

Fig. 5.11: Canopy of the west front (from the 1920s) showing cracked columns. One of the corbels bearing the canopy is a copy from 1935, replaced because of cracks (photo: PS 2/96).

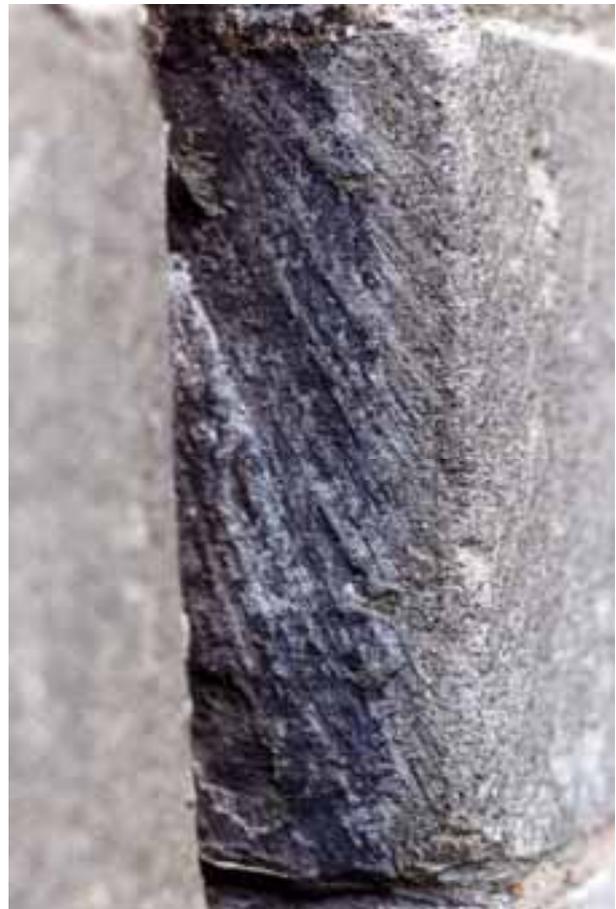
Fig. 6.6: Remaining layer of blue-grey paint on a medieval axed greenschist ashlar. The paint was probably applied in 1818 (see figure 3.5). North transept (photo: PS 5/96).

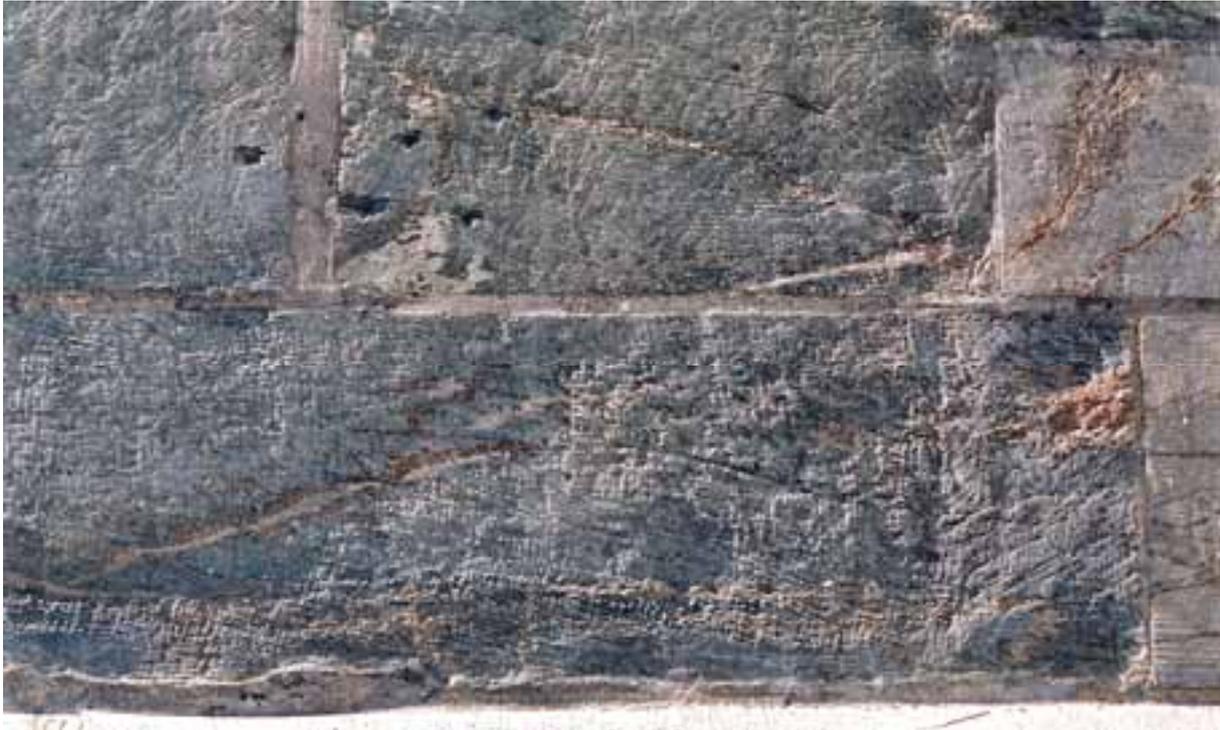
Fig. 6.8: Ashlar treated with bush hammer during the restoration (1870s), probably in order to remove whitewash. South transept (photo: PS 8/95).

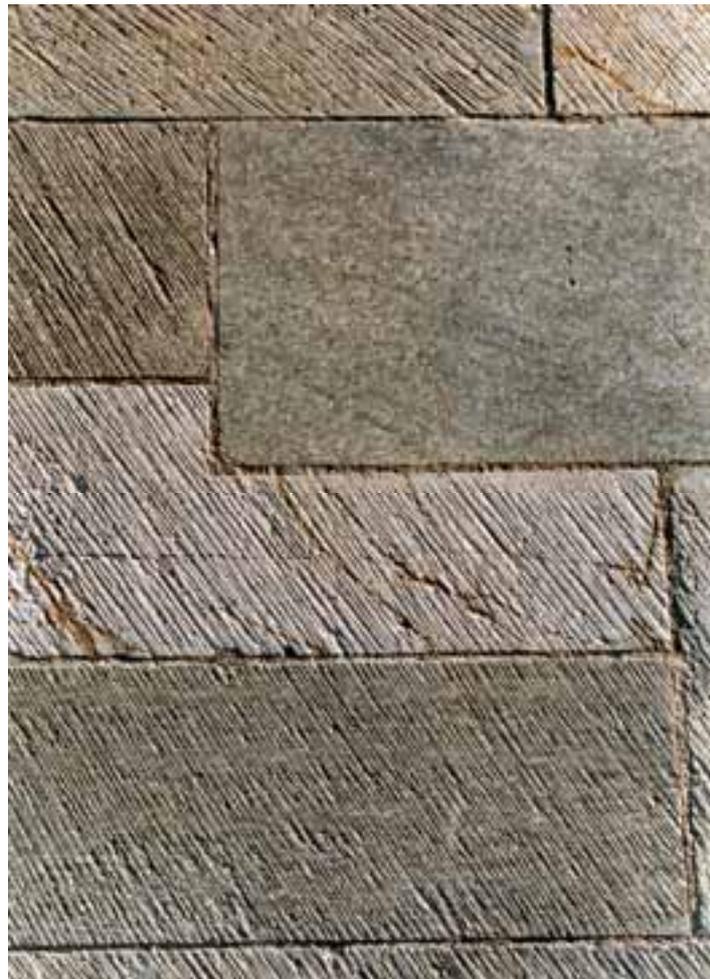
Fig. 6.9: Regular dressing marks on soapstone ashlars from the restoration (c. 1910, Bjørnå stone) in the northern west tower. The lighter ashlar is a redressed medieval one. Note also the rubbed-down ashlar (photo: PS 8/95).

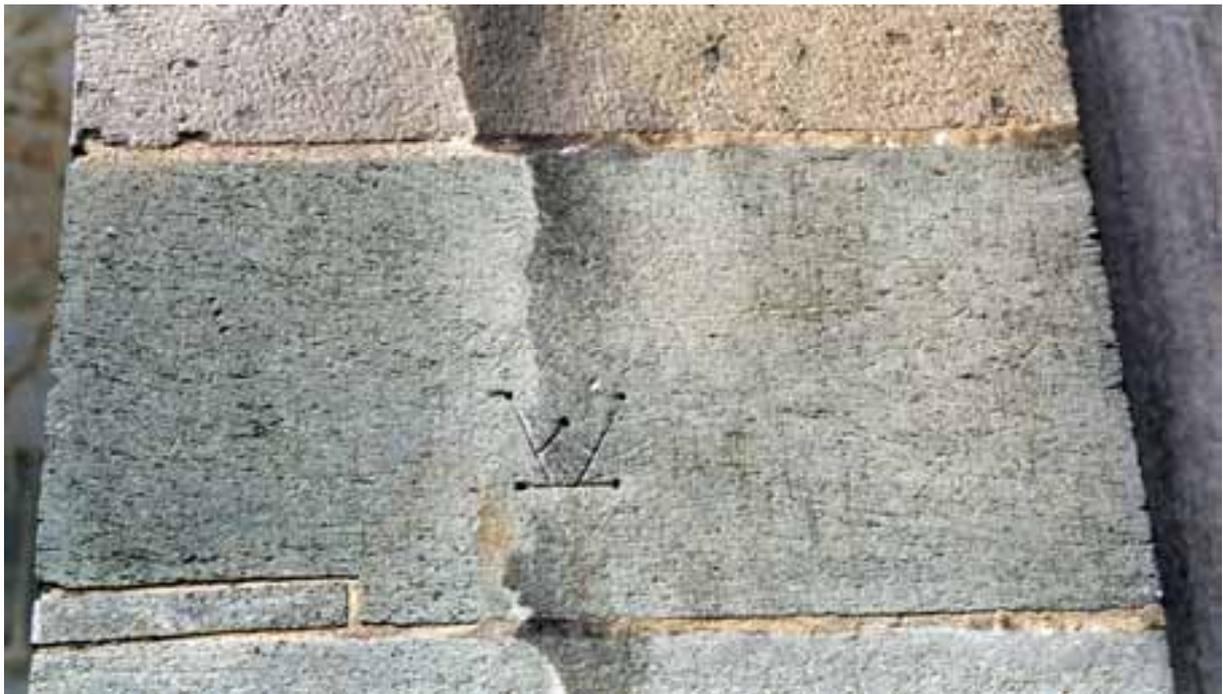
Fig. 6.10: Typical example of a well preserved masons' mark on a greenschist ashlar. South chapel of the octagon, 1180s (photo: PS 8/95).

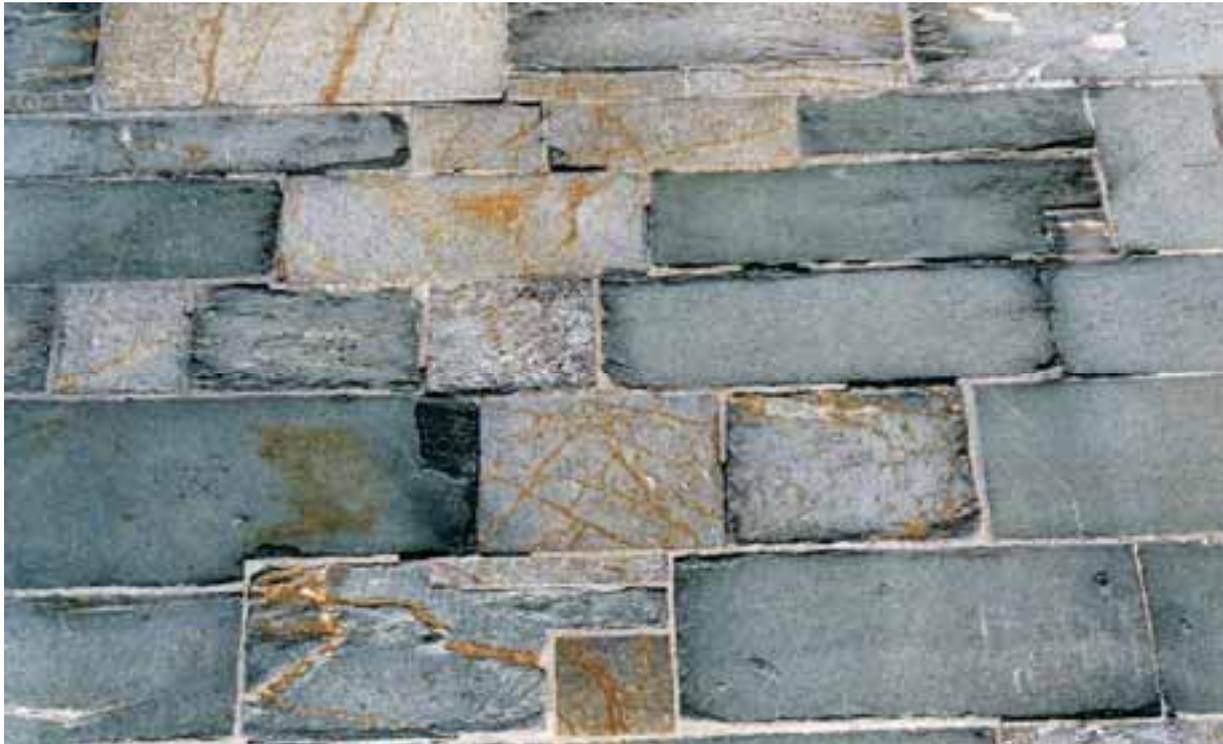
Fig. 6.11: Example of medieval masonry repointed by mortars based on Portland cement during the restoration. South-east wall of the octagon, made by greenschist and some soapstone, restored in the 1870s. The original medieval mortars are extremely thin and they have been widened in order to apply repointing mortars. It is evident that weathering preferentially takes place along the repointed joints (photo: PS 1995).

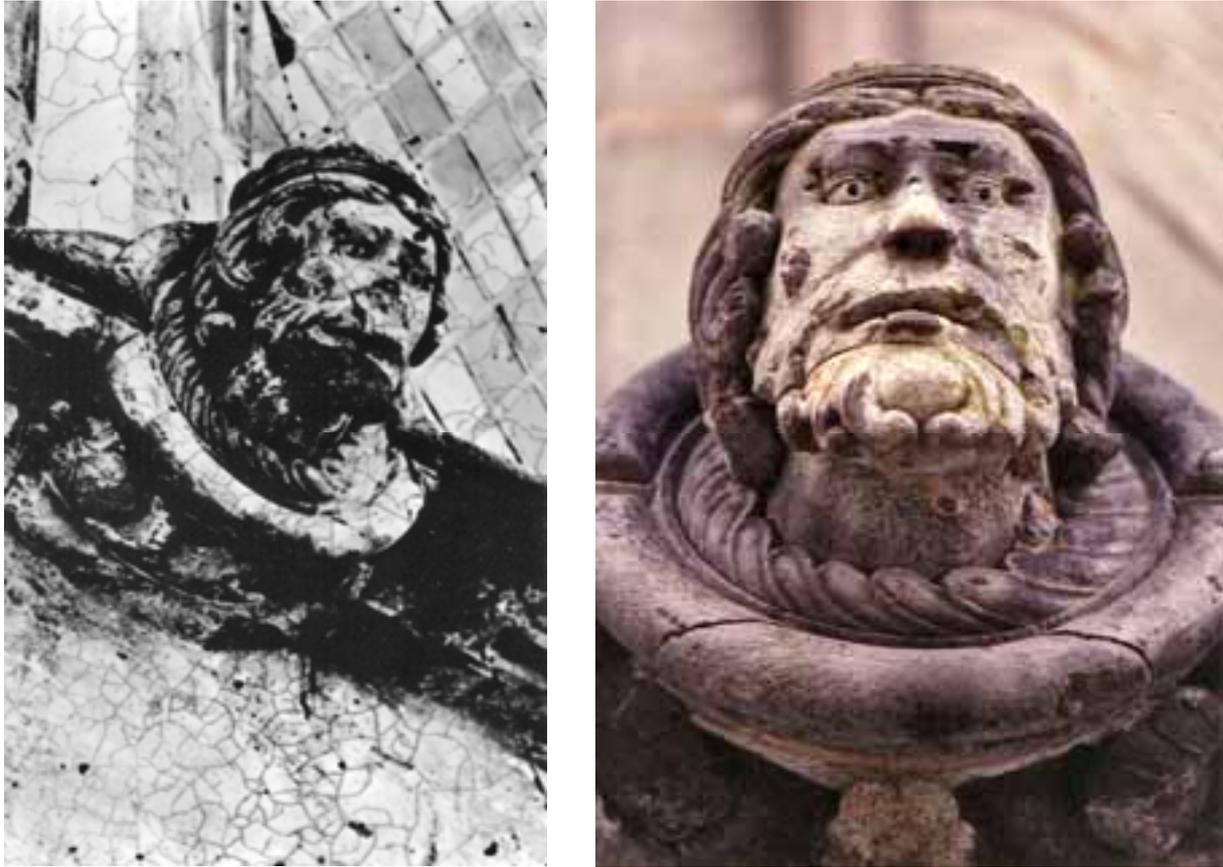
Fig. 6.13: Example of the principal method of reconstructing sculpture during the restoration of the octagon (1870s). Medieval (1180s) head in string course of the octagon's east chapel. The missing nose and chin (left) have been replaced (right) (photos: ARW and PS 3/90).
