The Stones of Nidaros

An Applied Weathering Study of
Europe's Northernmost
Medieval Cathedral

Dr. Ing. (Ph.D.) thesis no. 1997:92
Department of Architectural History
Norwegian University of Science and Technology
Trondheim, Norway

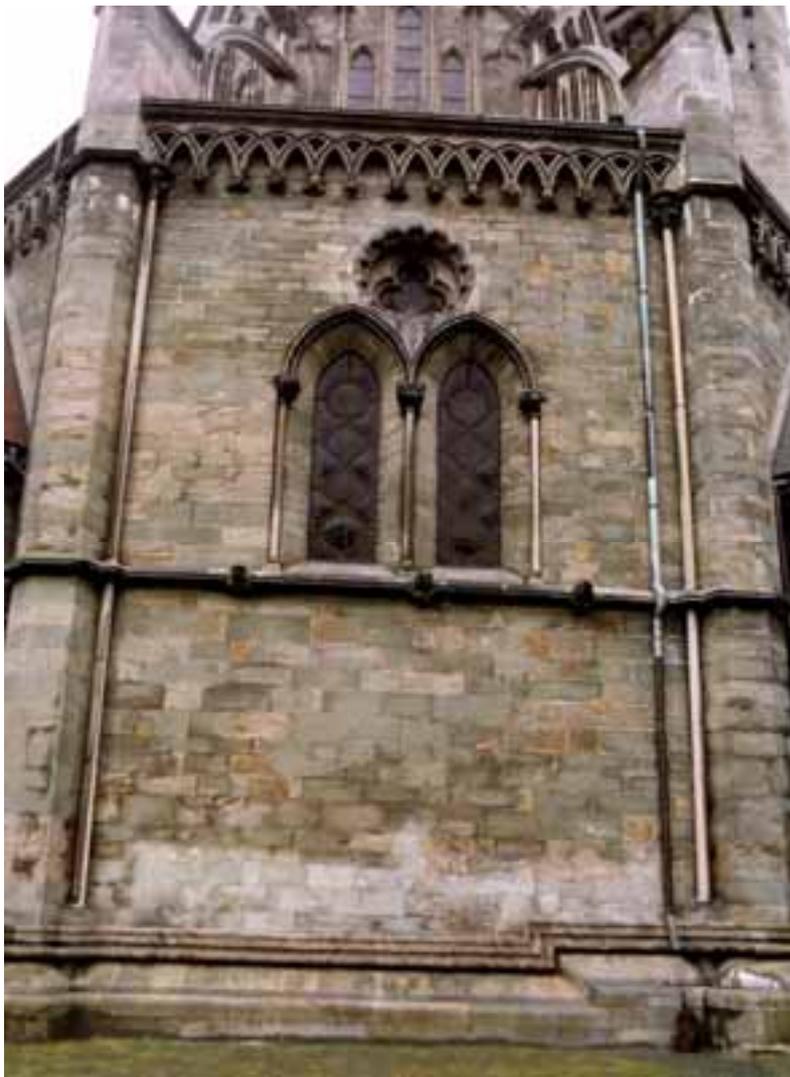
The cathedral was subjected to several graffiti attacks in the 1970s and 1980s.¹⁰³ The lower parts of the chapter house, octagon and choir were particularly affected. Removing graffiti is a difficult operation and The Restoration Workshop did it “the hard way” by wet grit blasting. Consequently, parts of the soft masonry surface were badly damaged, not only because the outer layers of stone were removed, but also because the masonry drastically changed its colour to become much too light (fig. 6.14).

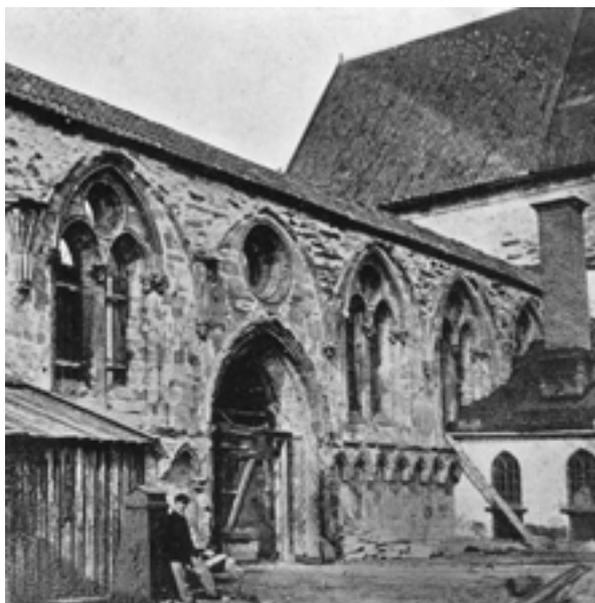
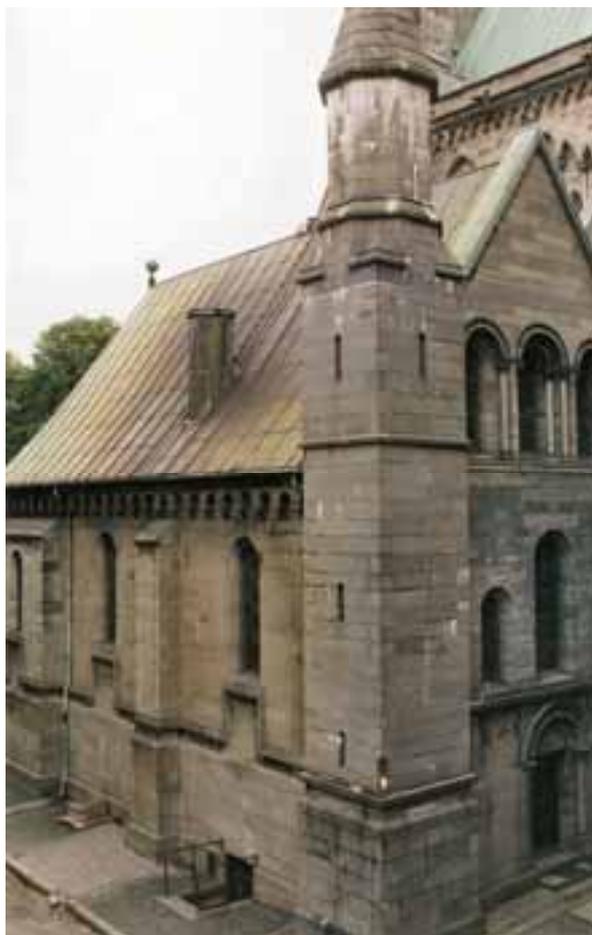
The first heating plant was constructed in 1860 and located in the corner between the north transept and the ruined nave (fig. 7.10). It was moved to a new cellar which was dug out below the chapter house during the restoration in 1869-71. Since then the low chimney on top of the roof of the chapter house has been emitting soot and SO₂ for more than 125 heating seasons (October-May).⁴¹

Fig. 7.10: The first heating plant of the cathedral was located in the corner between the north wall of the ruined nave and the north transept in the 1860s (left, photo: ARW). Since 1870 the heating plant has been located in the cellar below the chapter house (right, photo: PS 8/95). Note the chimney and the discoloured copper plates on the roof.

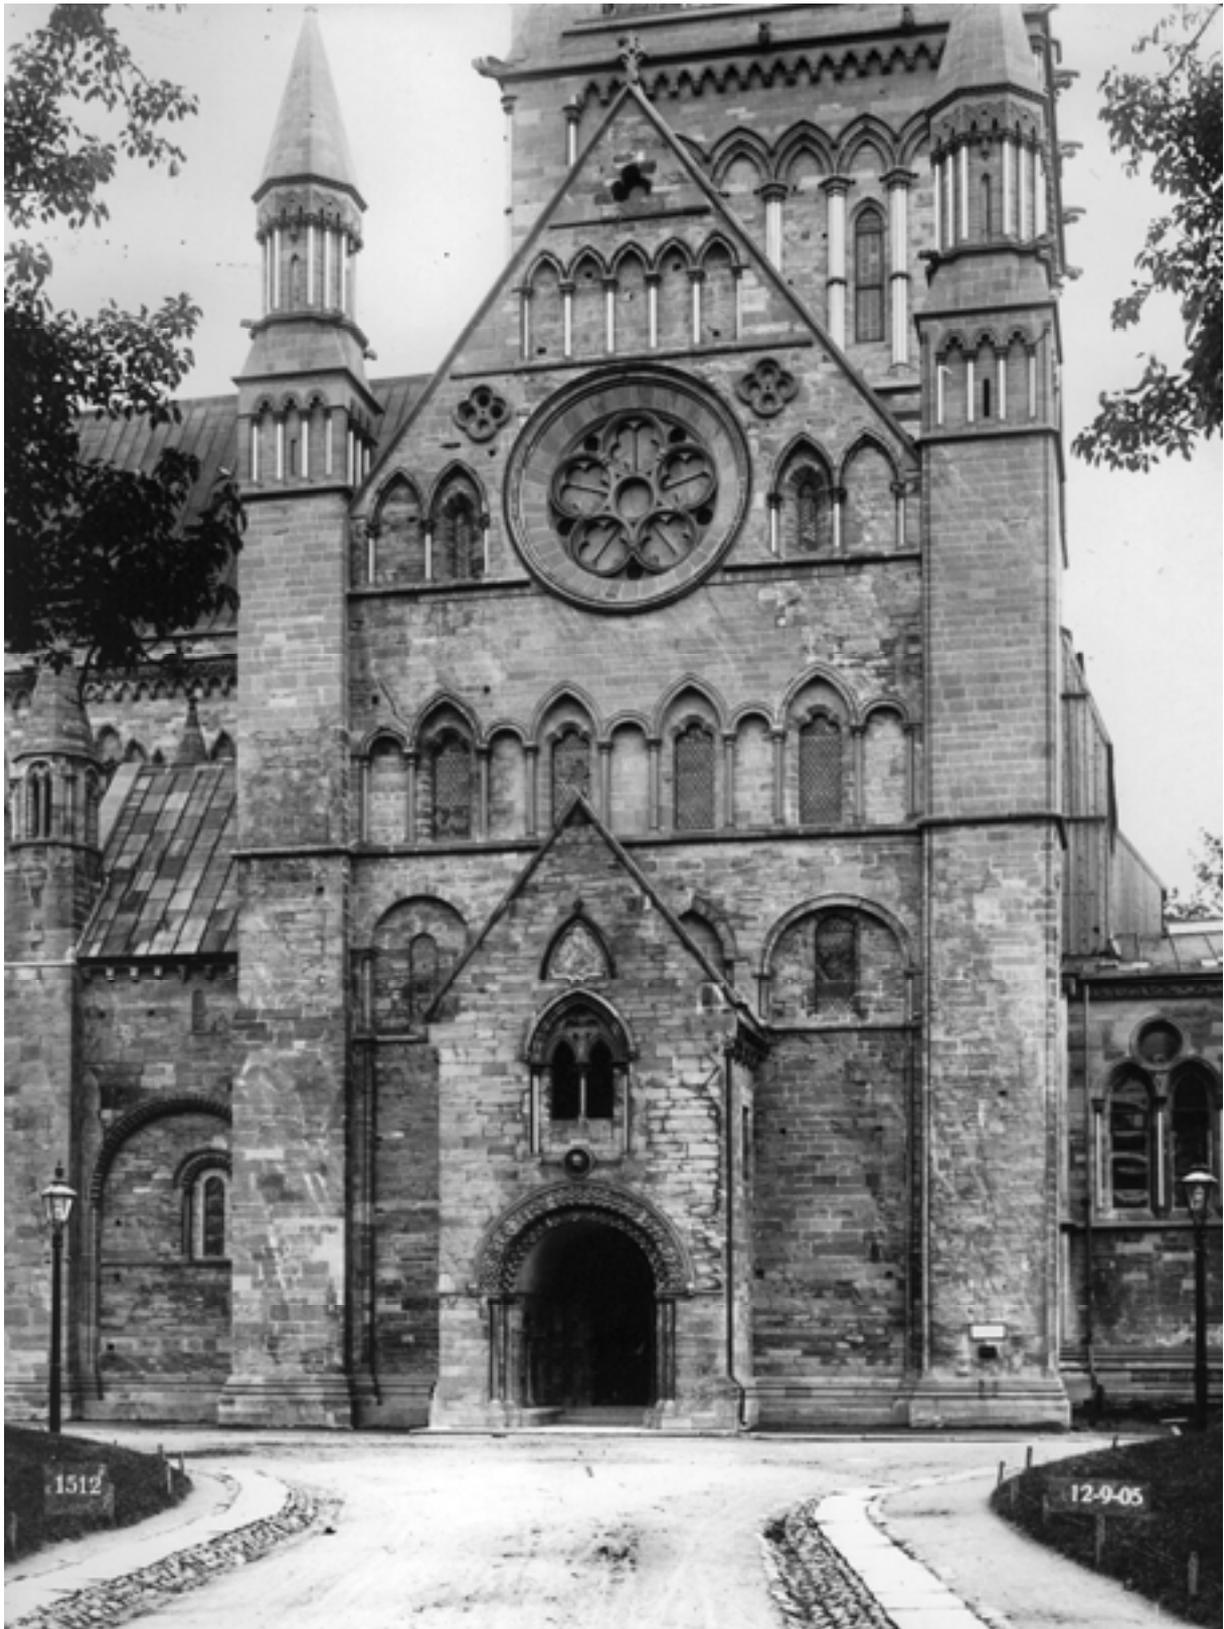
Fig. 7.13 (cont.): 1905

An example is the north porch of the cathedral from 1880 until recently (fig. 7.13). Immediately after the porch was restored in 1880, the north wall was very smooth and without

Fig. 7.13: The development of black crusts on the north porch of the cathedral. Above: c. 1881, just after the porch was restored. Next pages: 1905: There is a distinct line of black crusts along the wall. 1930: Black crusts are very widespread. 1993: The black crusts have largely disappeared, probably due to a combination of decreasing air pollution and rain washing (photos: ARW and PS).

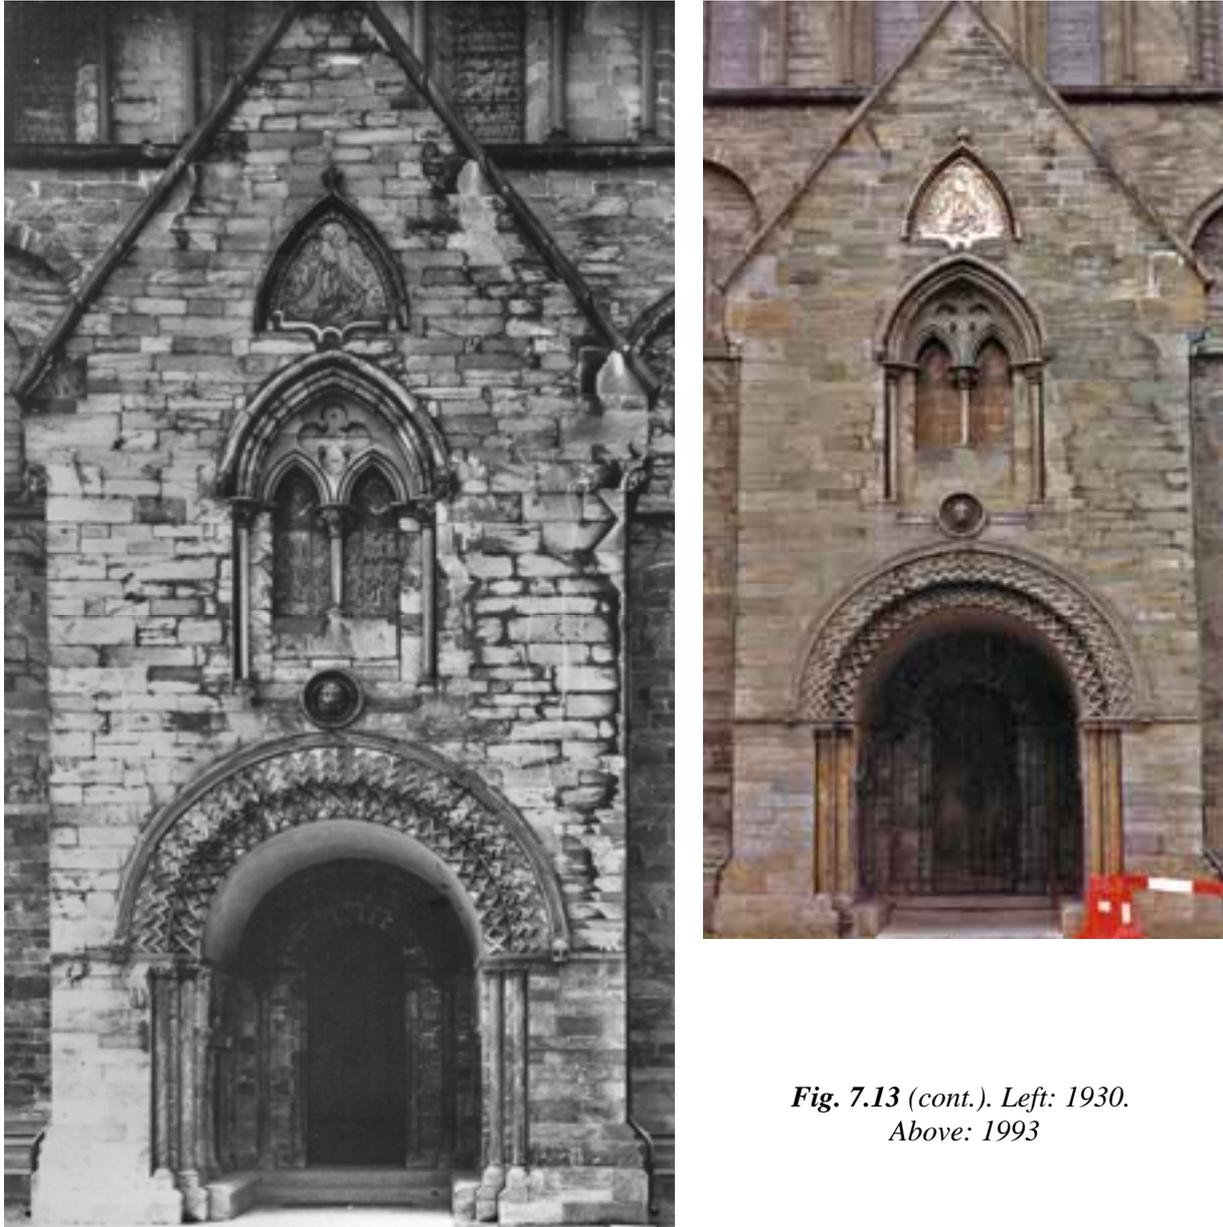
*Fig. 7.13 (cont.). Left: 1930.
Above: 1993*

Since no relevant photos taken in the period between 1930 and 1990 have been found, it is difficult to say if the maximum distribution was reached by 1930. It can only be stated that the occurrence of black crusts is far less extensive today than in 1930. As far as is known, the wall was not cleaned between 1930 and 1990. Therefore, it is concluded that the formation of crusts has halted because of reduced levels of SO₂ (and soot), and that already formed crusts have been washed away by rain (run-off).

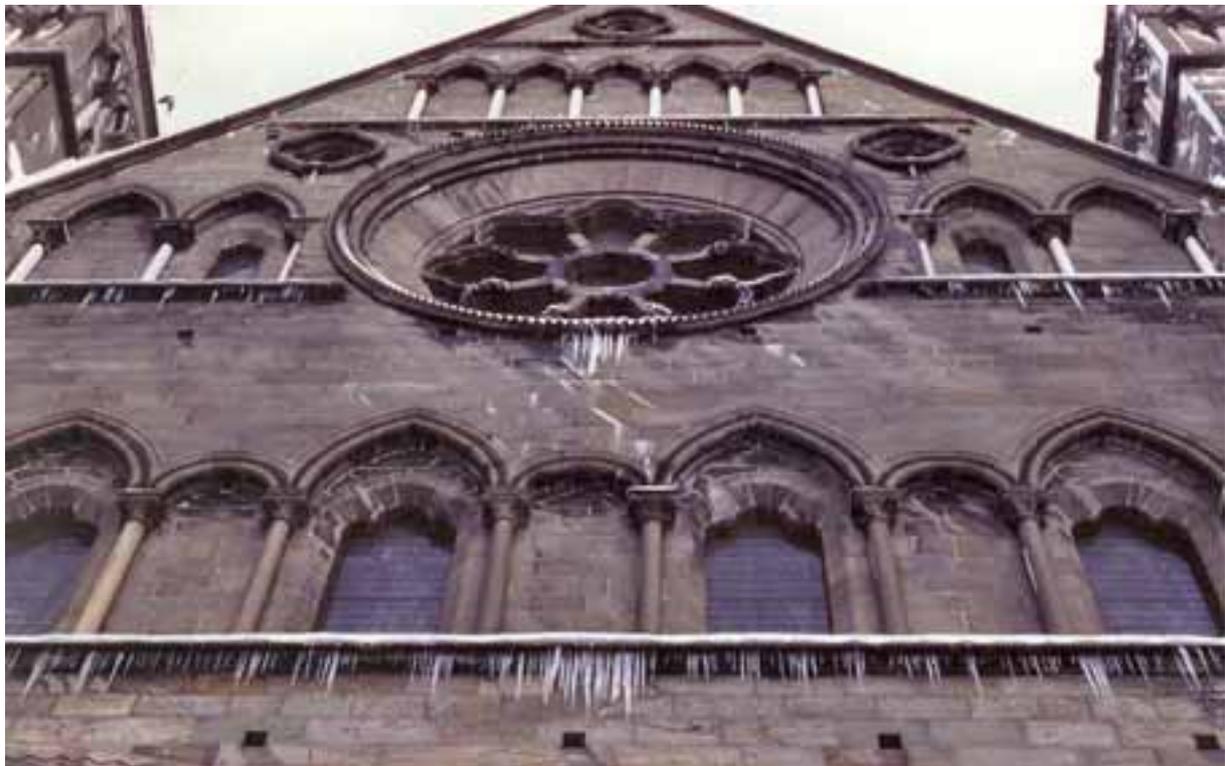
It has been estimated that the cathedral has some 2 km of horizontal and inclining, “linear” elements such as moulded bases, string courses, sills and copings made of stone. There are in addition almost 60 stone capped towers, pinnacles and flying buttresses, as well as thousands of projecting sculptures and decorations. These elements are exposed to virtually every event of rain, drizzle, hail, sleet, accumulating snow, thawing snow, freezing cold nights, ice formation - and sunshine when facing south and west (fig. 7.17).

Fig. 7.17: The south transept in Feb. 1995. Formation of icicles from string courses (photo: PS).

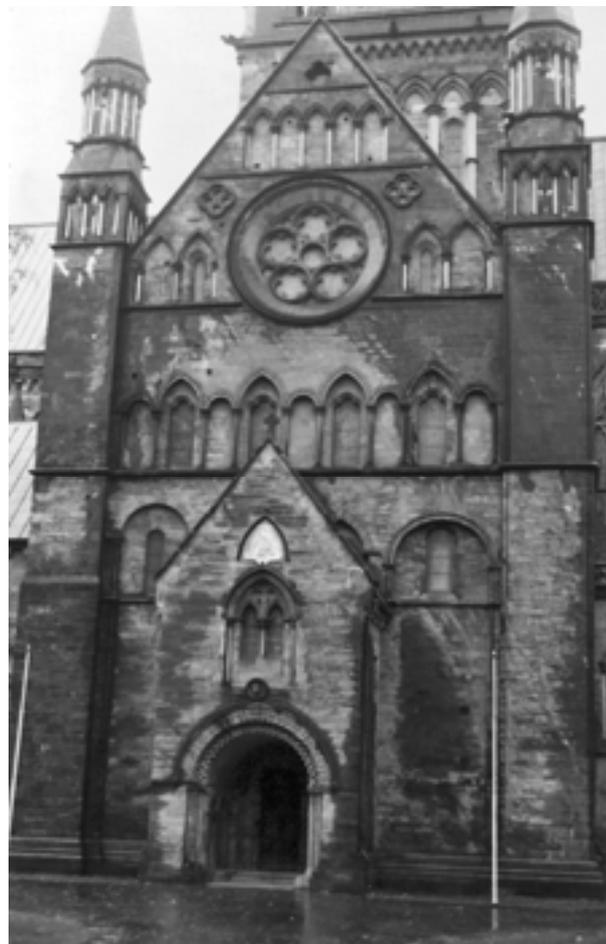
Since vertical walls are never plain, but include numerous buttresses, windows, decorations etc., they tend to become very unevenly wetted (fig. 7.18). As an example one of the heaviest rainfalls during the last 5 years could be mentioned. A northwesterly gale on October 8, 1992 brought about 50 mm of rain, making elevated vertical walls as well as projecting elements and the lowermost parts of many walls completely wet. At intermediate elevations and just below projecting elements, most walls remained dry. The lowermost part of the west front stayed completely dry - a phenomenon observed during practically all events of precipitation.

Fig. 7.18: The north transept became unevenly wetted during a northwesterly gale with heavy rainfall on October 8, 1992 (photo: PS).

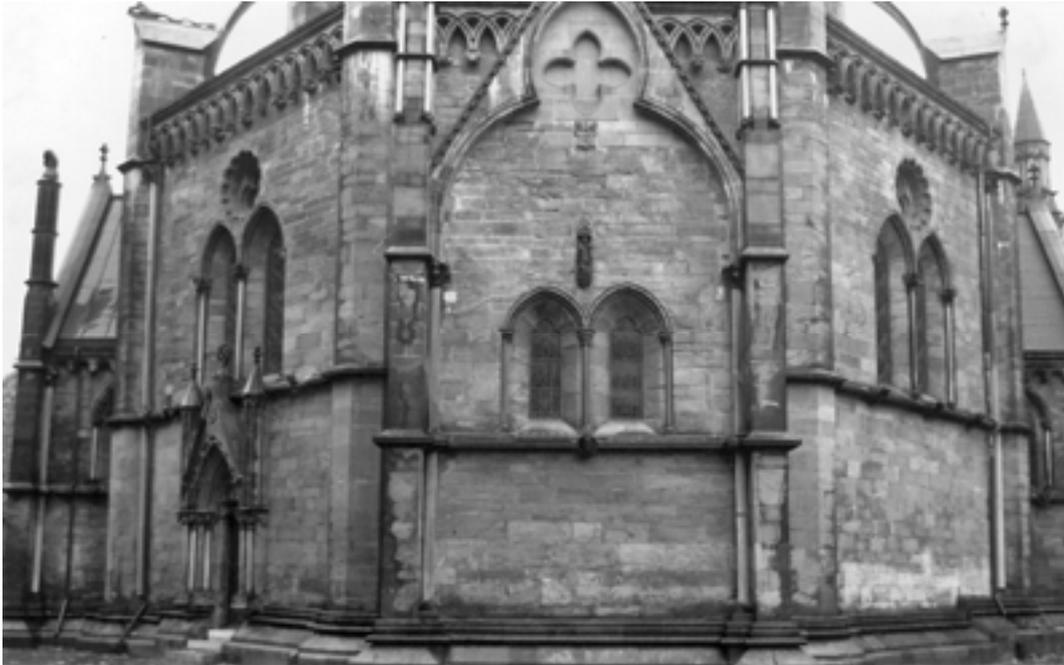
The gale on October 8th 1992 also illustrates how east-facing walls behave. Like the rest of the cathedral, projecting walls members etc. became wet. Other parts of the walls - in particular on the octagon - remained virtually dry (fig. 7.19). After several years of observation under the most diverse weather conditions, it is in fact possible to state that large parts of the octagon are never hit by direct rain.

The significance of this observation is obvious: on walls practically never exposed to rain it is possible for dry deposited air pollutants and sea salts to accumulate.⁵⁴ Salts from other sources (water leaks, run-off systems, materials and conservation products) also accumulate on such walls.

Fig. 7.19: Large parts of the east-facing octagon remained dry during a northwesterly gale with heavy rainfall on October 8, 1992 (photo: PS).

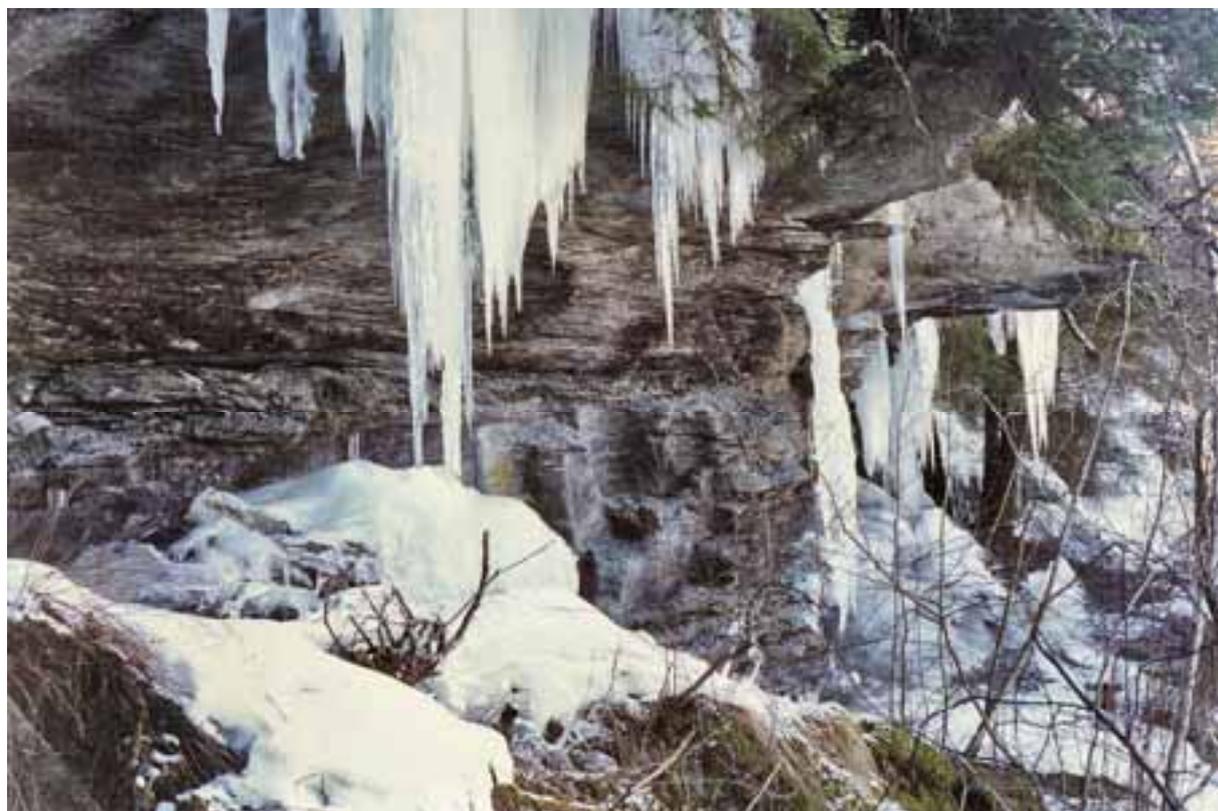
Fig. 8.3: View of the central part of the Øye quarry in March 1996. The greenschist horizon can be seen in the centre of the picture, below overhanging rock from which large icicles have formed (photo: PS).

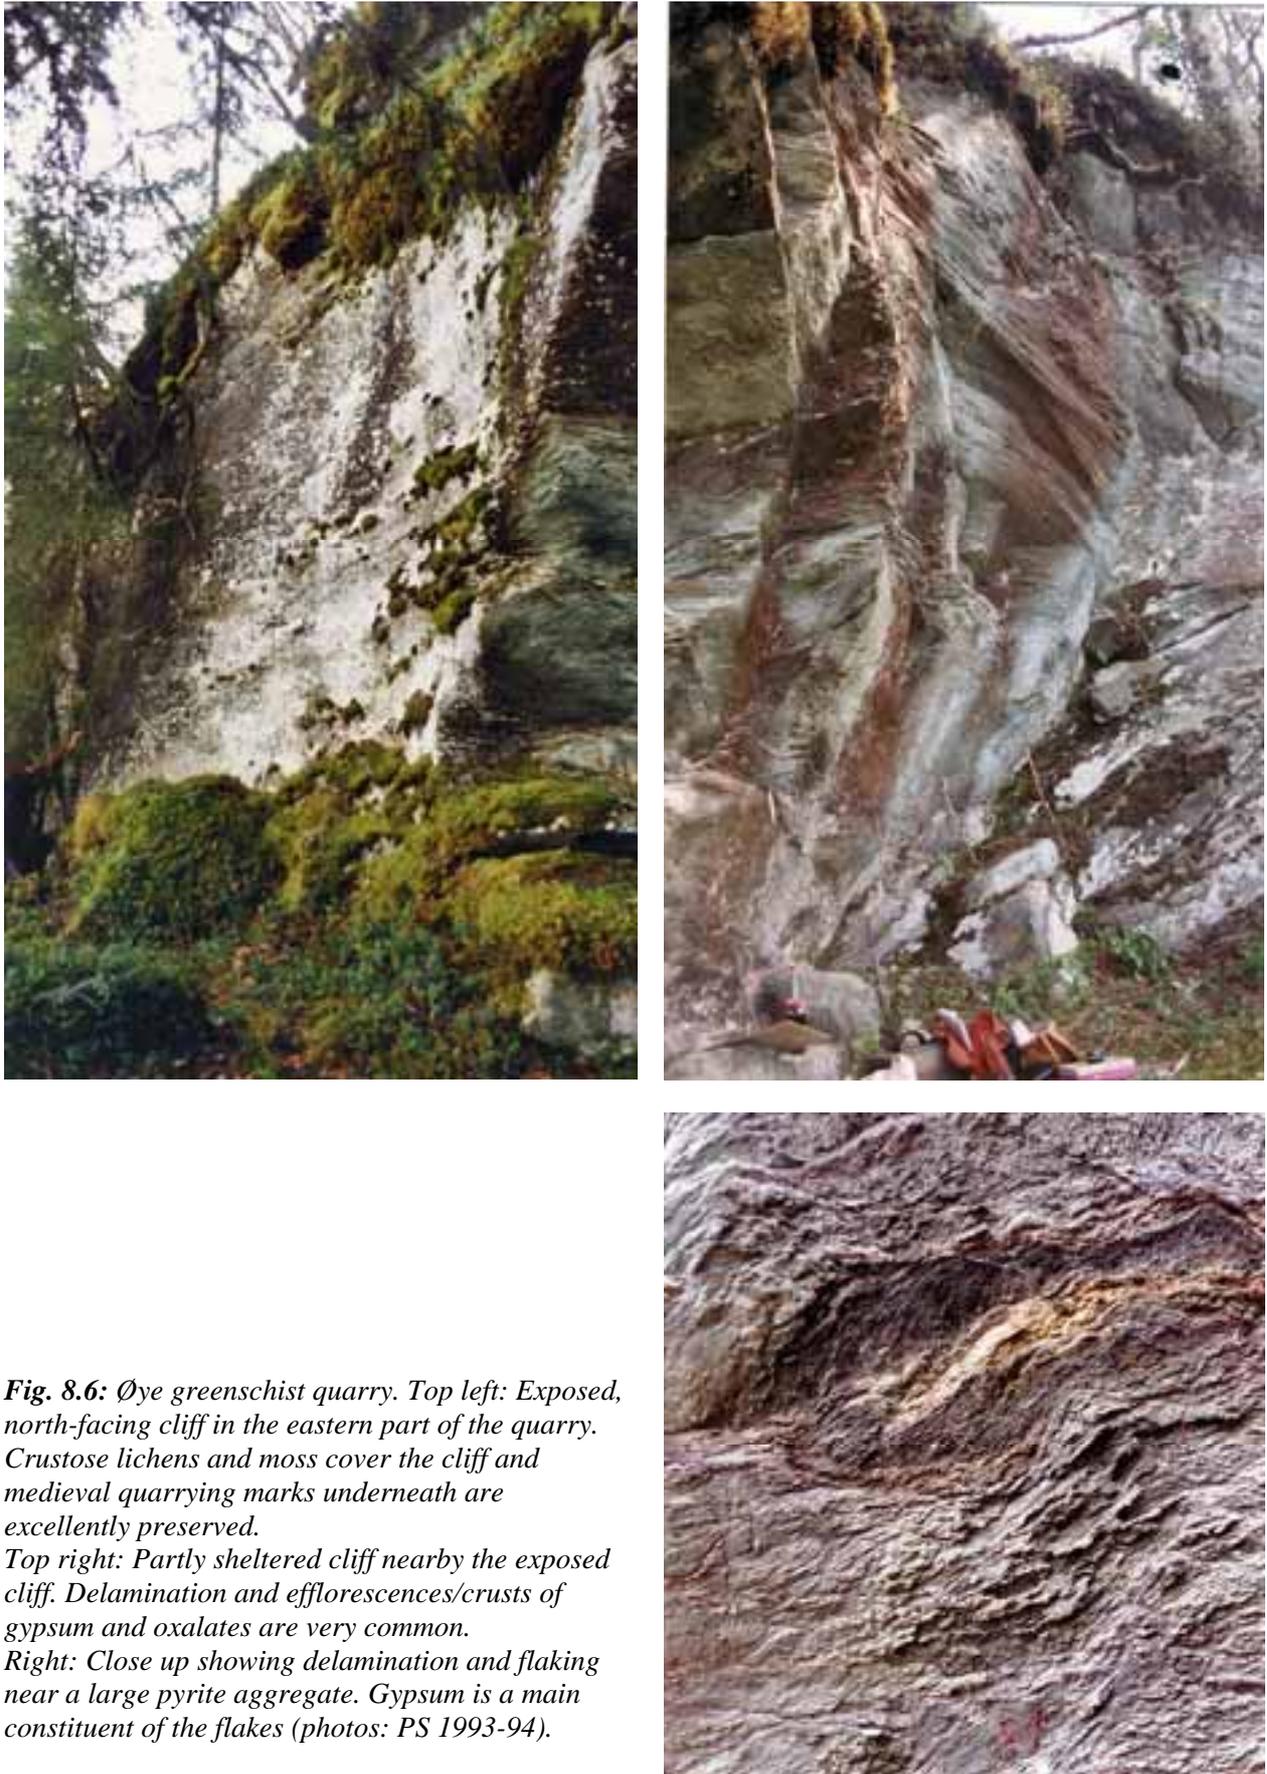
Although involving similar phenomena as described above, a more complex weathering situation can be found in the eastern part of the quarry (fig. 8.6). The complexity of the situation is largely related to diverse exposure conditions and to the existence of vertical cracks which enhance moisture transport (run-off).

Fig. 8.6: Øye greenschist quarry. Top left: Exposed, north-facing cliff in the eastern part of the quarry. Crustose lichens and moss cover the cliff and medieval quarrying marks underneath are excellently preserved. Top right: Partly sheltered cliff nearby the exposed cliff. Delamination and efflorescences/crusts of gypsum and oxalates are very common. Right: Close up showing delamination and flaking near a large pyrite aggregate. Gypsum is a main constituent of the flakes (photos: PS 1993-94).

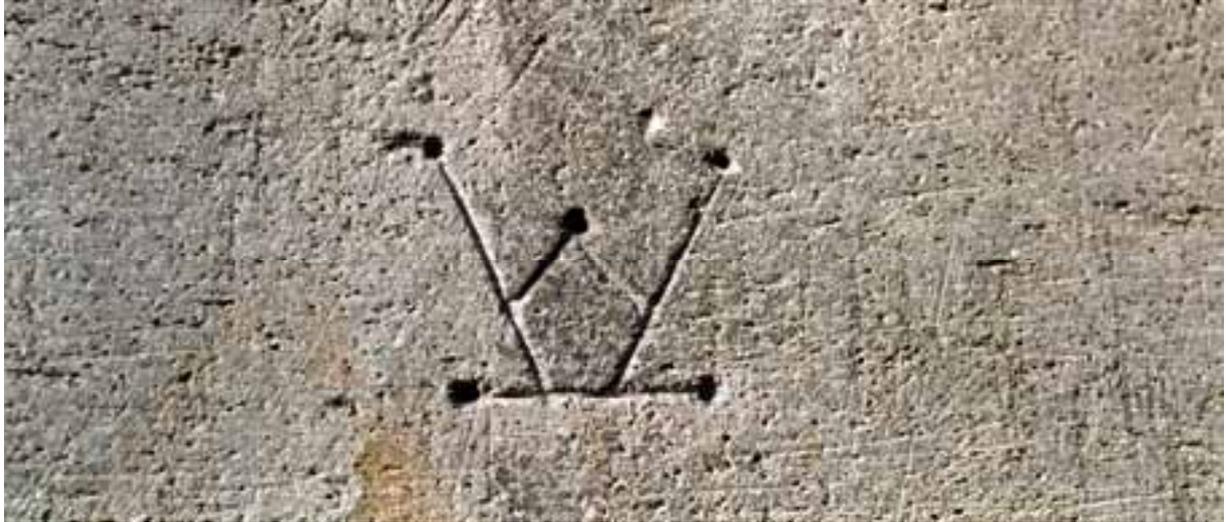
The first example is a strongly exposed, vertical pillar of the octagon's south chapel (fig. 8.7). Parts of the medieval (1180s) pillar were pulled down, cleaned and carefully redressed during the restoration of the early 1870s,¹¹ but it still has fully intact medieval masons' marks. The greenschist ashlar of the pillar are very sound, except for a few edges along joints.

Fig. 8.7: Detail of severely exposed pillar made of greenschist, octagon's south chapel, Nidaros cathedral. The pillar was erected in the 1180s and carefully redressed/rubbed in the 1870s. Note the excellently preserved medieval mason's mark (photo: PS 8/95).

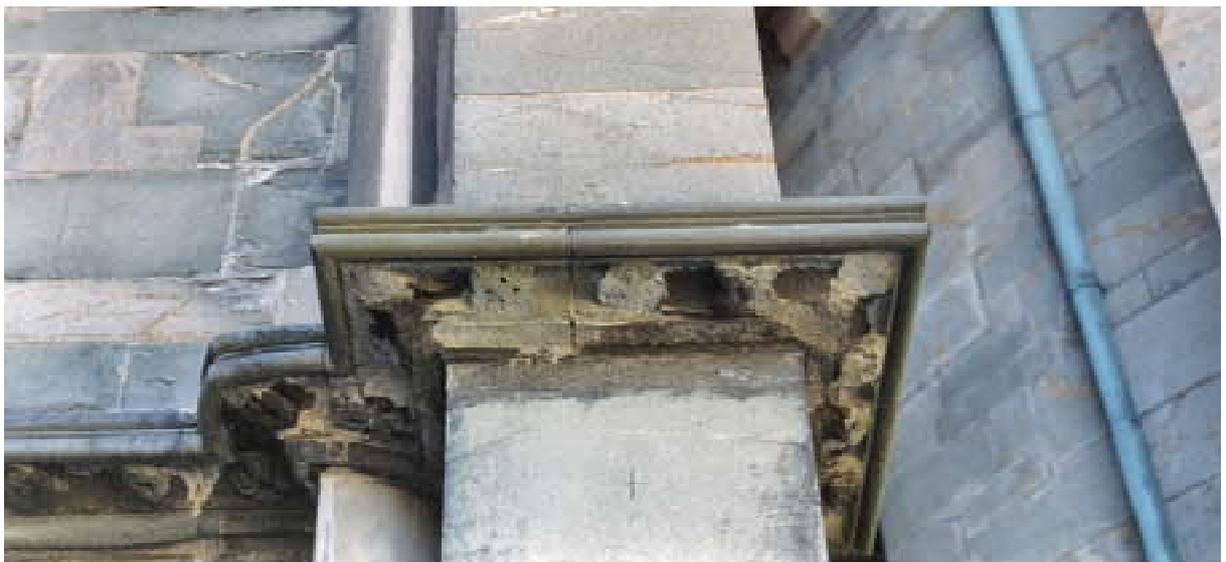
In the second example, which is a medieval (1180s) string course in the octagon's north chapel (fig. 8.8), it is possible to observe that the exposed upper part behaves in very much the same way as the vertical pillar mentioned above - i.e. it is well preserved. The sheltered flower ornaments underneath are, however, largely lost due to fissures formed along foliation planes (delamination). Black crusts also prevail in this region, probably contributing to the delamination. It should be noted that the flowers were lost after the restoration of the 1870s - a restoration which probably involved cleaning the string course with acid and/or lye.

Fig. 8.8: String course made of greenschist, octagon's north chapel (1180s), Nidaros cathedral. The exposed, upper side is in excellent condition, whereas the sheltered ornaments underneath have been lost along foliation planes, probably because of the development of black crusts (photo: PS 8/95).

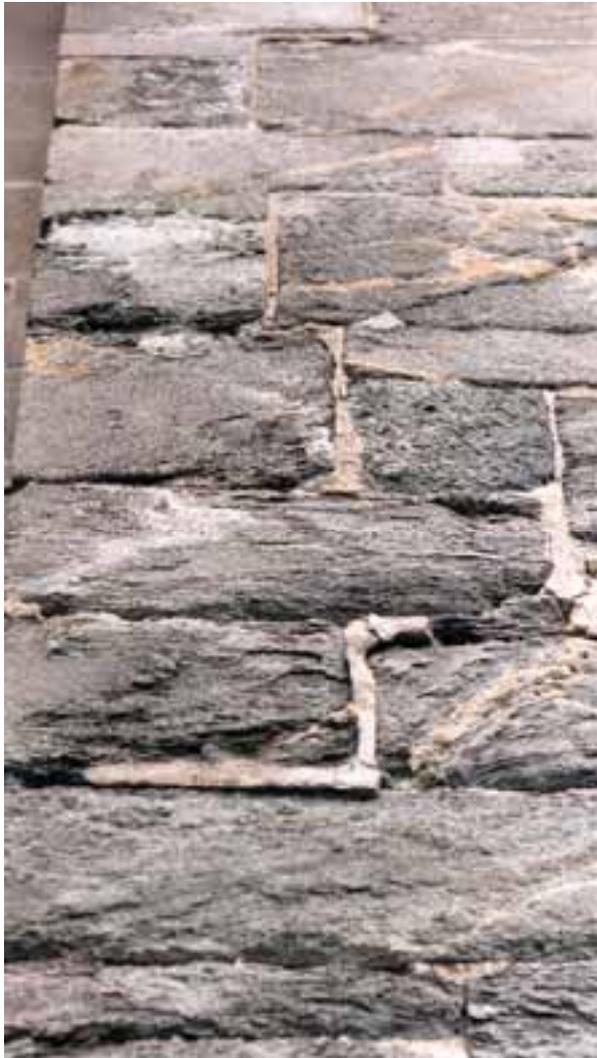
Delamination, often in combination with granular disintegration and some flaking, is the main weathering form on partly sheltered ashlar masonry influenced by moisture and salts from “within” the walls (water leaks). Highlighting this phenomenon is the third example taken from the medieval masonry of the north transept's eastern tower (fig. 8.9). Just above the area in question, the tower was rebuilt with new stone and Portland cement mortars during the restoration at the turn of the century. Alkaline salts from Portland cement seem to be the main reason for the heavy delamination.

Fig. 8.9: Strongly delaminated medieval greenschist masonry (c. 1150) in the eastern tower of the north transept, Nidaros cathedral (photo: PS 8/95).

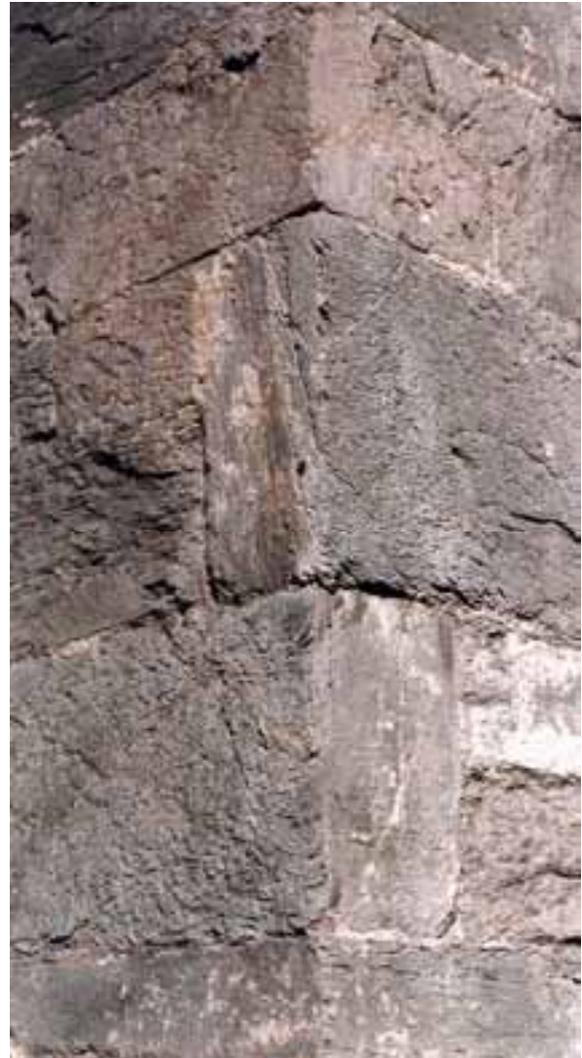
The choir of St. Mary's church (c. 1200) in the city centre of Trondheim has masonry of so-called “long and short work” made of greenschist. “Long” ashlars are horizontally bedded, whereas the “short” are face-bedded (fig. 8.10). The face-bedded ashlars tend to delaminate and lose the outermost parts, especially in the zone of rising damp. Although the greenschist naturally develops fissures along the foliation planes, the pronounced loss of material in St. Mary's church is also related to complex historical events, for instance fire and removal of former plaster and whitewash.¹²

Fig. 8.10: Face-bedded ashlars made of greenschist in the choir of St. Mary's church (c. 1200). Observe that delamination leads to loss of the outermost layers (photo: PS 6/96).

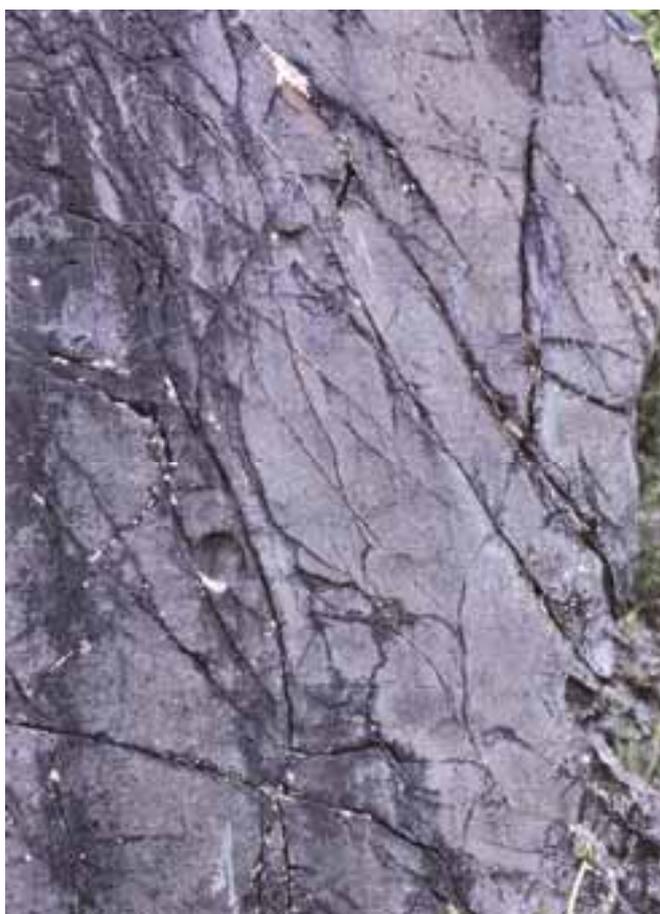
Dissolution of carbonate veins occurs on near-vertical, smooth surfaces strongly exposed to precipitation (fig. 8.13). Some veins are deeply weathered, filled with lichen and moss, leaving a crack-like pattern on the surface. When carbonates are intergrown with massive talc, surfaces tend to develop micro-karst. Originally white carbonate veins are always oxidised (brown/red colour) due to small amounts of iron in the crystal structure. Dissolution and oxidation phenomena - probably connected with frost - may cause total breakdown of many carbonate veins to earthy masses of iron hydroxides and similar minerals. These phenomena often result in major chipping and spalling of the rock structure; relatively large pieces of soapstone may loosen and detach.

Fig. 8.13: Part of the Bakkaune soapstone deposit. On exposed surfaces carbonate veins tend to dissolve, leaving a crack-like pattern and sometimes leading to spalling and chipping of the rock (photo: PS 1994).

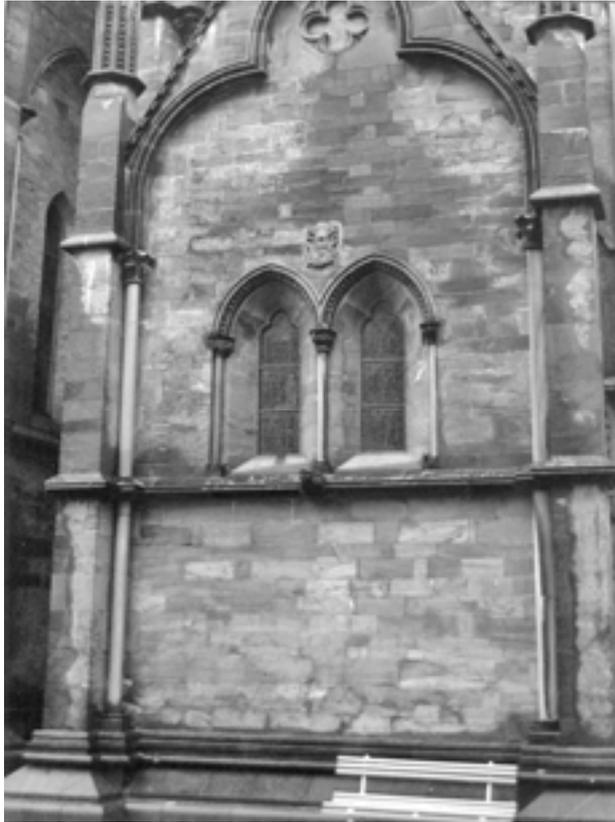
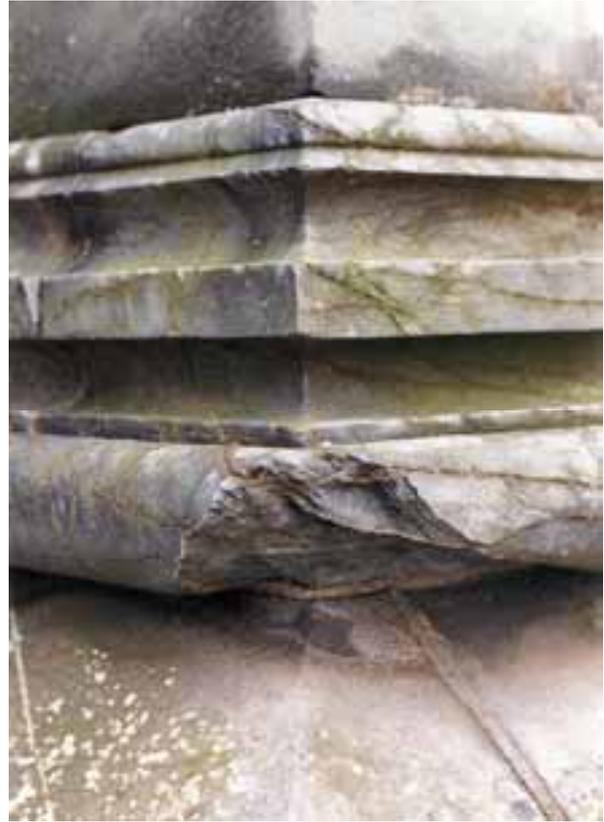
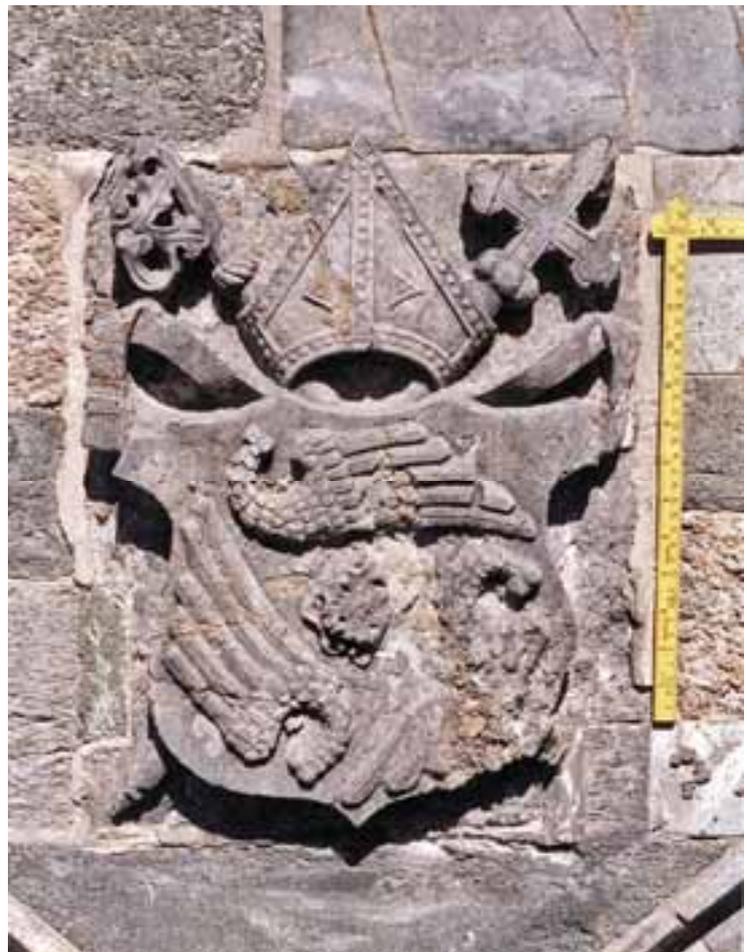
Loss of pieces in connection with dissolving carbonate veins can also be observed on the replaced (1870s) base of the octagon's south chapel today (fig. 8.15). Although some fracture planes cut directly through the matrix of the stone, it is evident that the carbonate veins represent specific planes of weakness, along which fractures preferentially develop. Except for cracking and spalling along the carbonate veins at the most exposed places, the surface of the stone is sound - it has hardly changed in character since the 1870s. The same phenomena can be observed on most medieval soapstone (Bakkaune or Klungen) sculptures of the octagon. Arms, chins, noses - and any other exposed detail - have the tendency to fracture along carbonate veins. At a distance, it is often difficult to observe such phenomena because most lost pieces were reconstructed

Fig. 8.15: Top left: The south chapel of the octagon. The moulded part of the base was replaced by Bakkaune soapstone in the 1870s. Archbishop Erik Valkendorf's coat of arms (from the early 16th century) above the windows is also made of Bakkaune stone. Note that the coat-of-arms is only partly exposed to rain. Photo taken during a very heavy shower in 1992 (photo: PS).

Top right: Carbonate dissolution has led to loss of a strongly exposed edge of the base (photo: PS 3/96).

Right: The crumbling of the lower right side of the coat of arms is mainly caused by soluble salts (magnesium sulphates) (photo: PS 6/93).

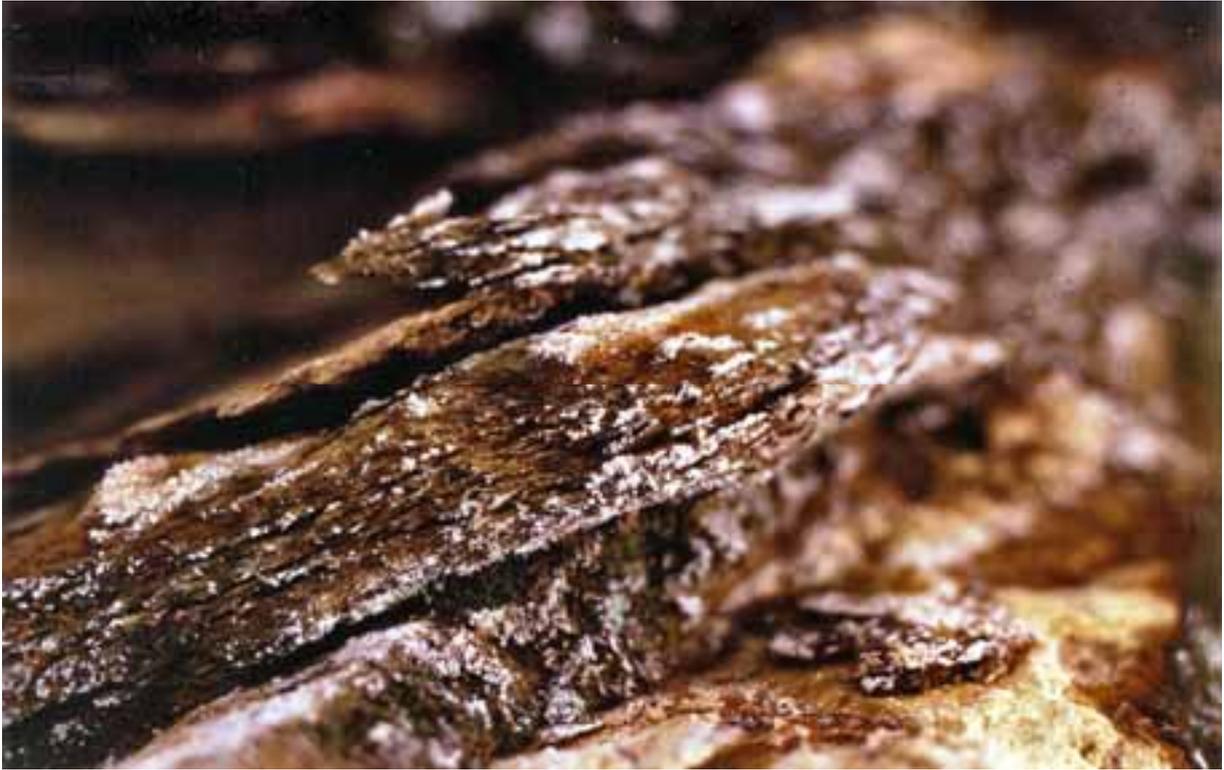
Fig. 9.5: Exposed and cracked soapstone slab in the eastern part of the Grytdal quarry. The slab has crispy efflorescences of gypsum during the cold season (photo: PS 3/95).

Being partly sheltered from direct precipitation, the eastern wall of the Grytdal quarry shows most of the characteristic weathering phenomena mentioned above. The outermost portion of the rock has usually completely disintegrated to a powdery material (fig. 9.5 and 9.7). The formation of goethite and other iron hydroxides - as well as jarosite - render surfaces brown, reddish and yellowish and large amounts of gypsum can be found. As a result of small variations in exposure conditions, gypsum occurs as large, cauliflower-like crusts, beautiful, needle-like, white rosettes and “mats” of tiny efflorescences (fig. 9.5-6). The latter form seems to flourish on exposed areas in cold, stable winter weather. During thawing and rainy periods the efflorescences dissolve and then reappear the next winter. Epsomite can also be found in the quarry, but in surprisingly limited amounts and only during extended dry periods. The salt occurs like gypsum as “mats” of tiny efflorescences and as thin, but extensive white crusts.

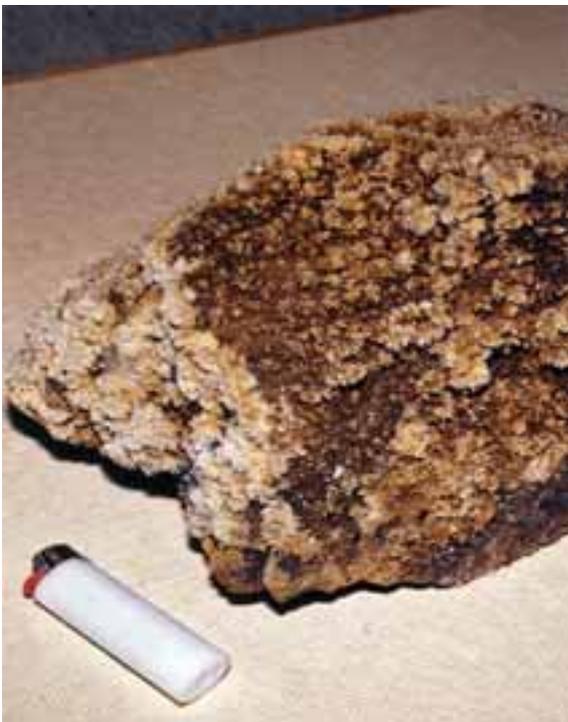
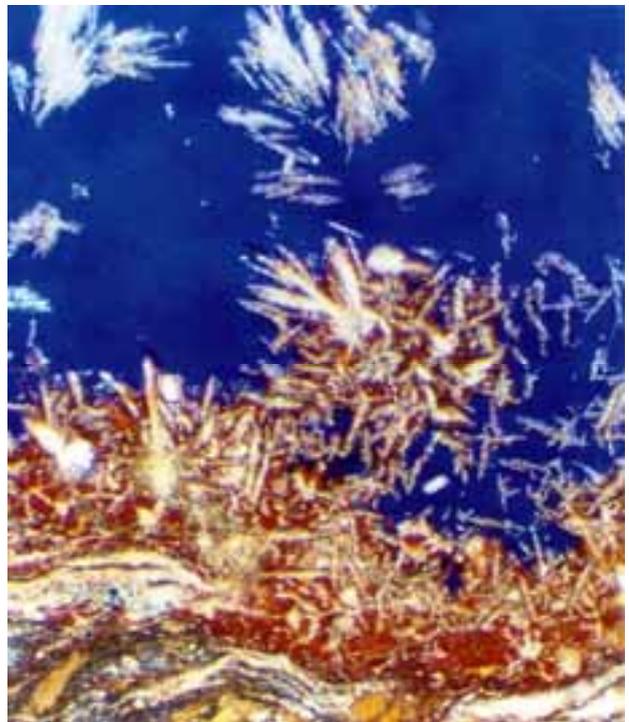
Fig. 9.6: Gypsum in the Grytdal quarry. Left: Amphibolite overgrown with gypsum rosettes. Right: Microscopic view of the gypsum rosettes. Gypsum is intergrown with jarosite (width of field: 8 mm) (photo: PS 1990).

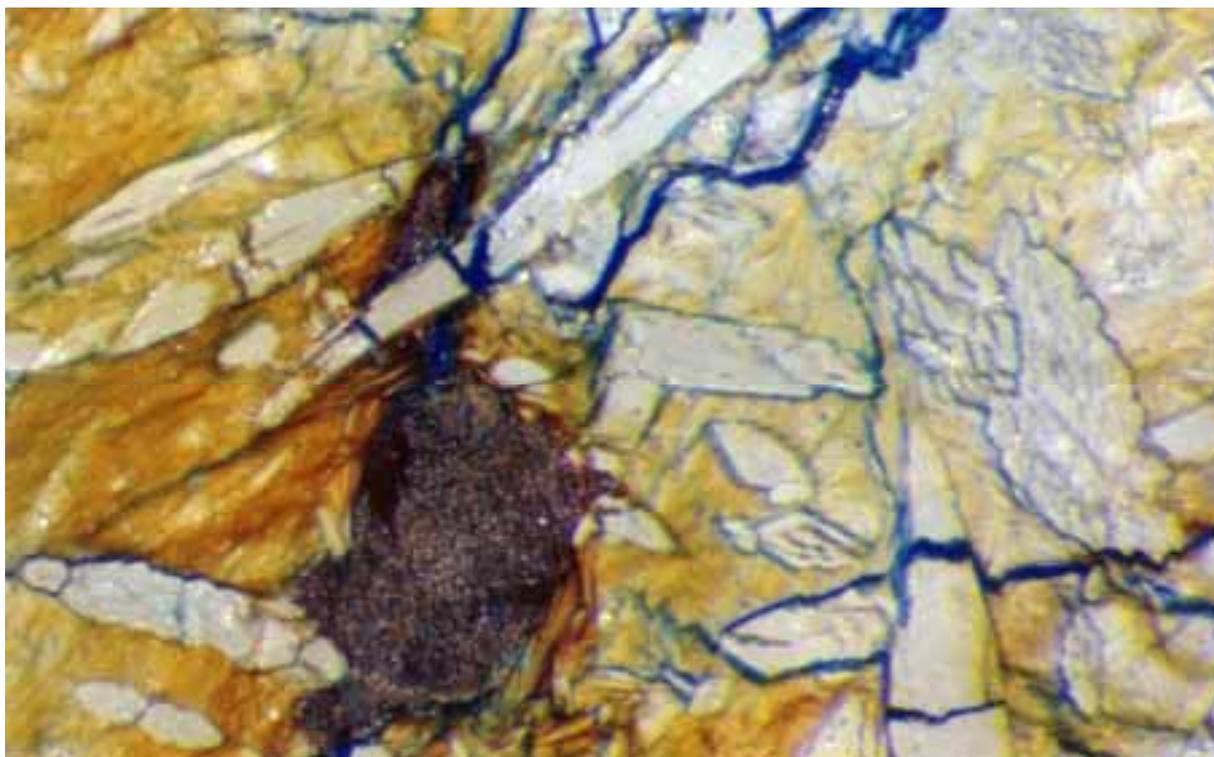
Fig. 9.7: Microscopic view of cracked Grytdal soapstone. The central grain of pyrrhotite has oxidised to form goethite, whereas fissures are preferentially associated with relatively stiff tremolite needles (width of field: 3 mm) (photo: PS 1990).

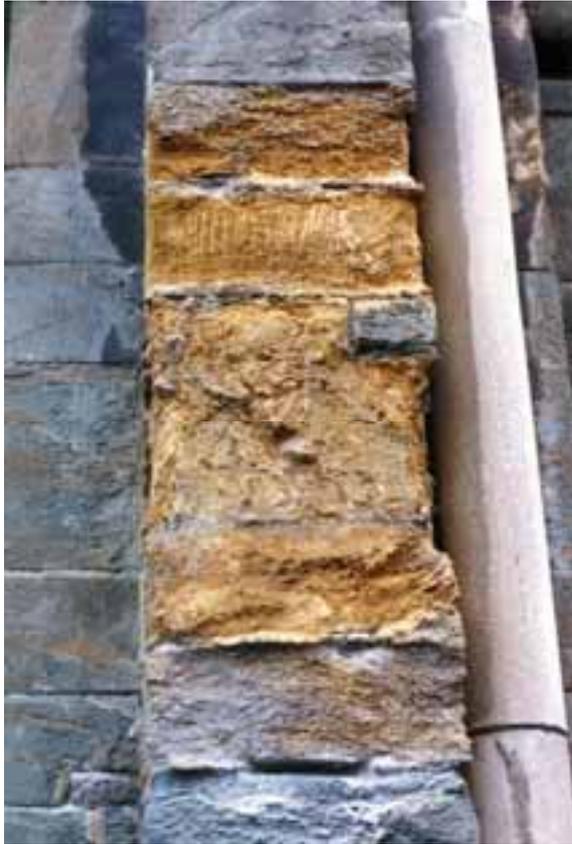
Fig. 9.8: *Hopelessly lost Grytdal ashlars from the 1880s. North side of the choir of the cathedral. Although it cannot be observed in the picture, the disintegrated surfaces also contain extensive crusts of gypsum and epsomite (photo: PS 1992).*

Otherwise, Grytdal stone appears in all states between totally disintegrated to remarkably sound (fig. 9.8-9). When weathered, the surface or even the whole interior of the stone may have strong yellow-brown colours due to the presence of iron hydroxides and jarosite. The most disintegrated stone is usually hopelessly lost and consists of loose powder which is held in place by extensive crusts of epsomite and gypsum.
