The Stones of Nidaros

An Applied Weathering Study of
Europe's Northernmost
Medieval Cathedral

Dr. Ing. (Ph.D.) thesis no. 1997:92
Department of Architectural History
Norwegian University of Science and Technology
Trondheim, Norway

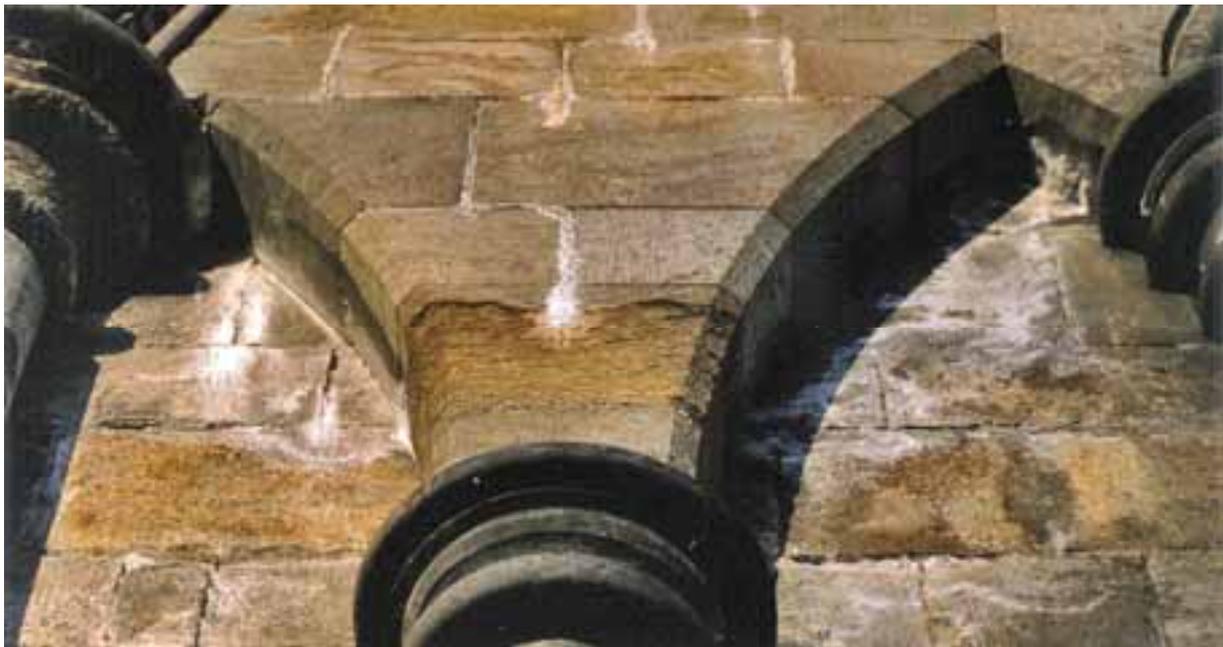
Otherwise, Grytdal stone appears in all states between totally disintegrated to remarkably sound (fig. 9.8-9). When weathered, the surface or even the whole interior of the stone may have strong yellow-brown colours due to the presence of iron hydroxides and jarosite. The most disintegrated stone is usually hopelessly lost and consists of loose powder which is held in place by extensive crusts of epsomite and gypsum.

Fig. 9.9: *Weathered Grytdal stone found beside relatively well-preserved varieties in the south wall of the choir of the cathedral (erected in the 1880s) (photo: PS 1991).*

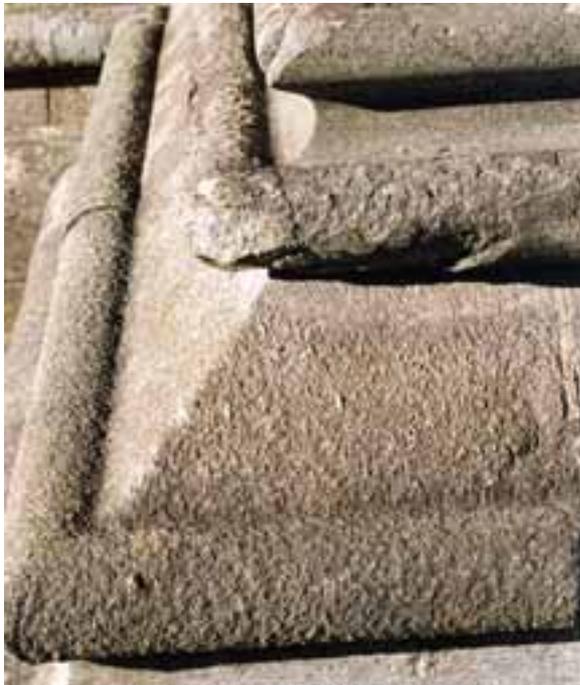
Fig. 9.11: Disintegrated surface of a moulded base made of Bjørnå soapstone around 1900. South side of the nave, Nidaros cathedral (photo: PS 8/95).

The weathering of Bjørnå soapstone used in the cathedral is extremely dependent on exposure conditions. It is possible to state that projecting features strongly exposed to precipitation weather most severely (fig. 9.11-12), while plain, vertical masonry and sheltered decorations usually remain sound.

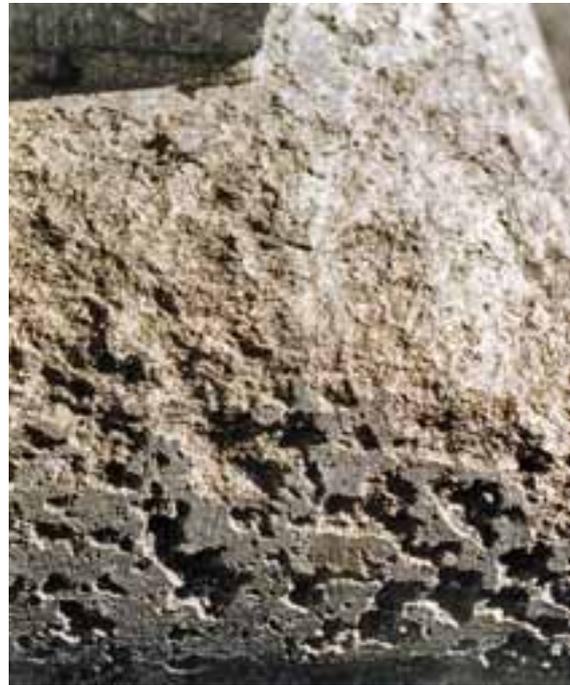
Fig. 9.12: Close-up showing connected pits in Bjørnå soapstone. Base from c. 1920 on the south side of the choir (photo: PS 8/95).

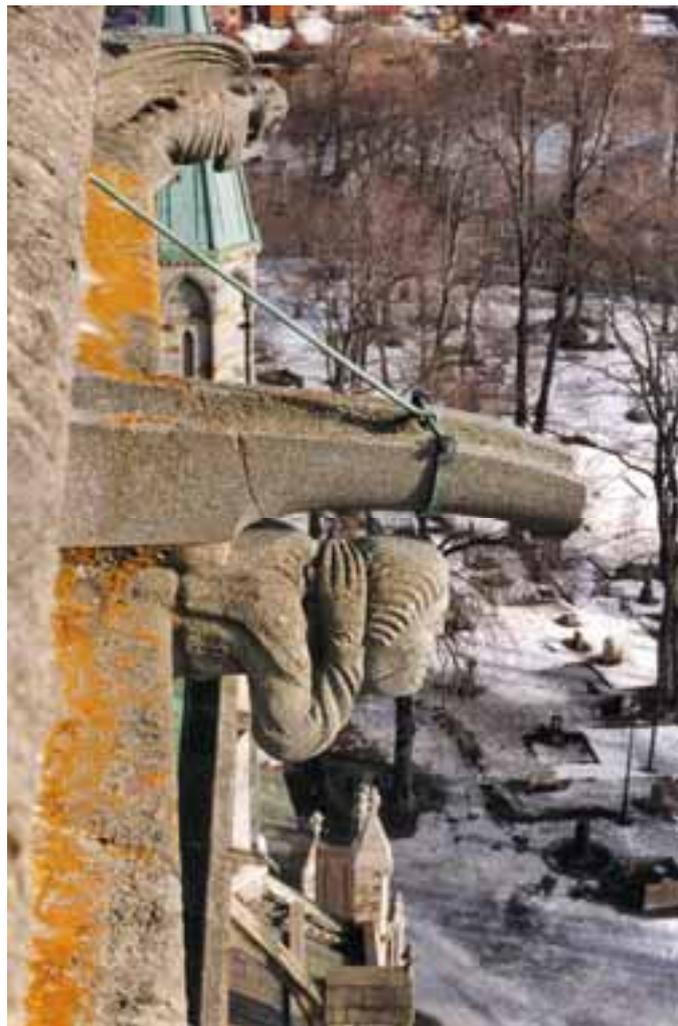
Fig. 9.13: Stone gully modelled by Gustav Vigeland and carved in Bjørnå soapstone at the turn of the century. The gully is located by the parapet on the south side of the central tower of the cathedral. It has been secured because a crack has developed along a vein of talc or carbonate parallel to the foliation plane of the stone (photo: PS 3/96).

Representing a great safety problem, gargoyles and moulded copestones put in place between 1900 and 1930 tend to lose large pieces due to fissures developing along foliation planes (fig. 9.13). Along some foliation planes thin talc veins occasionally occur, representing areas of particular weakness, but foliation alone may also lead to loss of fragments. It is evident that harsh exposure conditions involving rapid temperature changes facilitate the development of fissures, but several Bjørnå varieties are nevertheless good enough to withstand rapid weathering for prolonged periods of time.

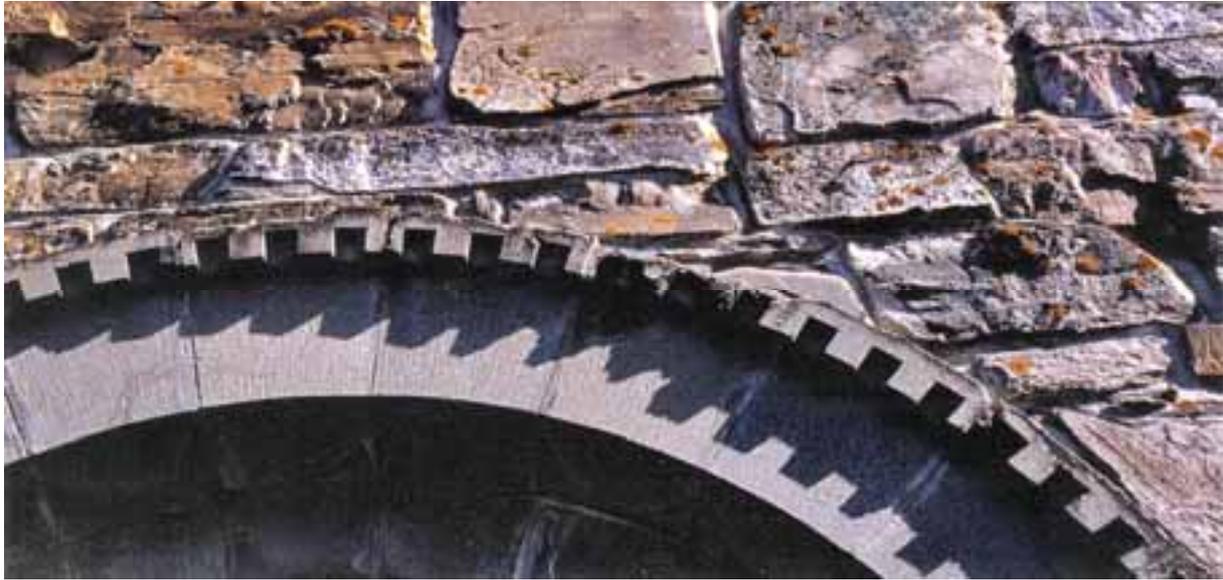
One example is the west portal of Stiklestad church, some 100 km north of Trondheim. The portal, which was built in the 1920s,¹² is very simple and features a semi-circular, slightly projecting arch on top (fig. 9.14). The arch, on which moss and lichens flourish and snow collects during the cold season, is the only part of the portal showing any kind of stone weathering. Parts of the arch are totally disintegrated, while others have developed extensive flaking.

Fig. 9.14: West portal of Stiklestad church. The portal was made of Bjørnå soapstone as part of a restoration programme in the 1920s. The upper side of the portal's arch is deeply weathered, whereas vertical surfaces remain sound (photo: PS 4/94).

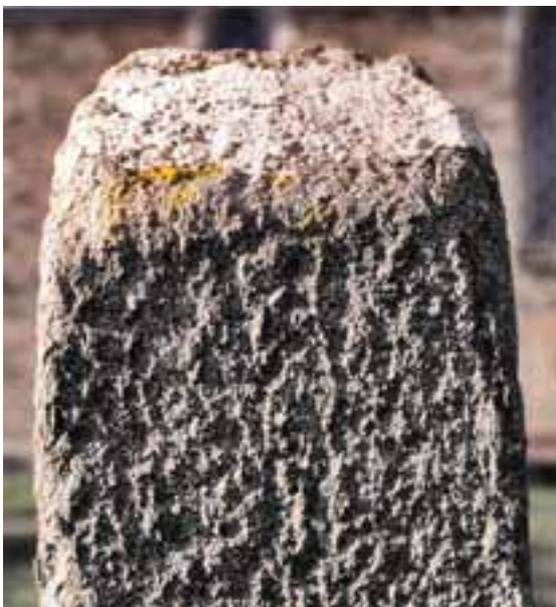
Another example is a group of simple tombstones in the cemetery of Havstein church in the western suburbs of Trondheim. The tombstones were made at the turn of the century and some show distinct weathering phenomena related to exposure condition. Sides facing east and north are generally in good condition, whereas the south sides are characterised by connected pits (fig. 9.15). The west sides develop distinct flaking parallel to the foliation of the

Fig. 9.15: Tombstone made of Bjørnå soapstone at the turn of the century. Cemetery of Havstein church in Trondheim. The south side of the tombstone is deeply weathered (photo: PS 5/94).

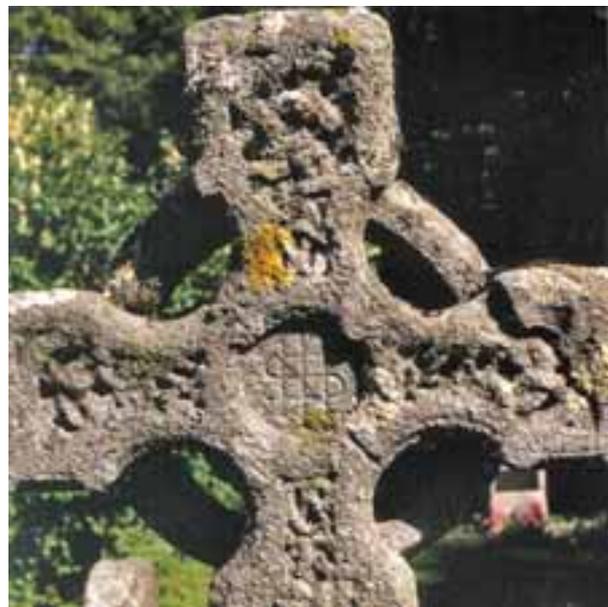
stones and the tops are usually covered by crustose lichens, which sometimes appear to protect the stone surface. Similar phenomena can be observed on elaborate tombstones at the cemetery of the Nidaros cathedral. Due to the fine carving, the tombstones have often lost pieces of varying size - usually connected with fissures along foliation planes or at exposed edges (fig. 9.16).

Fig. 9.16: Elaborate tombstone made of Bjørnå soapstone, probably from the turn of the century. Cemetery of Nidaros cathedral. The exposed surfaces are deeply weathered and fissures have developed along the foliation planes. More than 10 different species of lichens as well as moss flourish on the tombstone (photo: PS 7/95).

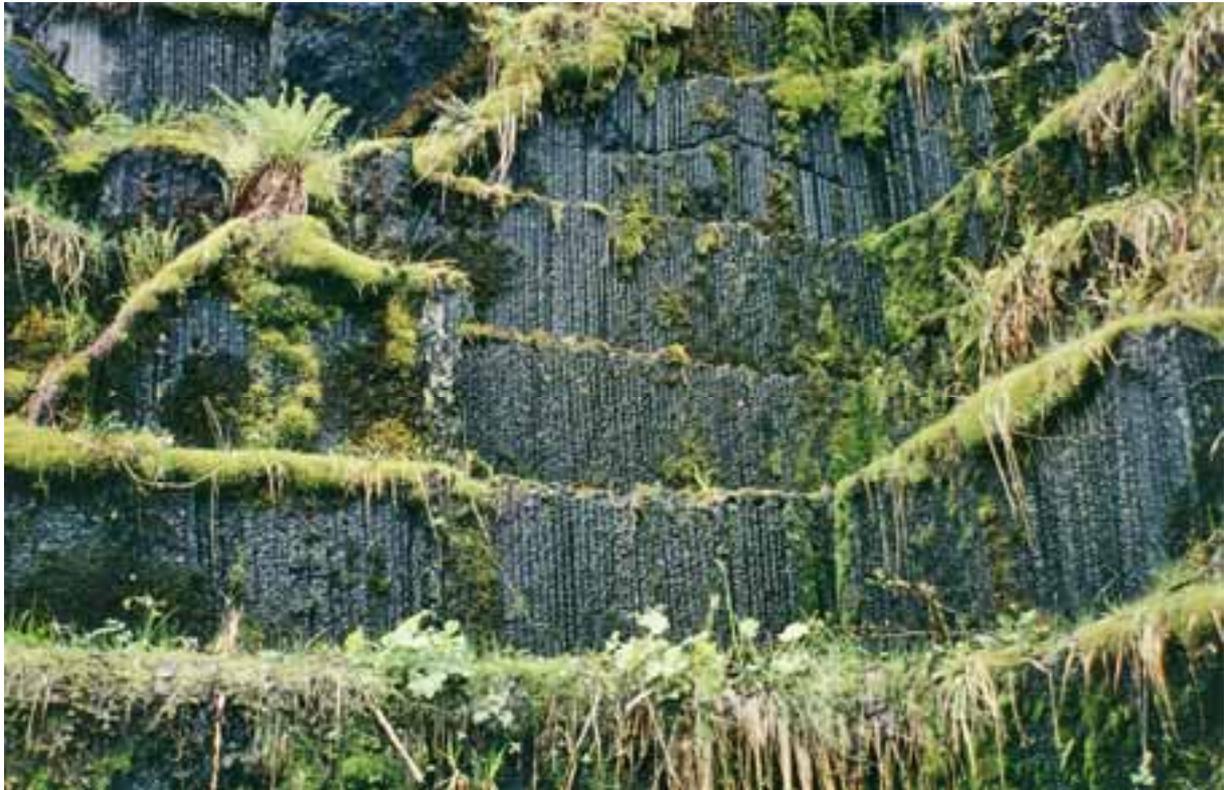
Fig. 9.17: Part of the Gullfjellet soapstone quarry close to Bergen. Manual channelling has been used to obtain raw blocks for several west front sculptures of the cathedral. Note the extensive growth of moss (photo: Tom Heldal 1993).

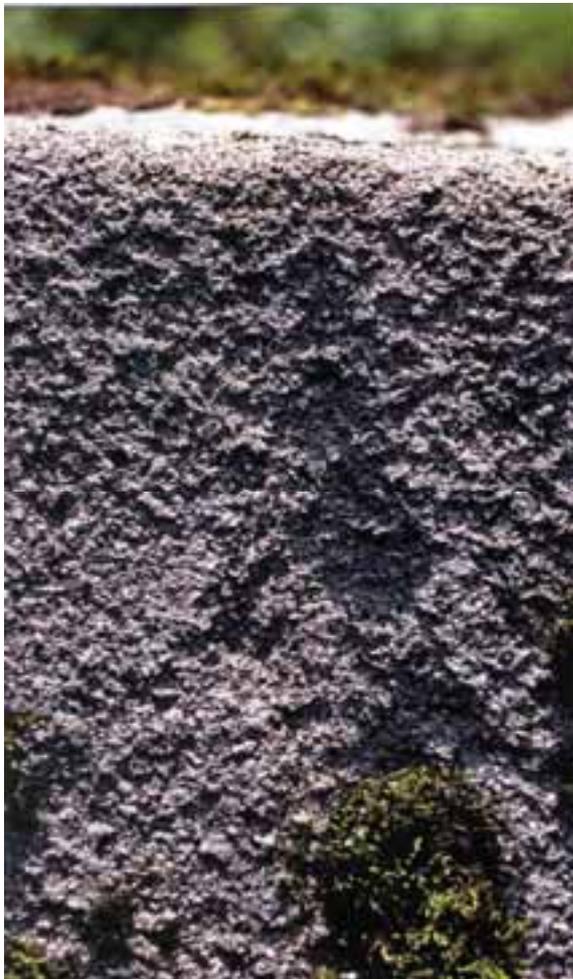
Fig. 9.18: Exposed rock face in the Gullfjellet quarry. The face contains rather homogenous soapstone which weathers intensively (granular disintegration) (photo: PS 7/95).

described as pitting. No flaking and delamination can be observed, features attributable to the lack of foliation. In parts of the quarry lacking talc aggregates, the stone weathers more evenly (granular disintegration, fig. 9.18). In other parts, it can be observed that moss and lichens apparently play a great role in the weathering. When moss and crustose lichens occur side by side, the surface underneath the moss is highly disintegrated, while lichens seem to “keep the surface together”.

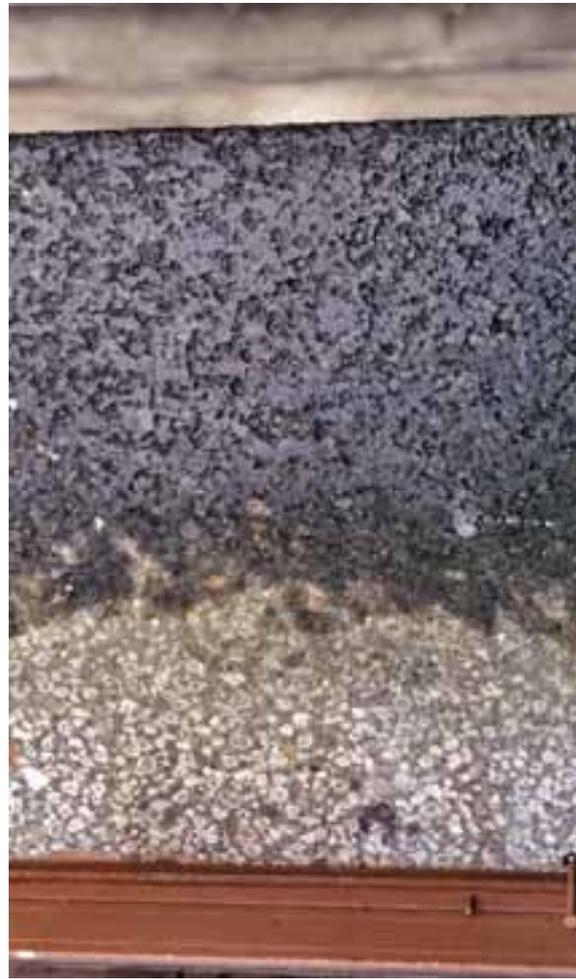
Fig. 9.19: Sill made of Gullfjellet soapstone in the Church of the Holy Cross in Bergen. The exposed part of the sill shows pitting as the main weathering form, while the sheltered part is unaffected. Picture taken during a shower (photo: PS 7/95).

Gullfjellet stone has also been used for several building and restoration projects in the Bergen region. One example is the replaced sills in the church of the Holy Cross in Bergen city centre. The sills, which are located below large windows in the main walls of the church, seem to have been put in place during a restoration campaign in the 1950s.¹⁶ As expected, only exposed parts of the sills weather. Although less intense, the weathering forms are precisely the same as in the quarry - pitting as a result of granular disintegration of the matrix and talc aggregates which stand out relatively unaffected (fig. 9.19).

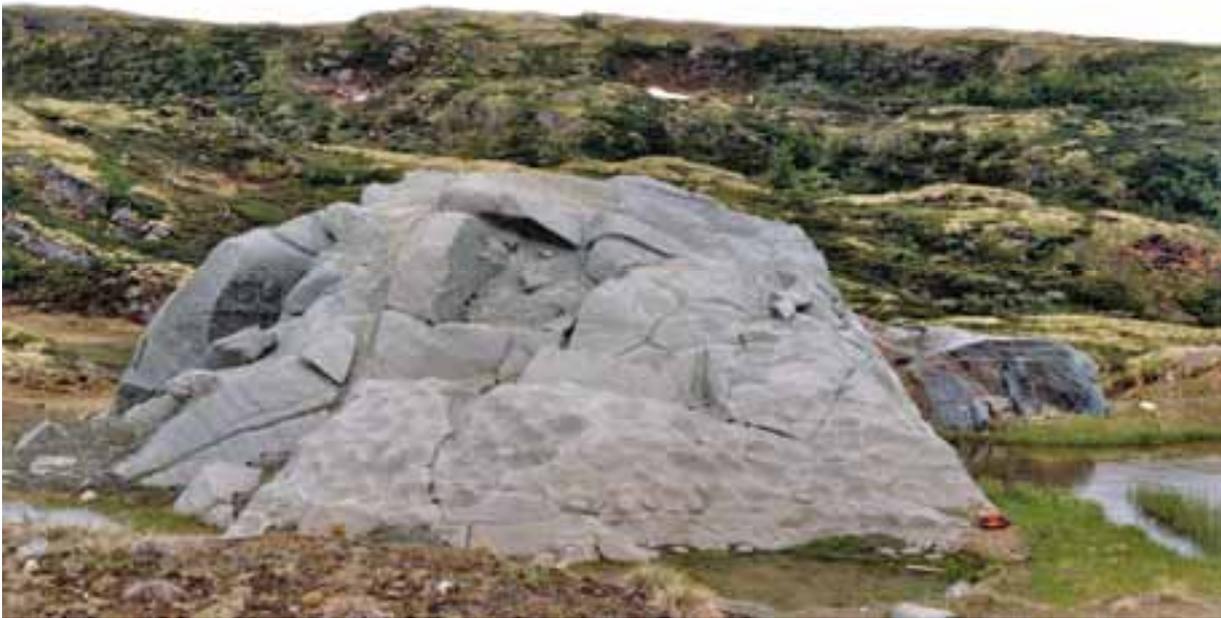
Fig. 9.20: The Bubakk serpentinite and soapstone deposit, looking north. The deposit is located in a barren mountain area c. 120 km south of Trondheim and has extensive traces of pot production in the pre-Roman Iron Age. The height of the knoll is c. 6 m (photo: PS 1990).

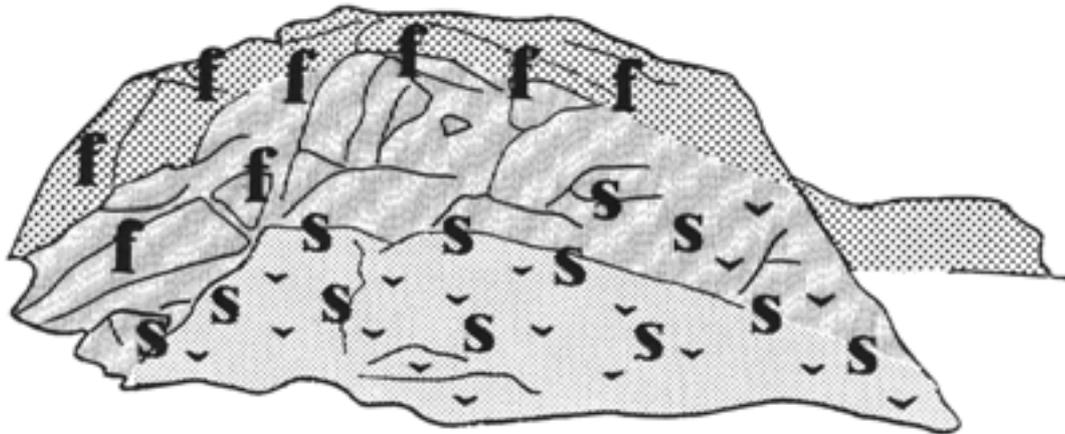
Fig. 9.21: Weathering of the Bubakk deposit. Coarse dots = serpentinite; vertical lines = transition zone between serpentinite and soapstone; fine dots = soapstone; v = traces of pot production; f = strong multiple flaking of the surface; s = pitting and flaking.

The rapid weathering in the quarry takes one main form, namely extensive, multiple flaking parallel to the stone surfaces, but other forms also exist (fig. 9.21).

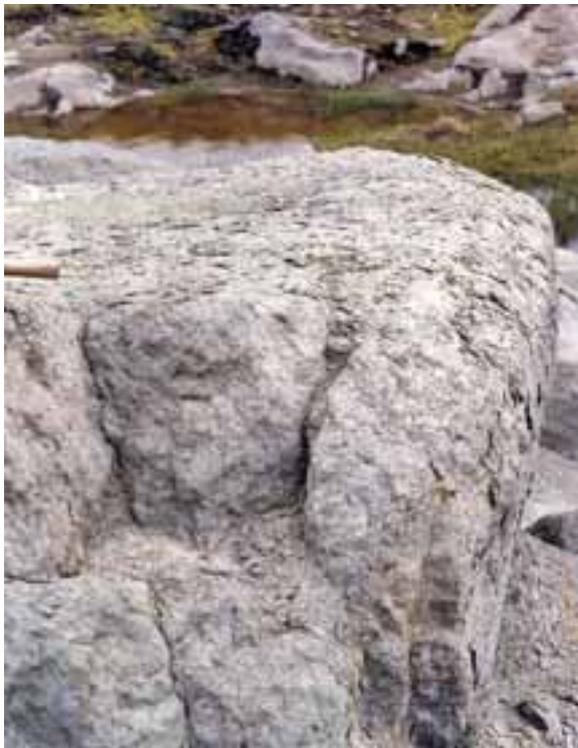
Fig. 9.22: *Weathering of Bubakk serpentinite. Multiple flaking is widespread (photo: PS 1990).*

Weathering is most pronounced on top of the small knoll where serpentinite can be found. This is the most severely exposed area of the deposit, and the part which has been exposed for the longest period of time (thousands of years?). The surface on the top is heavily disintegrated, full of serpentinite flakes and sand (fig. 9.22). Moreover, multiple flaking and exfoliation tend to occur along joints filled with loosely bound chlorite and talc. Such joints also tend to have carbonate veins (fig. 9.23).

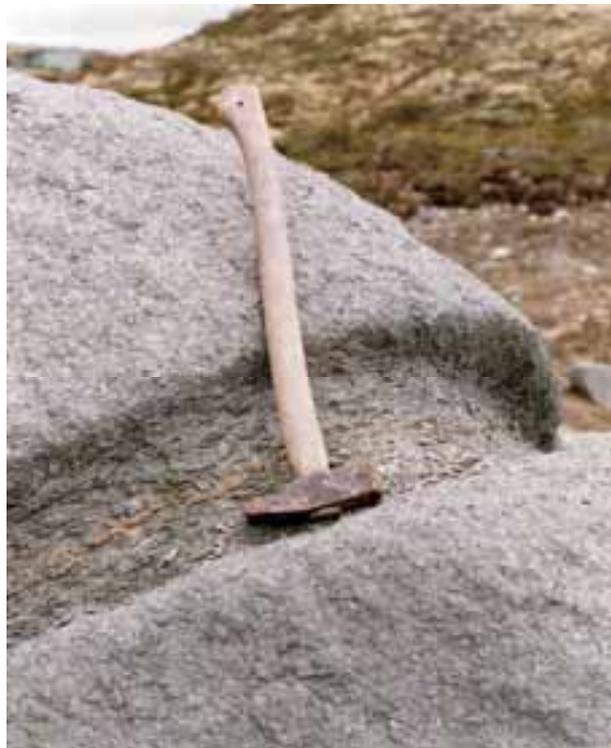
Fig. 9.23: *Weathering of serpentine-rich soapstone at Bubakk. Along joints with carbonate veins and loosely bound talc and chlorite the weathering is severe (photo: PS 1990).*

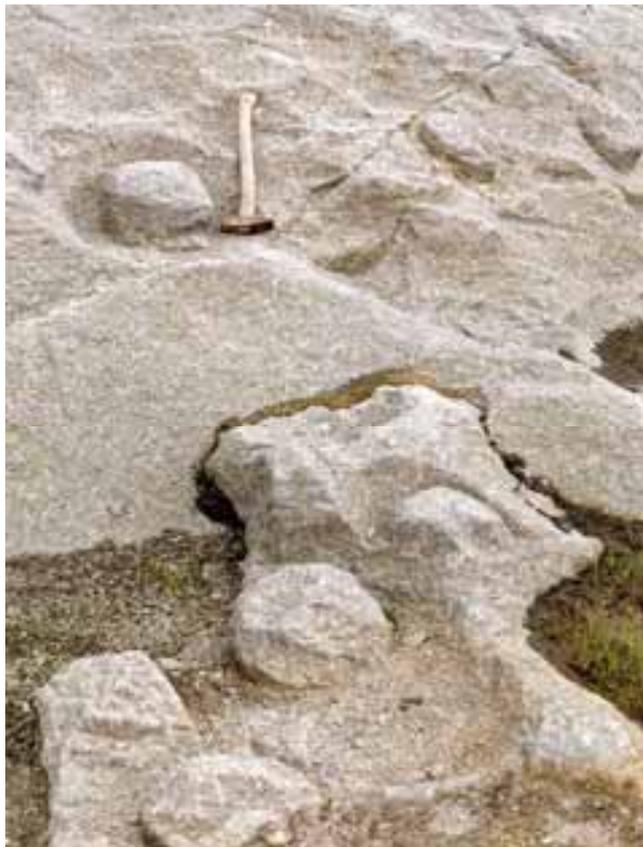
Similar weathering phenomena can be found all over the flat, exposed parts of the deposit. However, the intensity of the flaking is not so pronounced lower down, and pitting is a more widespread phenomenon on the soapstone from which pots have been produced. As mentioned earlier, the latter areas were uncovered only 30-40 years ago (fig. 9.24).

Fig. 9.24: Soapstone in the lower, south part of the Bubakk deposit. On traces of earlier pot production, marks of picks and chisels could be seen when the area was uncovered in the 1960s. Today these marks have completely disappeared (photo: PS 1990).

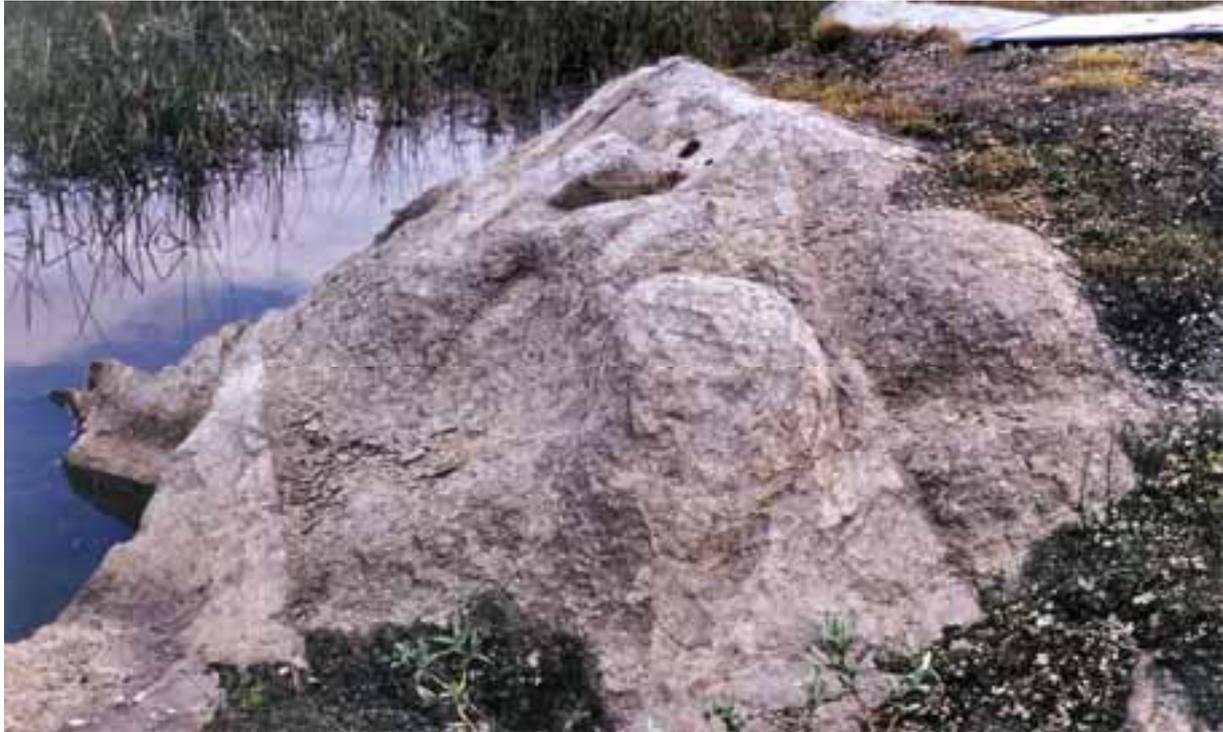
Fig. 9.25: Exposed surface in the peripheral part of the Bubakk deposit. Note the quality differences of the stone and that some areas weather more rapidly than others (photo: PS 7/95).

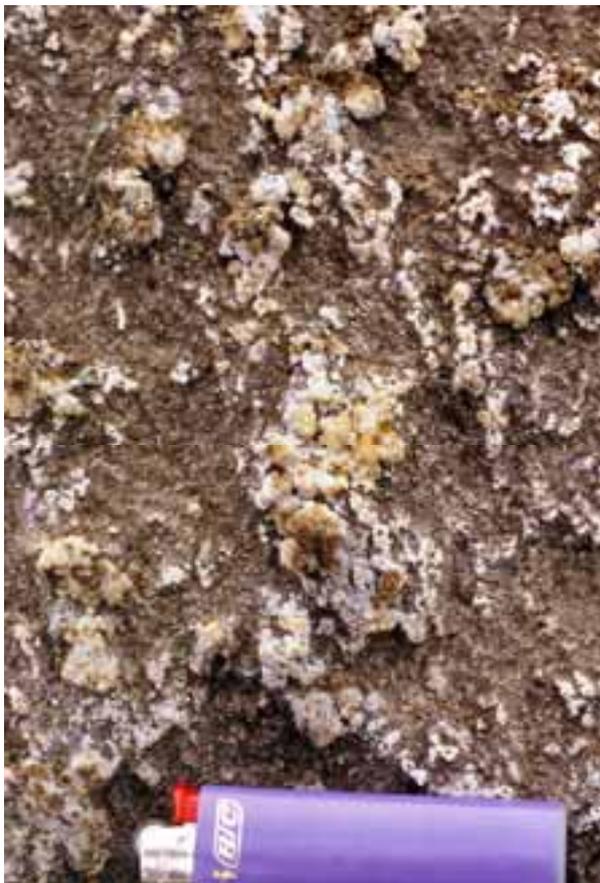
Fig. 9.26: Crusts of gypsum and epsomite covering the surface of a dump close to the Bubakk quarry (photo: PS 7/95).

epsomite cover large parts of this dump (fig. 9.26). Such crusts - in Norwegian called “Hakkemette” - are common in arid regions of the country.²³

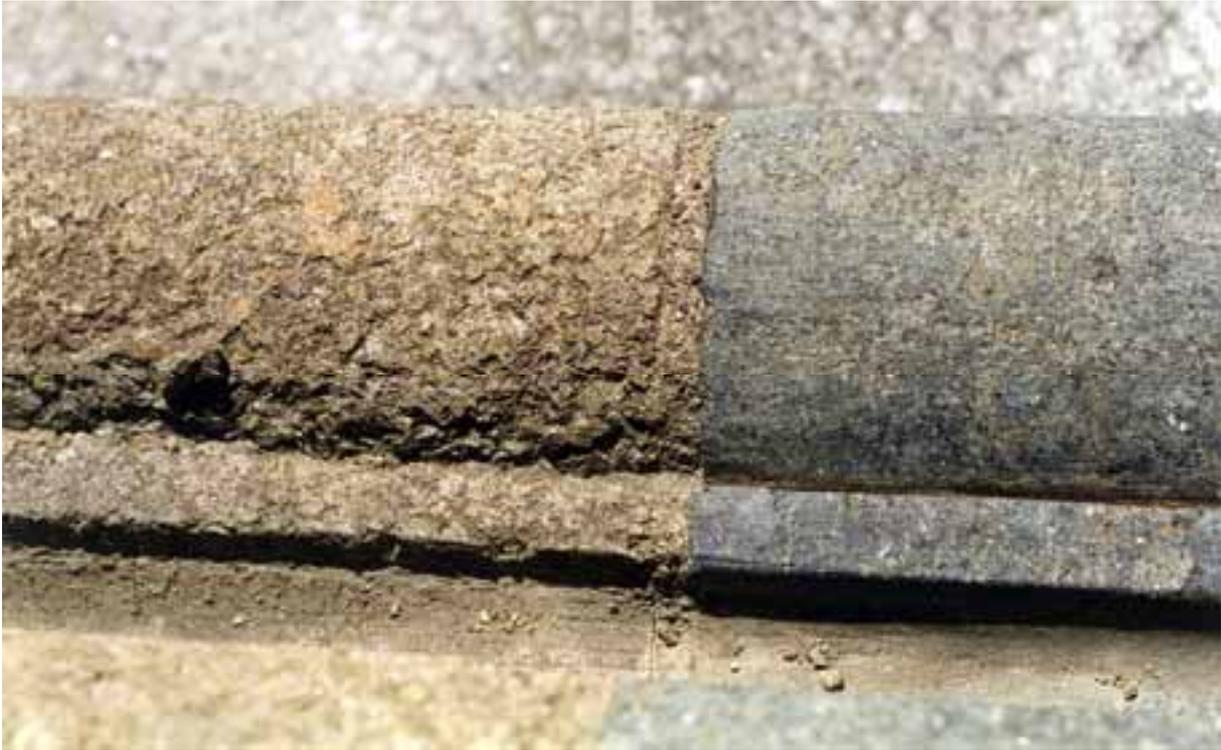
Fig. 9.27: Moulding of Bubakk soapstone and serpentinite in the base of the southern side of the choir (Nidaros cathedral). The moulding was put in place 10-15 years ago, and it can be seen that the soapstone weathers rapidly, while the serpentinite remains sound (photo: PS 8/95).

However, the diverse Bubakk varieties weather quite differently and at very different rates. The “real” soapstone seems to be the most vulnerable one - as indicated by replaced stones in bases and string courses of the choir. Put in place 10-15 years ago, these stones show extensive pitting and granular disintegration. Hard serpentinite used just beside the soapstones is on the other hand still sound (fig. 9.27).

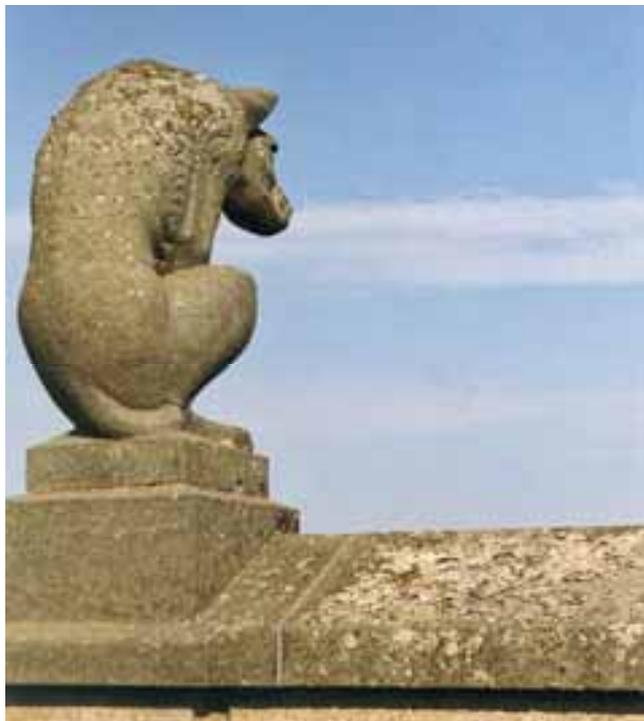
Fig. 9.28: Sculpture and copestone made of serpentine-rich soapstone from Bubakk. Northern west tower of the cathedral, finished in 1964. Note the pronounced flaking on the back of the sculpture as well as on the copestone (photo: PS 5/96).

finished in 1964 (N) and 1969 (S). Situated at weather beaten locations about 40 m above the ground, several stones have developed multiple flaking - often associated with growth of crustose lichens (fig. 9.28). It should be noted that the weathering is most pronounced on elements facing south and west and that it takes place preferentially where snow can remain for prolonged periods of time. These observations indicate that rapid temperature changes are very important for the weathering and that frost plays a vital role.

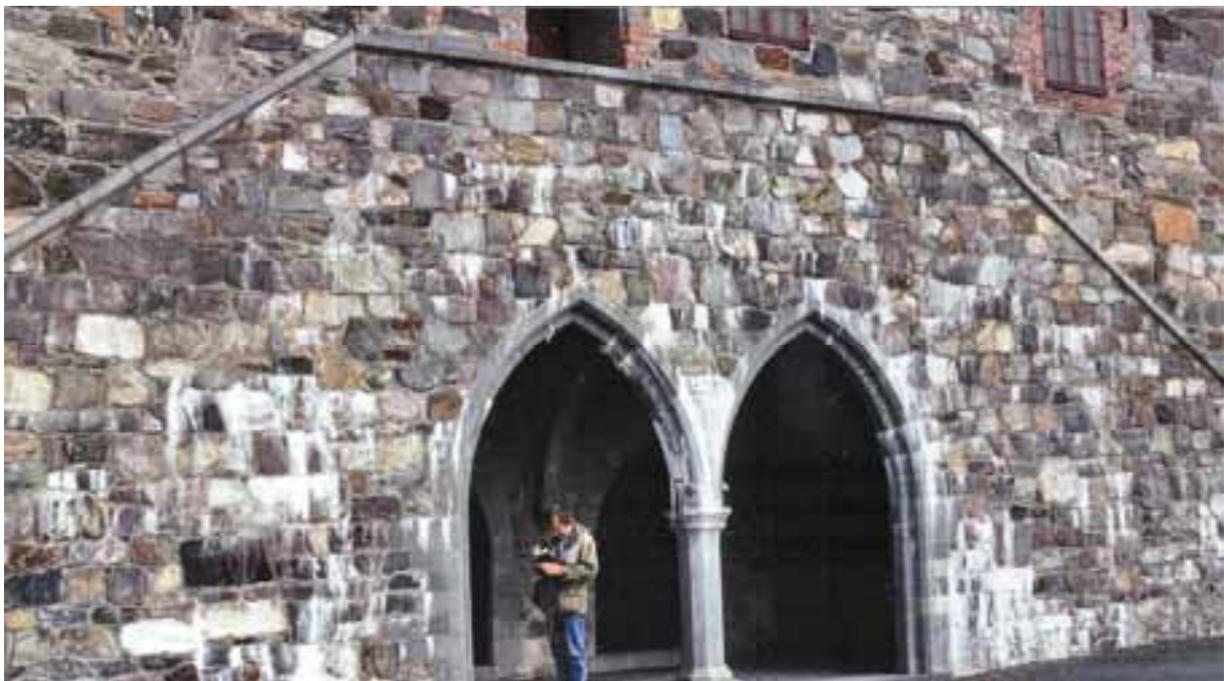
Fig. 9.29: Double porch and staircase in the Archbishop's palace in Trondheim. The construction was made of reinforced concrete with stone facings in the early 1970s. Grunnes soapstone was used for copestones as well as in the double porch. Leaks have led to the formation of large calcite crusts and alkaline salt efflorescences (photo: PS 1994).

A good place to study the behaviour of the stone is in the south-facing double porch and staircase of the Archbishop's Palace close to the cathedral (fig. 9.29). The porch was built during the restoration of the Palace between 1962 and 1975.²⁷ Built without regard to traditional craft, it was raised as a reinforced concrete construction faced by hard stone. Grunnes soapstone was used for copestones on the banisters as well as for mouldings in the porch itself. Today, less than 30 years later, the porch is in a dreadful condition because of water leaks, large calcite crusts and alkaline salts affecting plaster and stone.²⁸

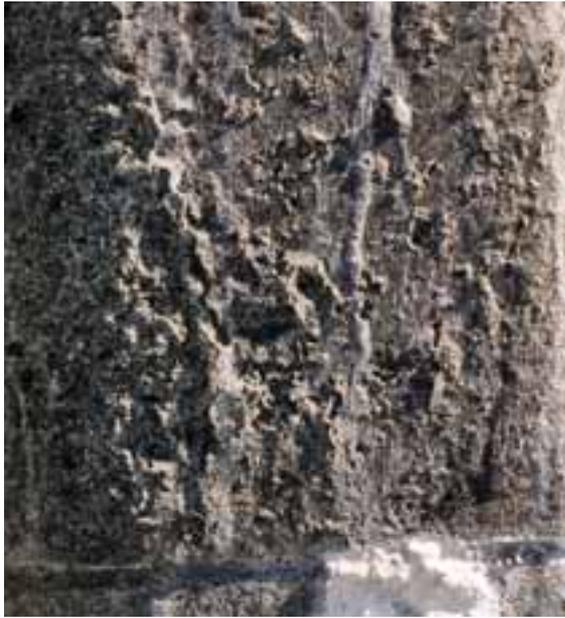
Fig. 9.30: Double porch in the Archbishop's palace. Grunnes soapstone flakes due to the presence of alkaline salts (photo: PS 1995).

Even though the porch is quite exposed, alkaline salts like trona may nevertheless accumulate on several mouldings and cause distinct flaking of surfaces (fig. 9.30). Given the short time of exposure, the flaking has not yet developed into a real problem, but compared to the west towers of the cathedral (built as reinforced concrete constructions in the 1960s) it is possible that the original surfaces will disappear soon. However, it is entirely possible that this weathering will cease as most of the alkaline components in the concrete seem to have already leached out. Supporting this interpretation is the fact that the weathering has not significantly increased over the last seven years. In the west towers where sources of alkaline salts are almost inexhaustible, several elements made of Grunnes soapstone still weather rapidly (see chapter 14).

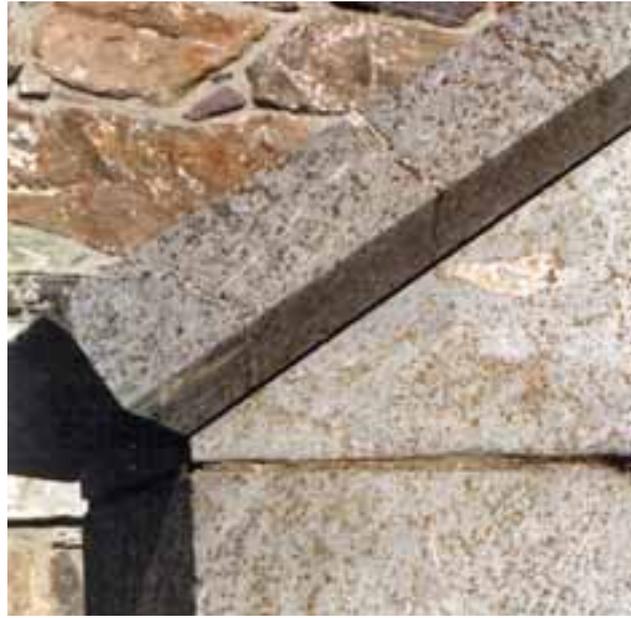
Fig. 9.31: Exposed Grunnes soapstone on the double porch and staircase in the Archbishop's palace is sound (photo: PS 1995).

Grunnes stone is remarkably sound in weather beaten locations (fig. 9.31), but due to the softness, the stone tends to lose carved edges etc. This can be observed on copestones of the staircase in the Archbishop's palace as well as on the west towers of the cathedral.

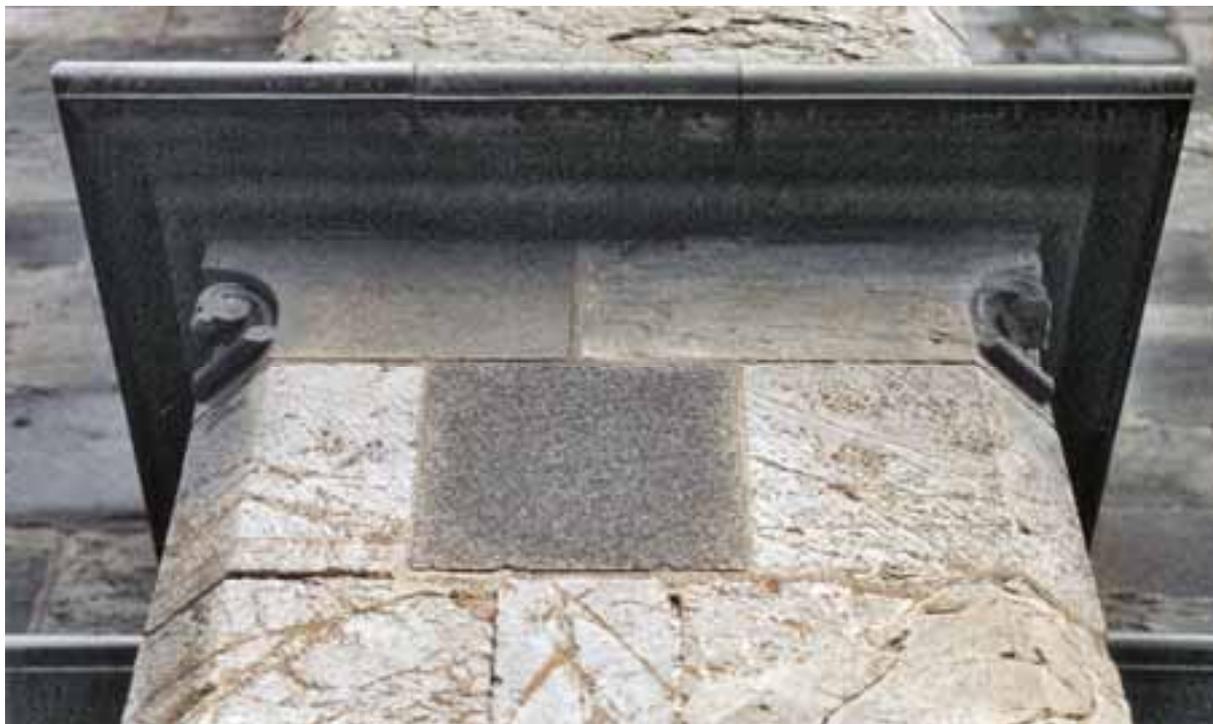
However, when looking at the water-vapour diffusion resistance, which may be regarded as a measure of how fast water evaporates from stone after wetting, it should be noted that Bjørnå soapstone shows the highest values (fig. 10.2). In short: when water in one way or another has entered pores of this stone, it may be more vulnerable to frost because water evaporates at a relatively slow rate. That moisture evaporates faster from Old soapstone than Bjørnå soapstone can be observed at the cathedral after showers. It should, however, be noted that hygroscopical salts in the masonry may disturb a pattern like the one shown in fig. 10.3.

Fig. 10.3: Drying out of masonry after a shower. Buttress of the northern west tower, Nidaros cathedral. The central Bjørnå soapstone (inserted c. 1900) remained moist much longer than surrounding Old (medieval) soapstone (photo: PS 1995).

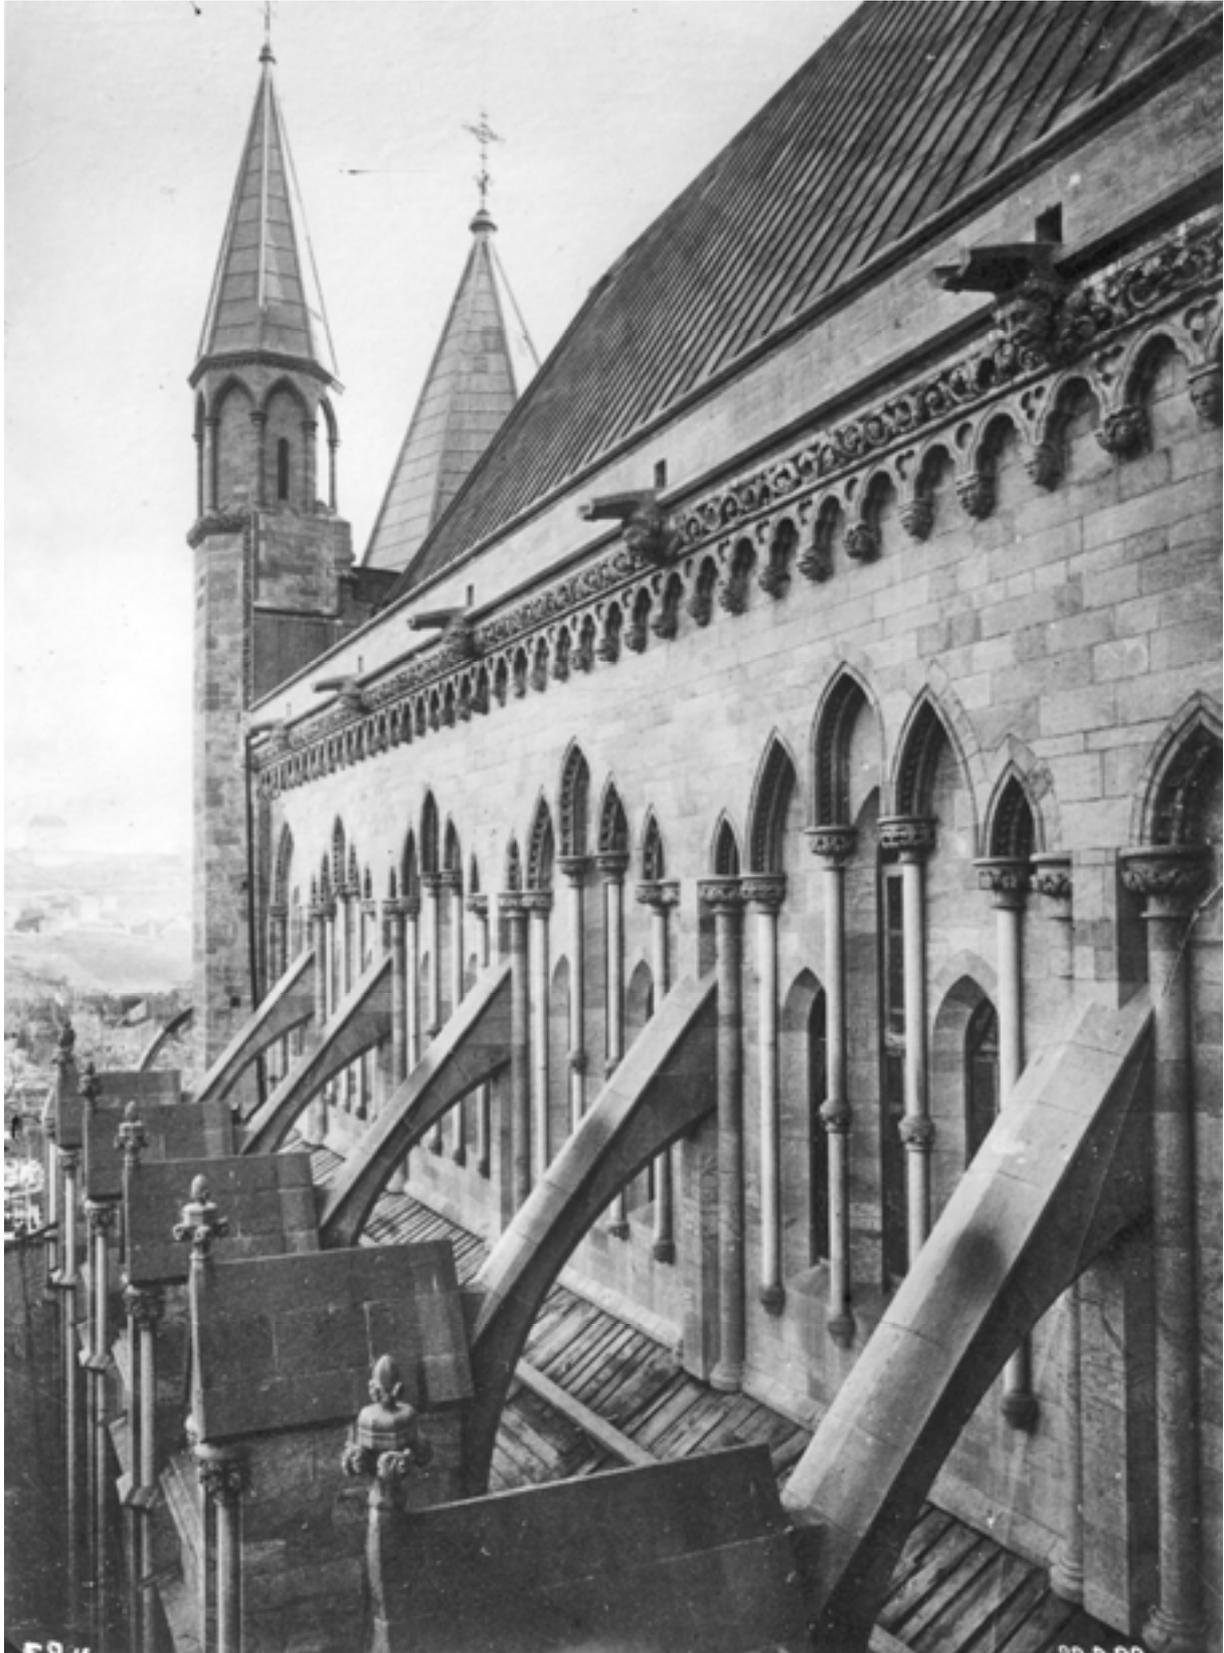
Fig. 11.1: The north side of the choir just after it was finished in 1890. Note that the stone gullies discharge water directly onto the flying buttresses (photo: ARW, no. 584).

Firstly, water from the upper stone gullies is directed onto flying buttresses which are not designed to receive water (fig. 11.1). They are not provided with water courses, only with copestones, which means that water penetrates virtually every joint - leading to severe weathering of the vertical parts of the buttresses. The flying buttresses are also affected by long icicles developing from the stone gullies in the winter. The downpipes are, moreover, underdimensioned and on the north side designed in an especially inappropriate way. The eastern downpipe in fact discharges water directly onto the masonry of the northern chapel of the octagon(!), which suffers severe salt weathering because of this peculiar design (see chapter 16.7).

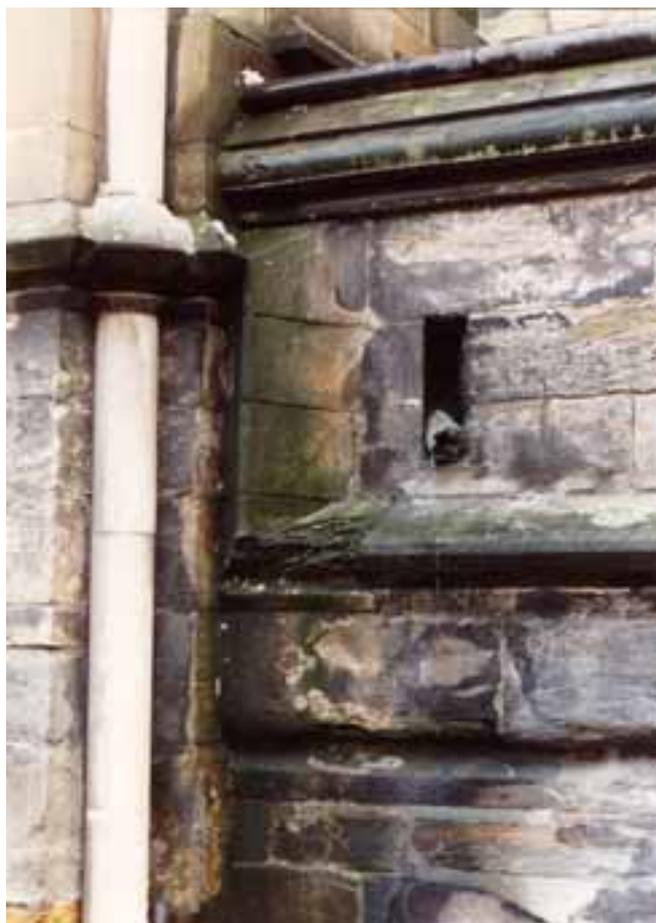
Fig. 11.2: An example of the inappropriate water discharge system of the choir: copper gully in the lower parapet on the north side (photo: PS 2/96).

Secondly, many copper gullies of the lower gangways are entirely inappropriate. They are too short and partially damaged, resulting in water running down the walls of the aisles rather than being removed from these surfaces (fig. 11.2). The result is severe weathering in the cornices just underneath.

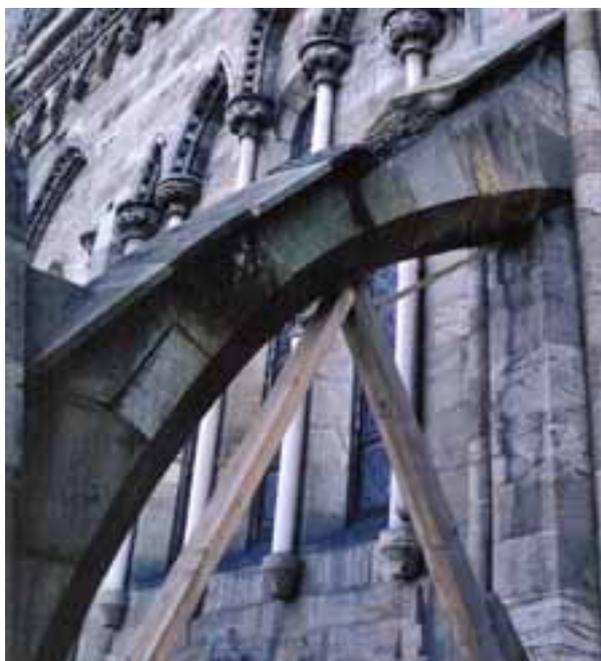
Fig. 11.3: Flying buttress on the north side of the choir in 1990. The condition is severe! (photo: PS).

Except for a few minor repair programmes, little was done to the flying buttresses between 1920 and 1990 (cf. fig. 11.3). Since then most of the stone on the north side has been replaced (with Bubakk and Gullfjellet stone).⁴ However, as nothing was done with the water discharge system - and as strong mixes of Portland cement mortars were used - “old” problems have returned: The joints are opening and resulting in formation of calcite crusts as well as alkaline salt efflorescences on the underside of the flying buttresses. The vertical parts of the buttresses were only partially repaired between 1990 and 1995, meaning that completely open joints and large calcite crusts are still major features (fig. 11.4). When a thorough restoration of the flying buttresses on the south side of the choir is undertaken, it will be necessary to improve the water discharge system simultaneously.

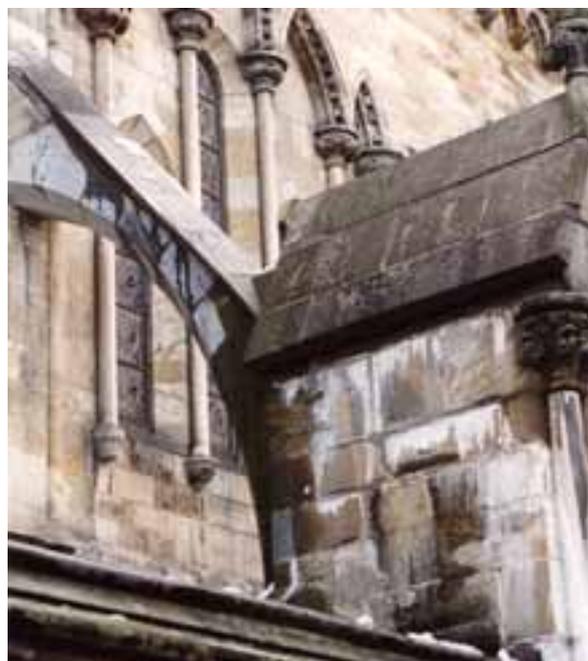
Fig. 11.4: The north side of the choir in February 1996. The flying buttress has been repaired (stone replacement), but the tower was not included in the programme. Open joints and large calcite crusts remain (photo: PS).

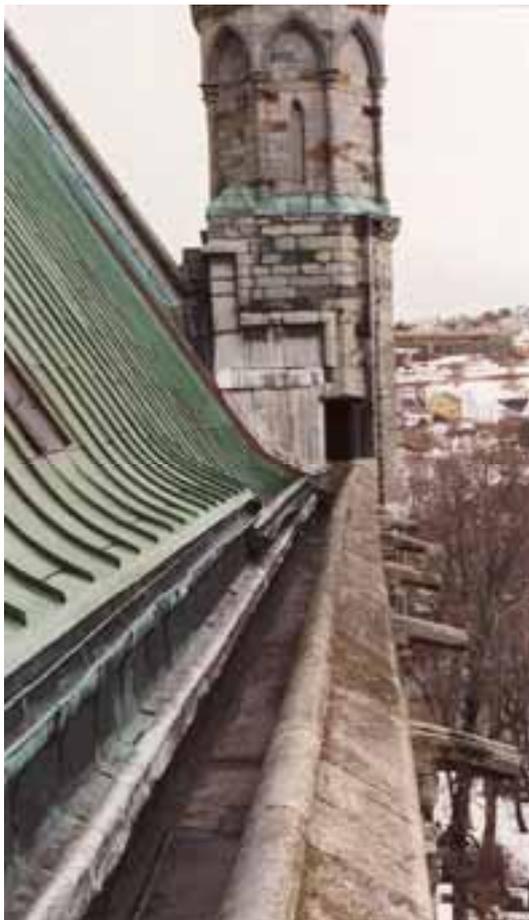
Fig. 11.5: The upper parapet of the south side of the choir in March 1996. The gangway is covered by cement/asphalt insufficient to withstand snow and ice formation (photo: PS).
