The Stones of Nidaros

An Applied Weathering Study of
Europe's Northernmost
Medieval Cathedral

Dr. Ing. (Ph.D.) thesis no. 1997:92
Department of Architectural History
Norwegian University of Science and Technology
Trondheim, Norway

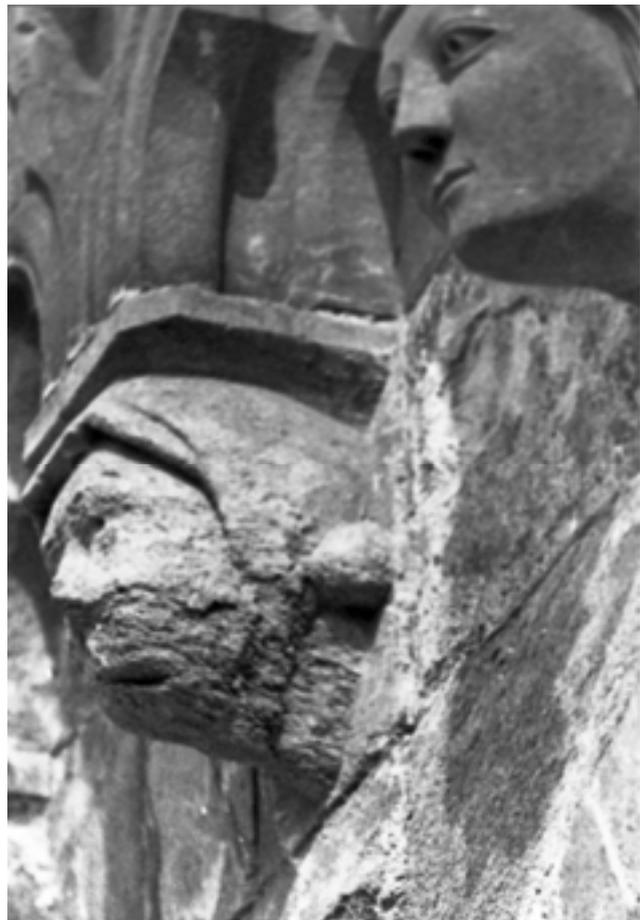
The most apparent weathering phenomena at the upper parapets are those related to the corbel heads in the associated cornices. On the north and south sides there are friezes with about 100 corbel heads carved in Grytdal soapstone. At least 50 have disintegrated to such an extent that they are hardly recognisable (fig. 11.6).

Fig. 11.6: The problematic condition of corbel heads in the south cornice of the choir in the 1980s. The heads are carved in Grytdal soapstone of variable quality. Note the salt efflorescences on the masonry (photo: Torgeir Suul).

Being strongly exposed to precipitation, and yet somewhat sheltered because of the complicated geometry, the corbels not only show the “normal”, intense Grytdal (salt) weathering - they are also covered with thick black and greyish (gypsum) crusts. The crusts are more widespread on the north side where they also frequently occur underneath the cornice as well as on plain masonry. A programme aimed at replacing the most damaged corbel heads is currently underway.

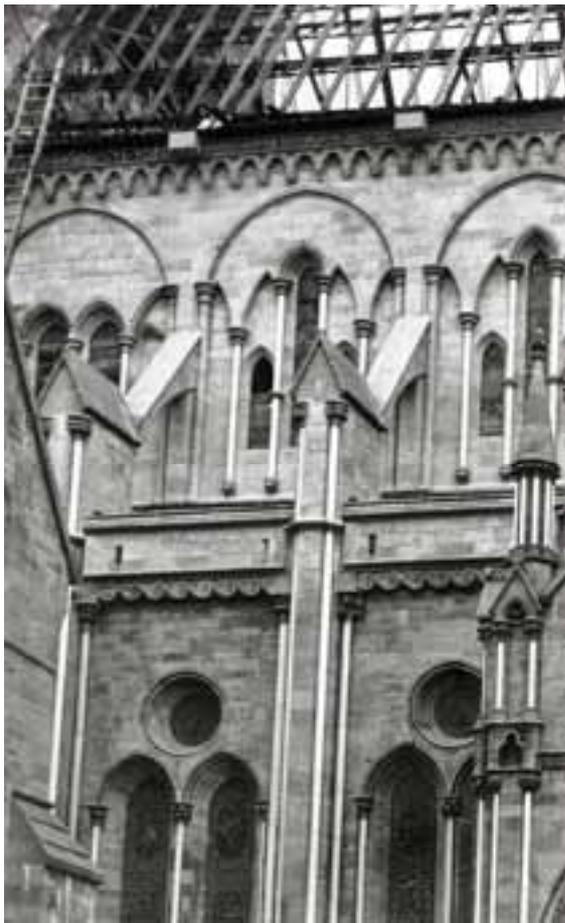
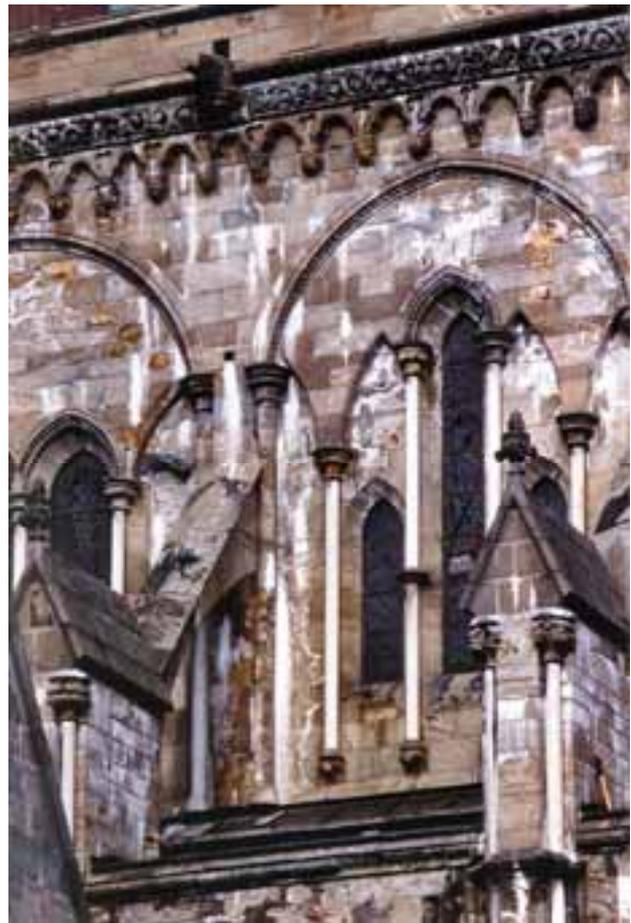
Fig. 11.8: The south side of the choir in March 1994. Note all the calcite crusts and salt efflorescences (photo: PS).

Although less severe, the weathering of other bays in the interior of the clerestory follows the same pattern - both on the north and south sides. A similar pattern can also be found on the *exterior* walls (fig. 11.7-8), especially on the south side. Here weathering is more intense

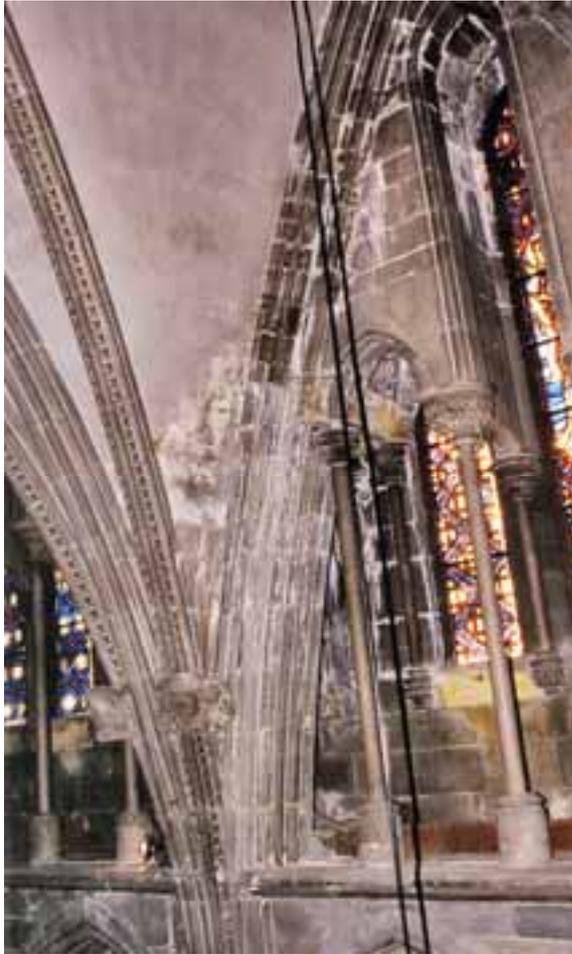
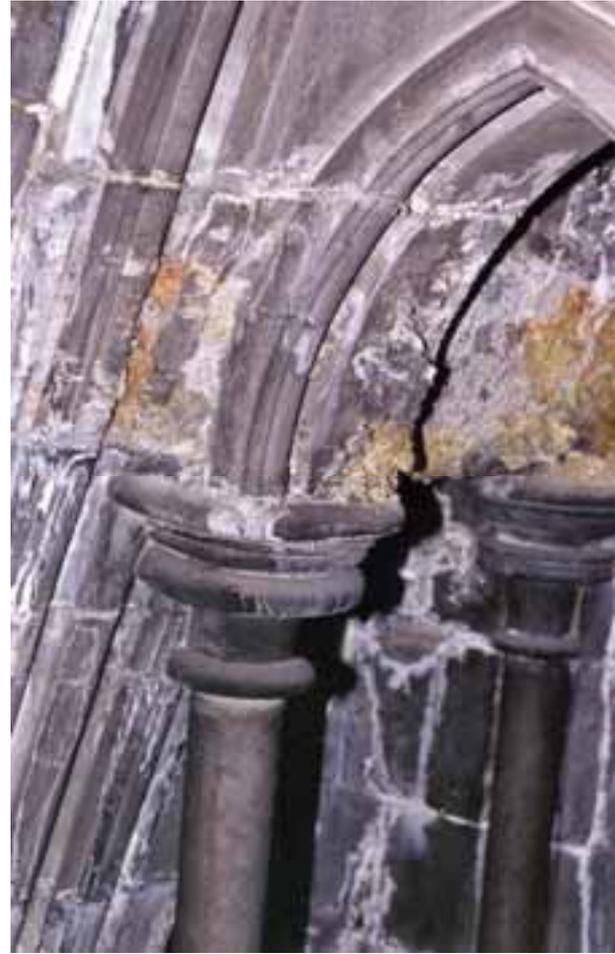
Fig. 11.9: Clerestory of the choir, south side. A leak, active for more than 20 years, has caused extreme salt weathering (photo: PS 3/95). **Fig. 11.10:** Detail of figure 11.9 (photo: PS 3/95).

After penetrating the 1,3 m thick, massive brick wall, leaching out lime and alkaline components from the lime-cement mortars, water with a pH of about 12 appeared in the gangway by the clerestory windows where ashlar, capitals and other decorations made of Grytdal soapstone were attacked (fig. 11.9-10).

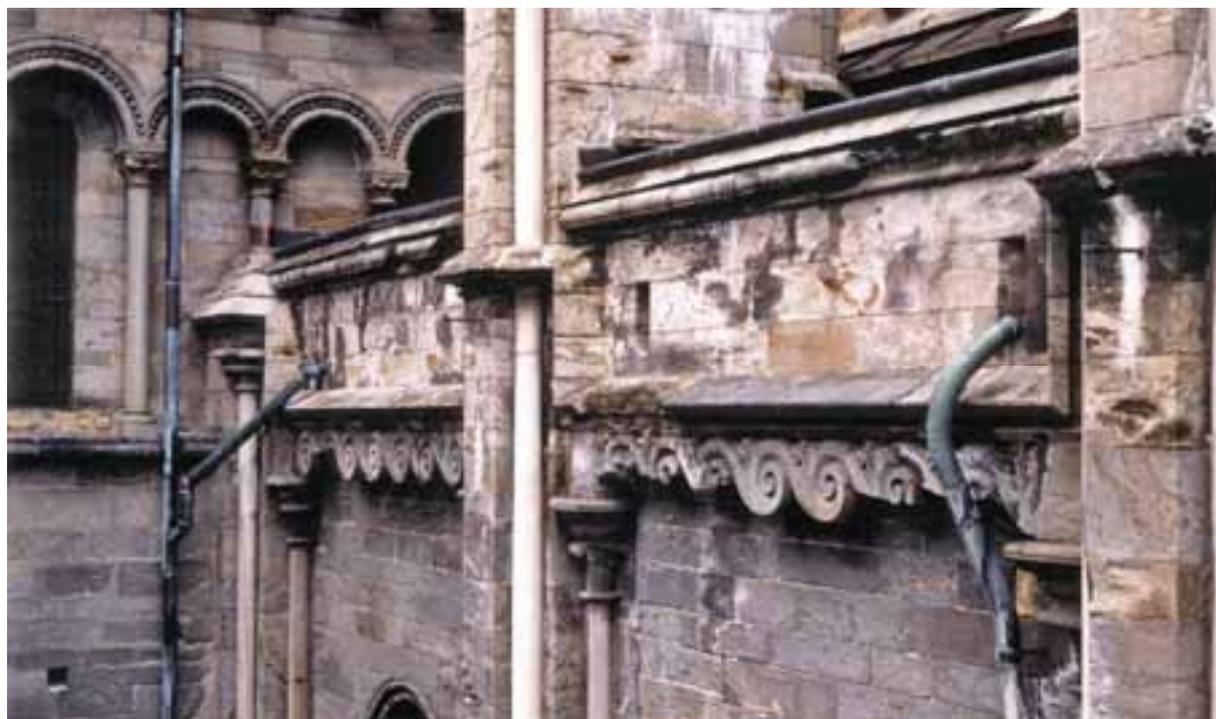
The lower parapets show similar weathering phenomena as the upper. A major problem is intense crumbling of the remaining medieval parts of the ornamented frieze in the cornice. The frieze is made of greenschist and has, undoubtedly due to run-off from the inappropriate copper gullies directly above, lost large parts along foliation planes (fig. 11.11). Otherwise, the condition of the parapets is, especially on the north side, characterised by the most widespread development of black crusts on the whole cathedral.

Fig. 11.11: Parapet and cornice on the south side of the choir. Note the poor condition of the frieze directly below the holes (for copper gullies and gutters) in the parapet (photo: PS 1996).

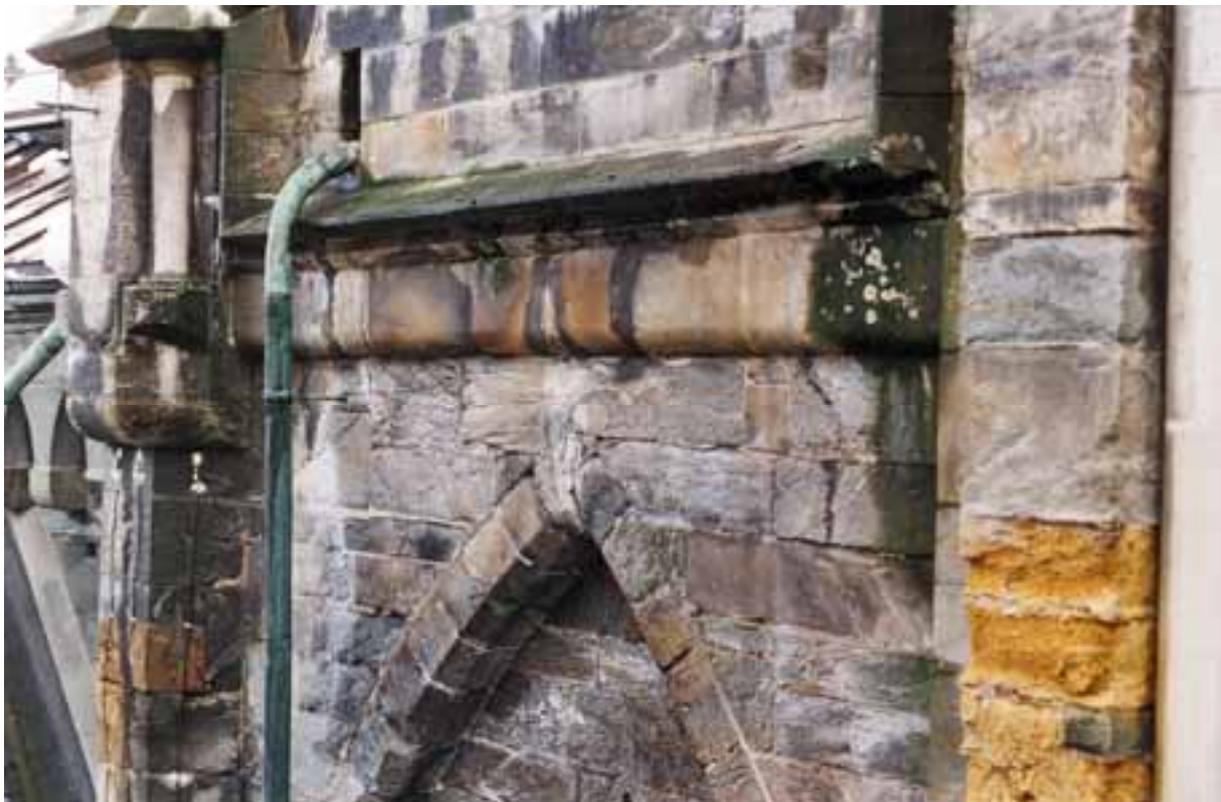
Considering historical circumstances and what is already known about water leaks from the parapets, the present condition of the walls is astonishingly good. The eastern part of the north side must, however, be regarded as problematic. This is probably because the wall is located above an earlier vaulted room in the narrow space between the wall and the chapter house.⁷ During one or more fires, burning wood must have concentrated above the vaults, causing weakening and discoloration of the medieval stonework. What makes the situation look distressing today is the yellow, disintegrated Grytdal stone which replaced fire-damaged greenschist and soapstone during the restoration. Obviously, salts associated with leaks from the parapet and cornices contribute to the pronounced weathering of already fire-damaged stone (fig. 11.12).

Fig. 11.12: Eastern part of the wall of the aisle on the north side of the choir. The area has been affected by fire, there are leaks, salts, black crusts and strongly weathering Grytdal stone as well as green algae - all giving the masonry a sad look (photo: PS 2/96).

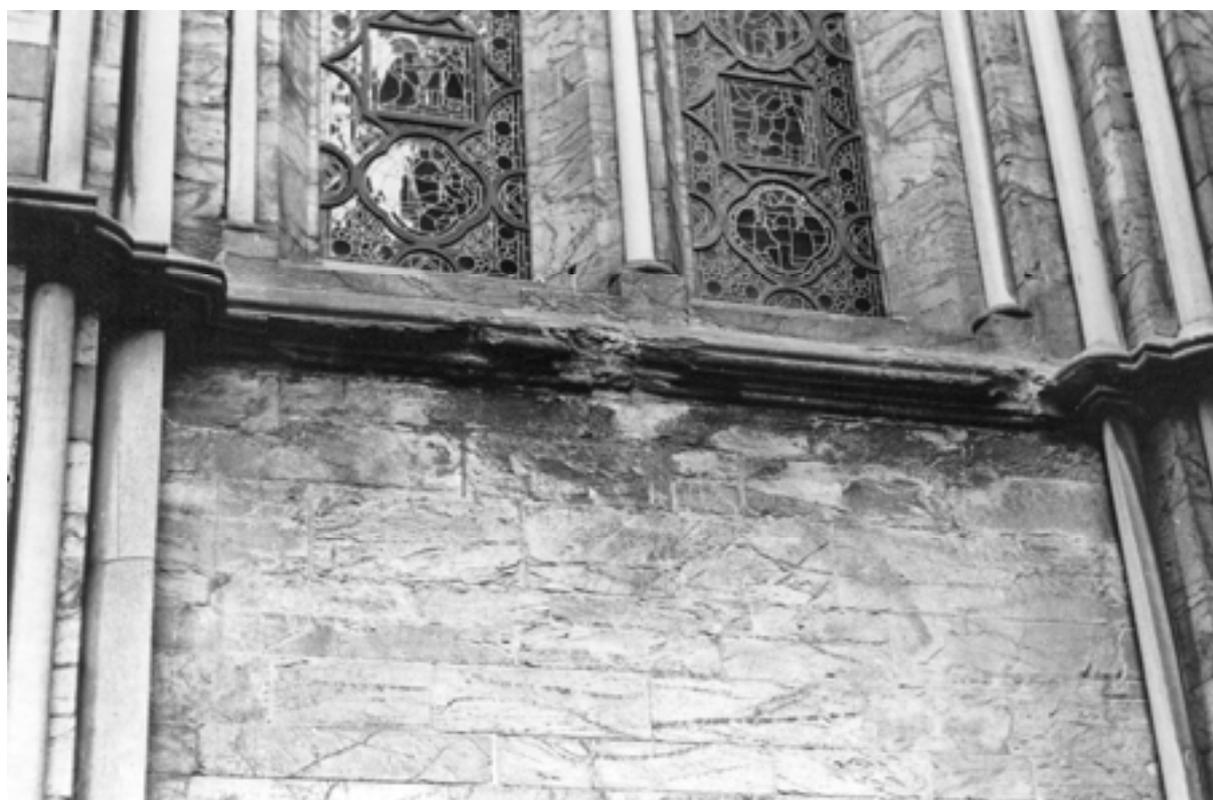
Before replacement the Grytdal stone was extremely damaged, especially just below windows (fig. 11.13). An important observation is that black crusts formed preferentially just below the most damaged parts. Associated with flaking and disintegration of the stone work underneath, the crusts are largely gone today, probably because they have weathered away.

It is reasonable to suggest that not only air pollution, but also sulphates from Grytdal stone contributed to the formation of the crusts. The sulphates from the stone may have worked in two ways - directly by providing gypsum (and eventually epsomite) to the crusts and indirectly by making the surfaces hygroscopic (epsomite), thereby enhancing the deposition of air pollutants.⁹ A local increase in deposition rate of air pollutants may also be explained by the generally moister conditions below the string course when the Grytdal stone in question became progressively damaged. The conditions were, however, not moist enough to remove the crusts (run-off).

Fig. 11.13: String course on the north side of the choir, probably in the 1970s. Black crusts have formed just below the destroyed Grytdal stone. The string course was recently replaced by Bubakk soapstone - which is already strongly weathered (photo: Torgeir Suul).

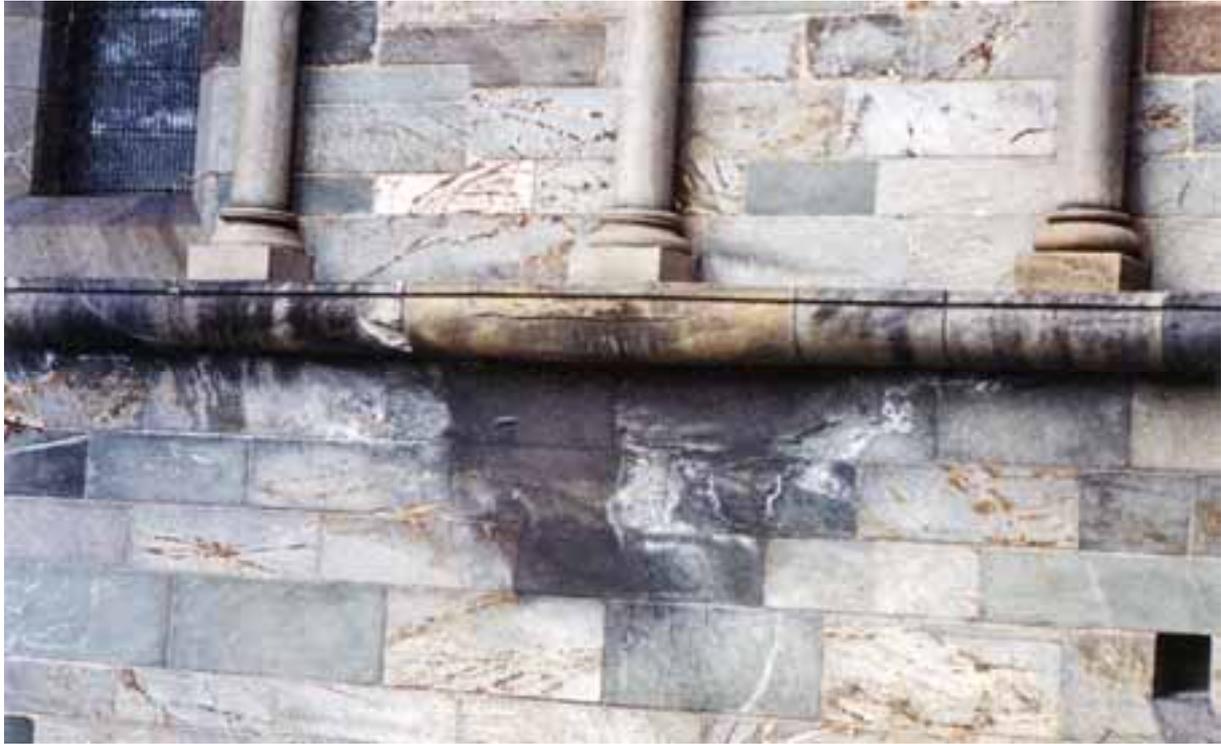
Although most of the cathedral's string courses made of Grytdal stone have been replaced, there remain a few examples of similar phenomena. One example is found on the west wall of the north transept (fig. 11.14). The string course below the clerestory windows is made of Grytdal stone of varying quality (from c. 1890), and a large black crust can be seen just below the most damaged stone (a stone with cracks).

Fig. 11.14: String course below the clerestory windows in the west wall of the north transept. Note the black crust that has formed below the Grytdal stone which has a large horizontal crack (photo: Eberhard Wendler, 6/93).

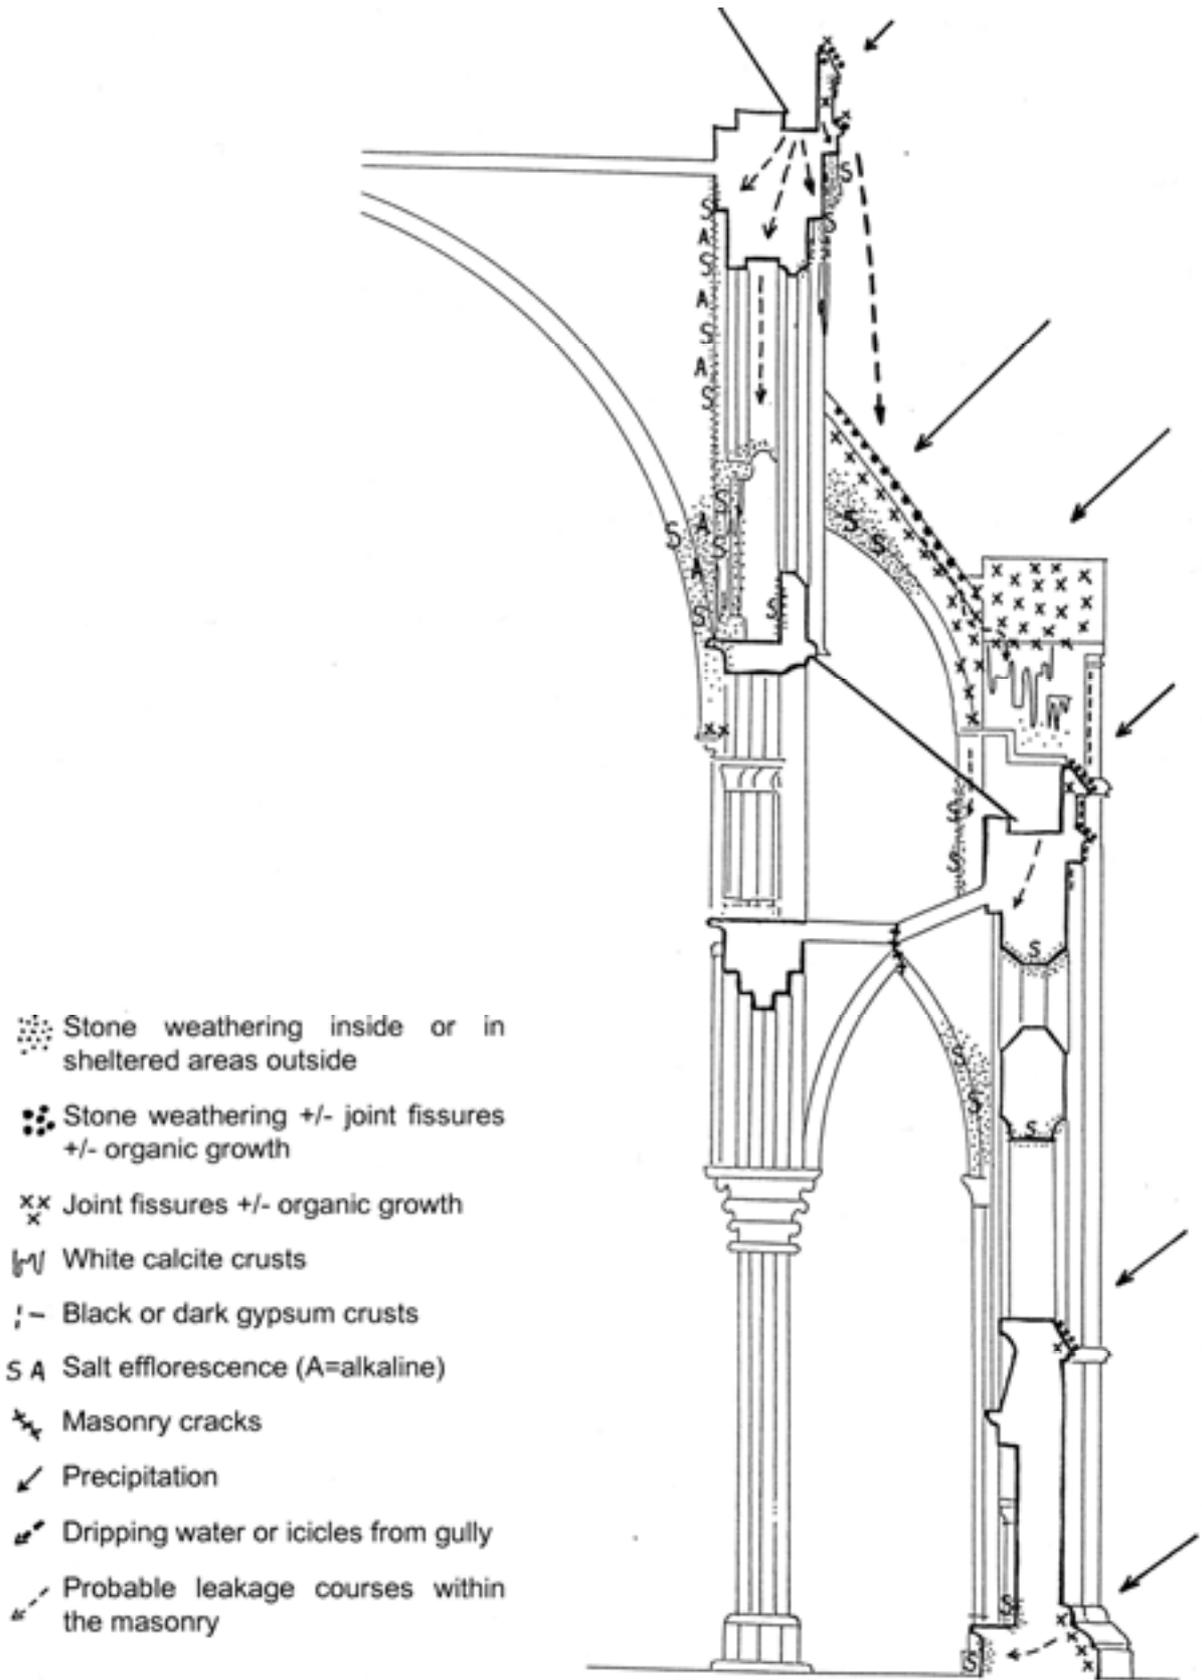
In all its complexity, the weathering of the choir is nevertheless rather simple (fig. 11.15). This is because water leaks from the gangways as well as leaks and run-off associated with gullies and parapets can account for most of the severe damage. Adding that large amounts of rapidly weathering Grytdal stone are to be found in the choir, the general weathering picture is almost complete.

There are, however, several reasons why the leaks have evolved into such a major problem throughout the past century since the restoration was completed in 1890. Large-scale stability problems leading to cracks is one reason, insufficient covering of gangways another and the improper design of the water discharge system a third.

Fig. 11.15: Transverse section of the choir showing the principal location of various weathering phenomena.

A conservation strategy aimed at slowing down the weathering rate certainly has to include control and improvement of these three basic issues. However, it is also my opinion that the replacement of badly damaged sculptures and architectural details made of Grytdal stone has to be continued (with better stone than Bubakk soapstone!). To replace up to several hundred 19th century details is, however, a question with major ethical, aesthetic and technical implications. It is therefore discussed on a more general basis in chapter 20.

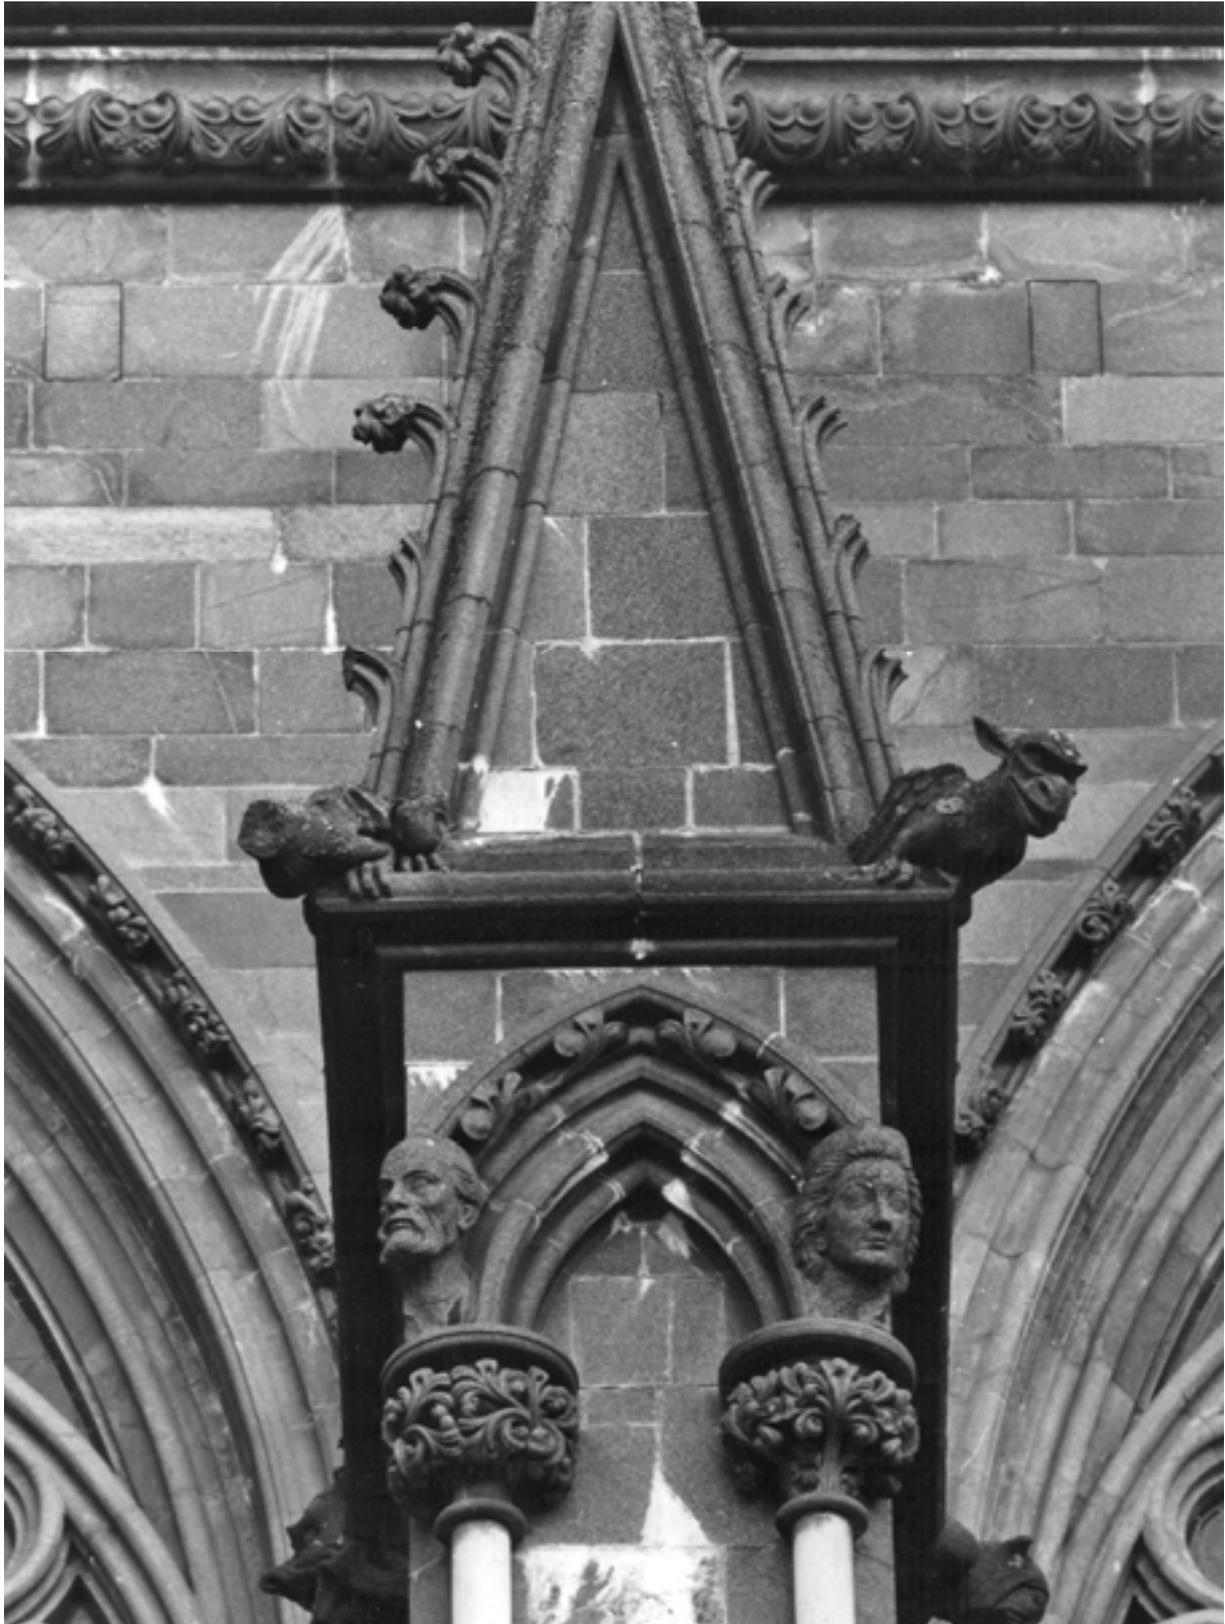
Fig. 12.1: Buttress on the south side of the nave in the 1970s. Note that most of the crockets (Bjørnå stone) have fallen down and that one fake grotesque gargoyle has lost its head. The buttress has later been restored (photo: ARW).

Having mentioned that the nave's water discharge system is underdimensioned, it is peculiar to observe that the flying buttresses are equipped with numerous grotesque gargoyles (fig. 12.1 and 12.2). The only trouble is that most of them are fake. Gargoyles originally intended to work as such are located at the ends of the two water courses in the flying buttresses. However, as the gargoyles have largely weathered away (rapidly weathering Bjørnå stone), water no longer runs through, but rather over them before being discharged into the lower gangways. The rest of the gargoyles (four on each buttress) are - and have always been - mere decorations.

The towers are decorated by crockets and fake grotesque gargoyles, and the front sides have blind arches and marble columns. The connection between the towers and the vertical pillars is formed by a small, projecting gable. Large, fake grotesque gargoyles modelled by Wilhelm Rasmussen around 1910 can be found just below. All the projecting decorations have been subjected to rapid weathering, involving the loss of relatively large pieces due to delamination (fig. 12.1).

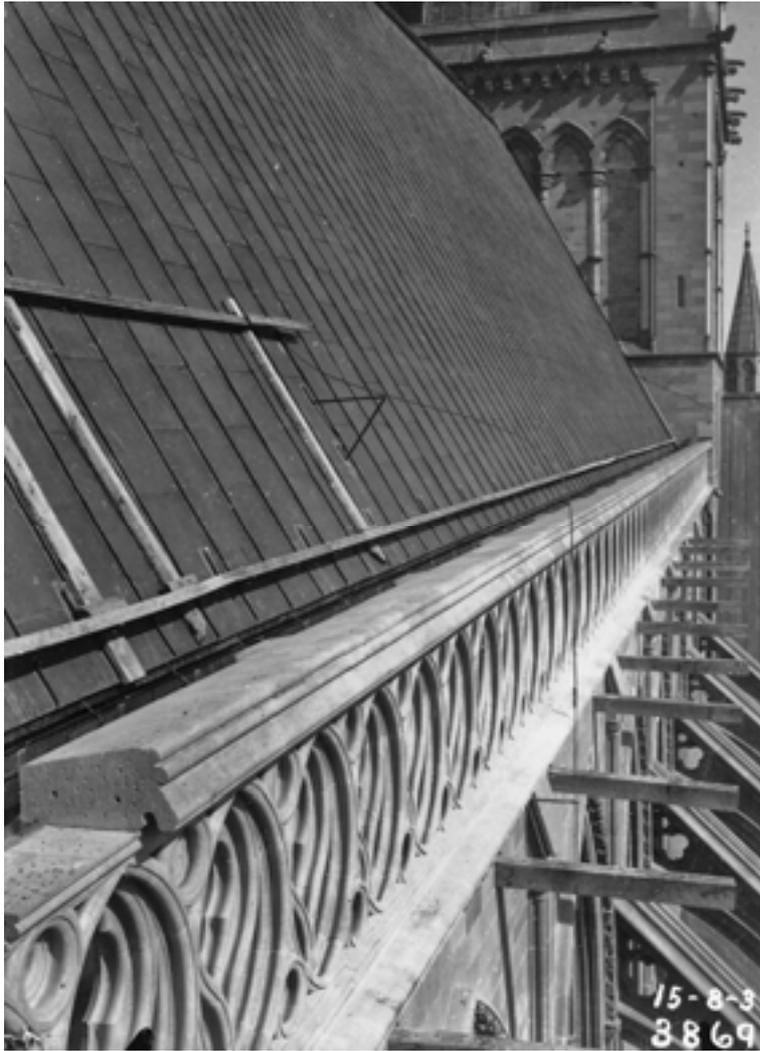
The tracery of the upper parapets are capped with foliated Bjørnå soapstone which have deeply carved, projecting mouldings (fig. 12.3). Similar mouldings can be found in the cor-

Fig. 12.3: The upper parapet of the south side of the nave was finished around 1930. Note the deeply carved mouldings of the copestones (photo: ARW, no. 3869).

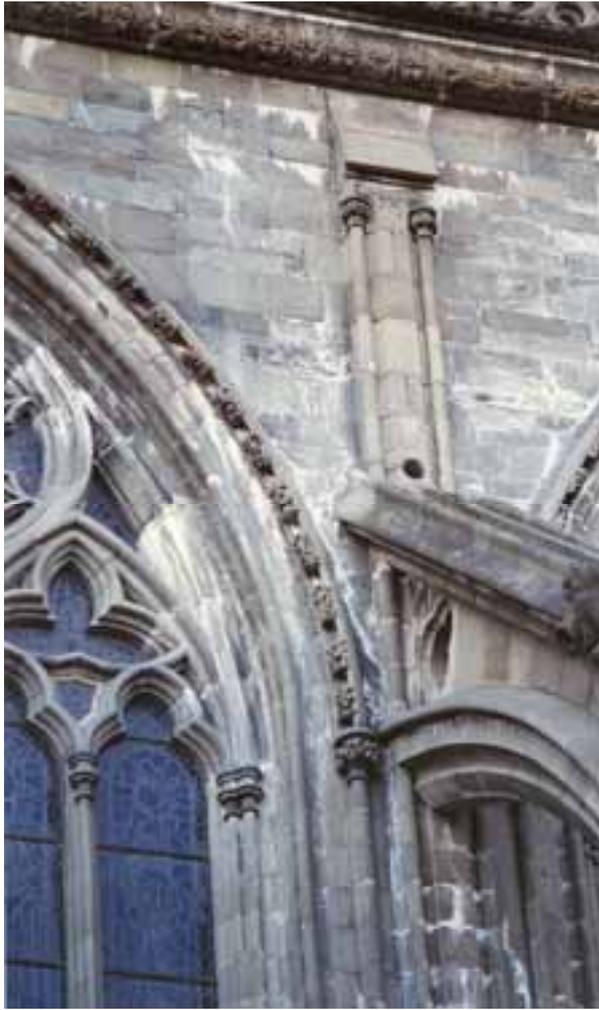
The clerestory walls are characterised by deposits of calcite crusts and alkaline salt efflorescences (fig. 12.5). The deposits have been observed, documented and discussed since 1950.⁵ The salts were at that time - as today - supposed to be caused by leaks from the gangways, but otherwise regarded as mere unsightly “saltpetre excretions”. However, in contrast to current knowledge ascribing the origin of most of the salt efflorescences to the properties of certain stones and Portland cement *paste*, a widespread belief in the 1950s was that the excretions originated from sea salts, particularly those thought to stem from aggregate materials in the mortars. Consequently, sandy aggregates for Portland cement mortars were usually thoroughly washed before use - the Restoration Workshop even had its own sand washing facility.⁶

Fig. 12.5: The clerestory wall of the nave's north side. Extensive salt efflorescences and calcite crusts cover the wall (photo: PS 5/97).

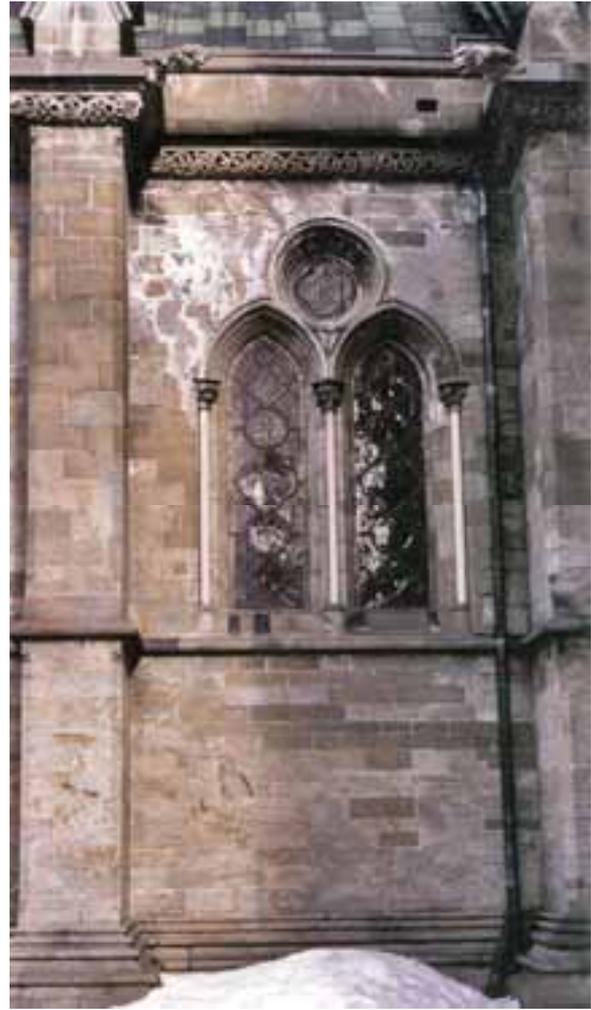
Fig. 12.6: The south side of the nave in dry spring weather. Extensive efflorescences of alkaline salts are usually observed below the parapets at this time of year (photo: PS 3/94).

Fire damaged stones are today sound - i.e. they do not weather actively - except at places where additional weathering agents influence the situation. As expected, these places are generally found just below the parapets and cornices. Also medieval stone not influenced by fire may weather actively at such places (fig. 12.6).

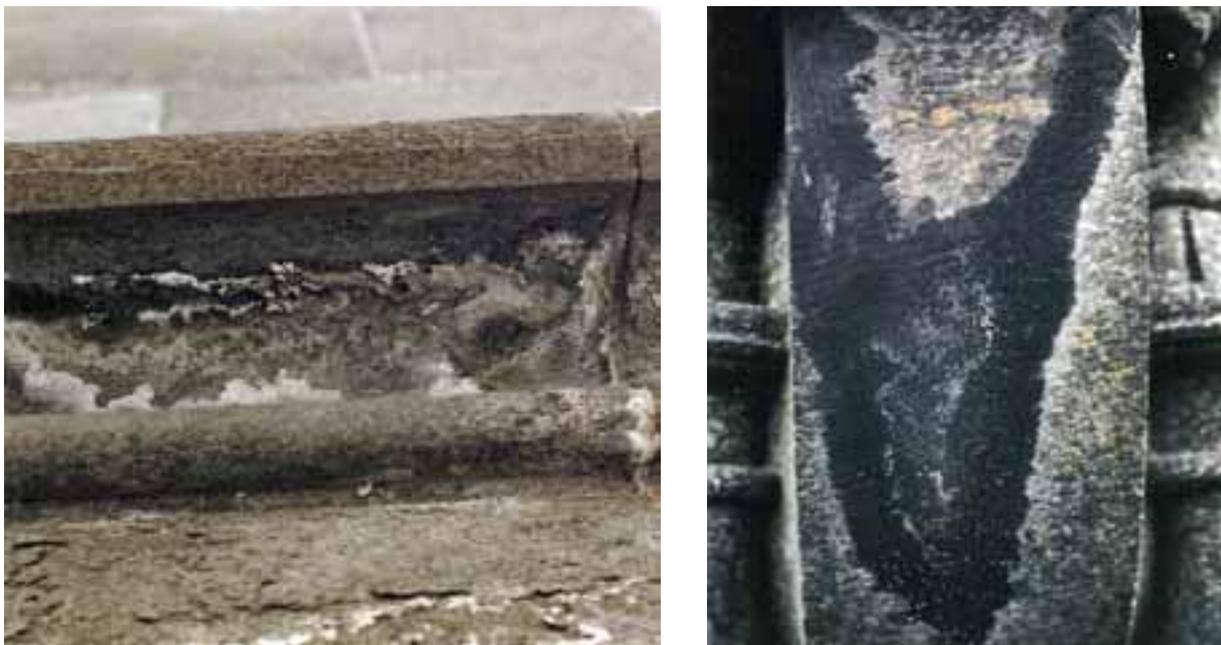
In contrast to observations on the walls of the choir, black crusts are almost absent on the nave. There are some crusts associated with particular run-off systems by the portals (chapter 17), as well as underneath a few cornices and string courses (fig. 12.7). The crusts are generally thin, but often associated with flaking and exfoliation. However, at most places where crusts have formed, there are also major amounts of salt efflorescence (sodium carbonates/sulphates) to be found in dry weather. Therefore, it is impossible to blame the associated flaking and exfoliation on the crusts alone.

These considerations are general ones. It should not be forgotten that the formation of black crusts always has to be seen in relation to the actual situation. For example, formation of thick black crusts on Bjørnå stone can be observed on several sculptures and projecting decorations on the lower part of the west front (fig. 12.7). They are not, however, causing significant damage to the stone.

Fig. 12.7: Black crusts on Bjørnå stone. Left: The underside of a string course on a buttress, south side of the nave. Flaking and granular disintegration associated with black crusts and salt efflorescences (photo: PS 5/96). Right: Thick black crust formed on the underside of a decoration in the lower part of the west front. The crust accumulated as a result of run-off on each side of the stone (photo: PS 4/96).

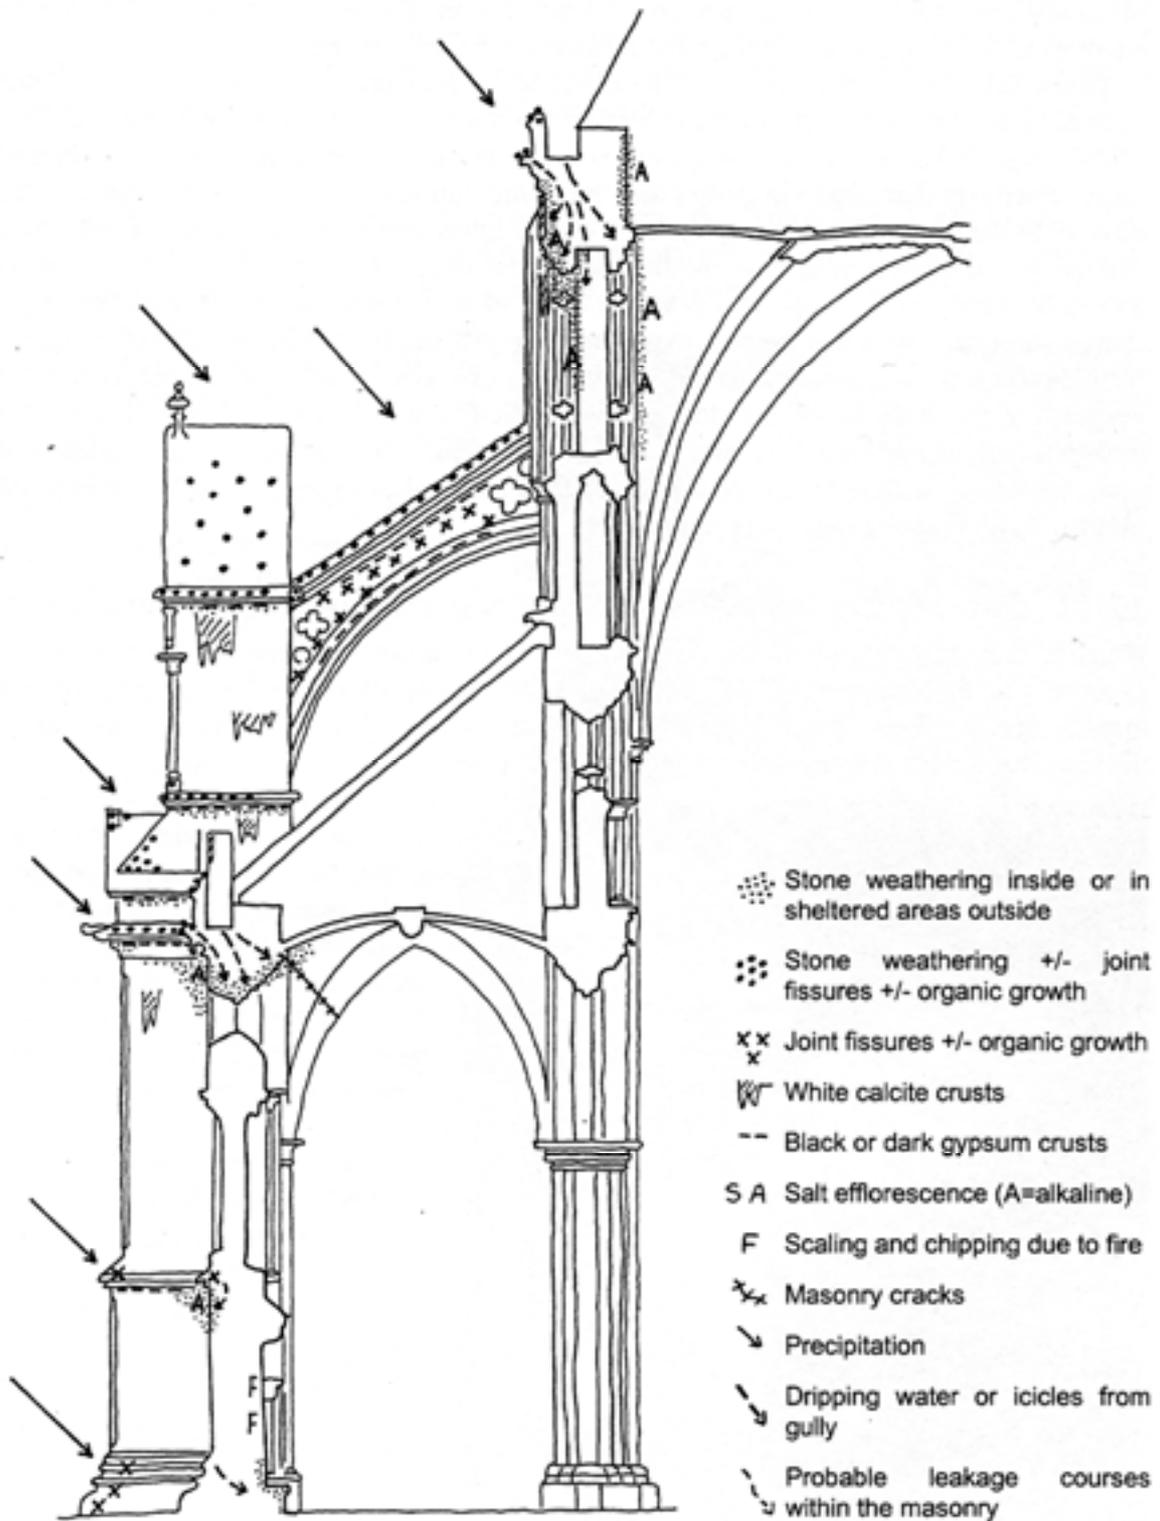
In addition to differential settlement causing masonry cracks and various interior safety problems, it is evident that there are two major problems at the nave (see also fig. 12.8):

- The safety risks associated with rapidly weathering Bjørnå stone which tends to lose projecting details.
- The poorly constructed and underdimensioned water discharge system which causes leaks and subsequent salt weathering.

Fig. 12.8: Transverse section of the nave showing the principal locations of various weathering phenomena.

As to the first problem, it is necessary to replace many copestones and decorations which have lost - or are about to lose - details. Considering the severity of the safety risks, it is

of utmost importance to use a very good stone in a replacement programme. Alternatively, attempts to fix or consolidate vulnerable details may be undertaken.

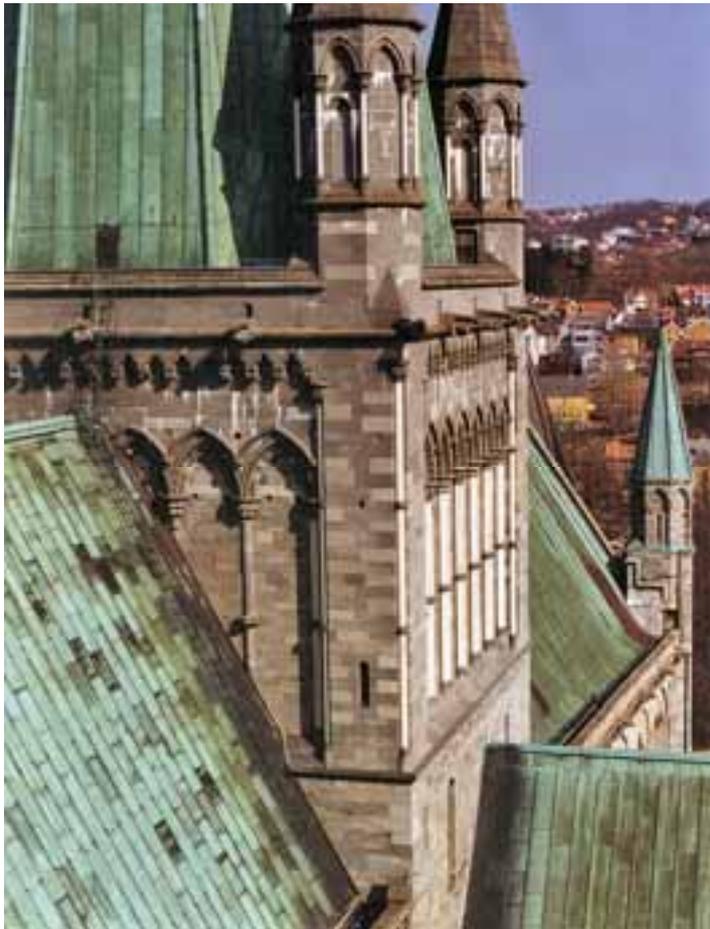
Finished at the turn of the century, the upper section of the central tower was built in much the same way as the clerestory of the nave (fig. 12.9). The walls above the stellar vaulting are massive constructions “faced” with ashlar of Bjørnå stone. This stone has also been used in the parapets, for copestones and most of the decorations.

Thus, we again meet the delicate weathering problems of Bjørnå stone. The weathering of copestones and decorations is, however, less pronounced than in the nave. This may probably be ascribed to the fact that at the turn of the century the Bjørnå quarry delivered better stone than 10-30 years later (see chapter 9.2).

The central tower seems to have been subject to less water leaks than the nave. Leaks have certainly taken place, but often they have been caused by weaknesses in the large spire.⁹ Despite some water infiltration from the tower's platform, the cement/asphalt cover seems to be durable enough.

Fig. 12.9: The central tower. Note that 3 large stone gullies on each side carry water away from the gangways behind the parapets. This is a very effective water discharge system (photo: 5/96).

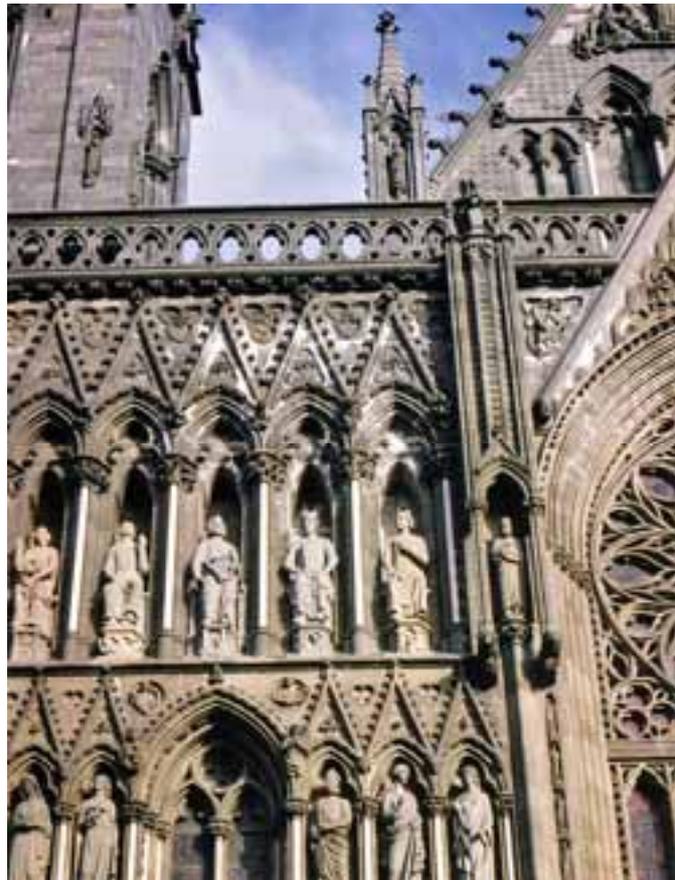
We have seen that below all parapets of the nave (and the central tower), salt systems have developed - mainly because of leaks and the use of Portland cement mortars. As a conclusion to this chapter, comparison is made to a similar situation below the west front parapet (fig. 12.10). The situation neatly sums up what happens when water percolates masonry built with Portland cement mortars and serves in this respect as an excellent model.

On the exposed decorated field there are thick white crusts of calcium carbonate, while in the sheltered niches efflorescences of powdery sodium carbonates prevail - usually associated with granular disintegration of Bjørnå stone.

The explanation of the phenomena is straightforward: Water percolating through the masonry dissolves lime and alkaline components in the Portland cement mortar producing a strongly alkaline solution. According to their respective solubility products, calcite precipitates before sodium carbonates, which can remain in the sheltered areas because there is no water to wash them away.

Fig. 12.10: The west front. Leaks from the gangway have percolated into masonry built with Portland cement mortars and led to the formation of a classical salt system below the parapet. Large calcite crusts have developed on the exposed masonry, while alkaline efflorescences prevail in the sheltered niches (photo: PS 8/93).

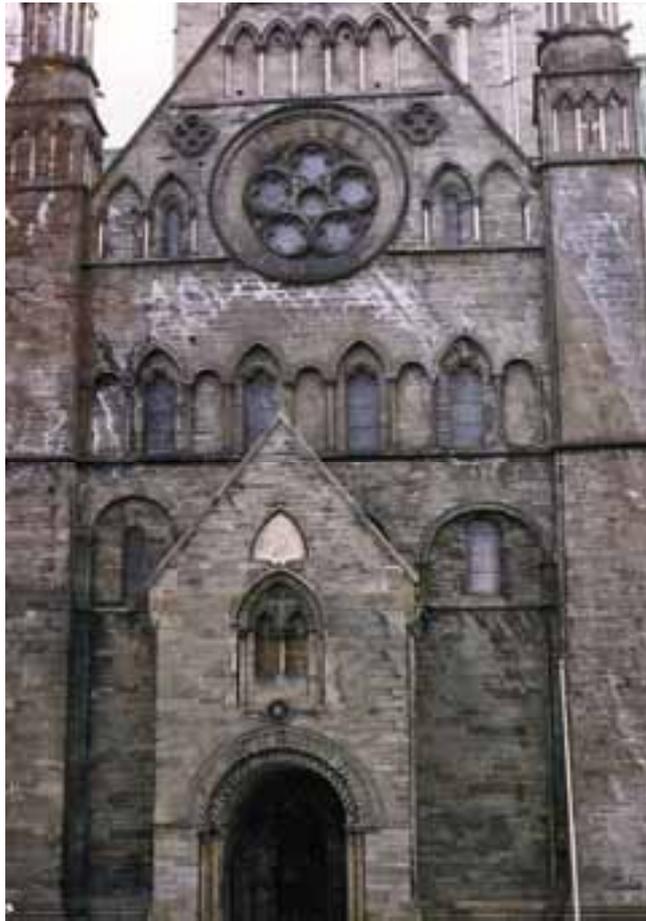
On the interior wall of the area in question, large amounts of alkaline salts can be found. This is understandable, considering that some of the run-off waters penetrate the wall and that window arches have been restored using concrete. Large amounts of alkaline salts can also be found just below the exterior part of the rose window (restored with Portland cement mortars), but no major disintegration of the Bjørnå ashlar has so far been observed here (fig. 13.3).

Fig. 13.3: The north wall on a dry day in March 1993. Note the distribution of salt efflorescences (white patches). The salts occur on and below new masonry from the restoration (photo: PS 3/93)

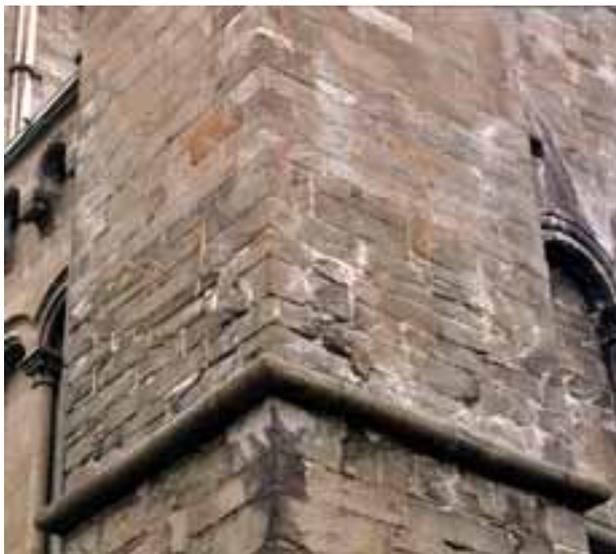
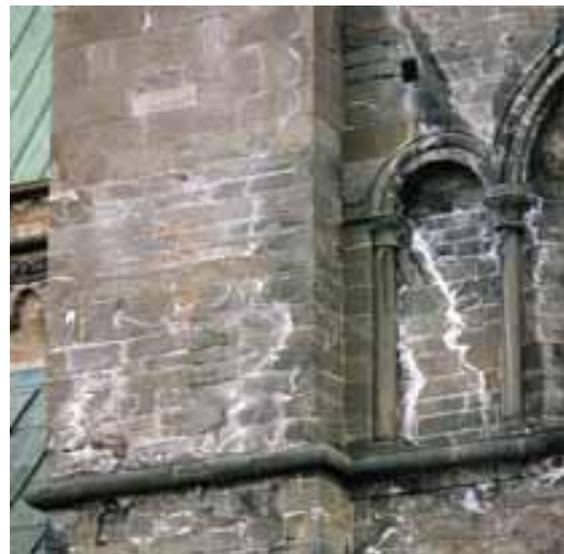
Water infiltration and alkaline salts have not only affected masonry erected during the restoration. The eastern tower, which has medieval greenschist masonry up to the clerestory level, shows sodium carbonates and sulphates accumulating in the contact zone between old and new stonework (fig. 13.3-4). However, the extensive delamination and granular disintegration of the greenschist ashlars are probably not caused by the actions of these salts alone. This is because we must also consider that the upper part of the medieval tower collapsed or was demolished - maybe as a result of the fires in 1432 or 1531. Thus, the masonry

The tower is not the only source of leaks and salts that affect the actual masonry. Run-off from the corner between the gable and the tower also tends to collect in the area, as can be seen during showers as well as in dry weather periods. In the latter periods, salt efflorescences neatly concentrate in the zone of evaporation beside the main waterways. Black crusts also tend to concentrate in similar areas (fig. 13.4).

Fig. 13.4: The eastern tower of the north transept. Left: Salts from Portland cement in the rebuilt upper part of the turret have caused weathering of medieval greenschist masonry below (photo: PS 8/95). Right: Run-off from the corner between the gable and the turret has led to the accumulation of salts in particular zones (photo: PS 3/93).
