The Stones of Nidaros

An Applied Weathering Study of
Europe's Northernmost
Medieval Cathedral

Dr. Ing. (Ph.D.) thesis no. 1997:92
Department of Architectural History
Norwegian University of Science and Technology
Trondheim, Norway

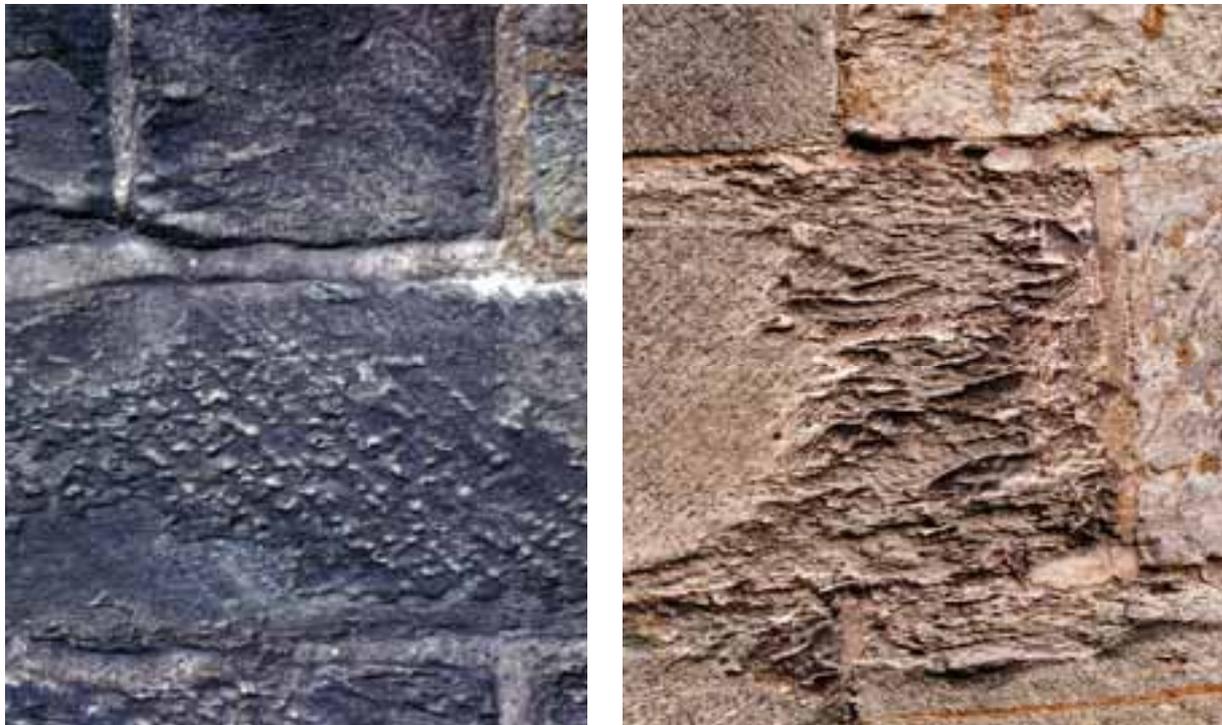
It is reasonable to explain the preferential development of black crusts on traces of whitewash and paint by the abundant calcium provided by these substrates. There are, however, several additional factors to be considered. One is the that dry deposition of air pollutants may preferentially take place on the relatively porous substrate represented by the whitewash/paint (compared to the dense stone). Another is the possible accumulation of chlorides on/in such substrates. Chlorides may either have been provided by cleaning operations (hydrochloric

Fig. 13.5: Black crusts on the north transept. Left: Thin black layer formed on a substrate of blue-grey paint, probably applied in 1818 (photo: PS 10/94). Right: Thin black layer formed on remains of whitewash. Observe that flaking is not taking place on the “clean” part of the ashlar (photo: PS 8/95).

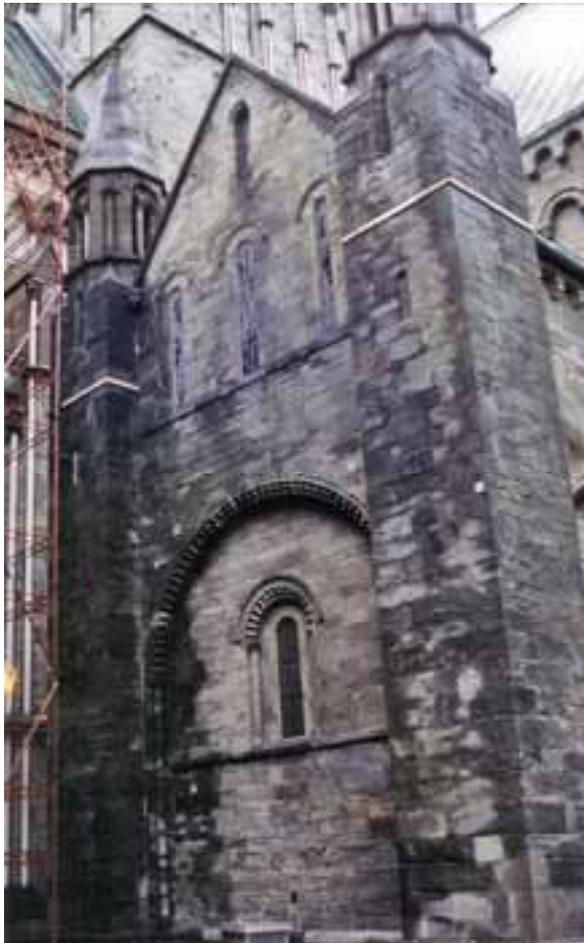
Using the east wall of the Lectorium/St. Mary's chapel as an example, it can be seen that a major feature of the wall is the distinctive waterways in the corners beside the towers. Run-off is caused by water collecting between the gable and the towers - a problem solved earlier (before the restoration around 1880) by gullies which were able to discharge water away from the wall (fig. 13.9). This system - as well as the design of the roof and towers - was changed during the restoration. Water has since then simply run down the wall (fig. 13.7).

Fig. 13.7: *The Lectorium and St. Mary's chapel during a shower in September 1994. Although the wall faces east, large areas get completely wet during most precipitation events (photo: PS).*

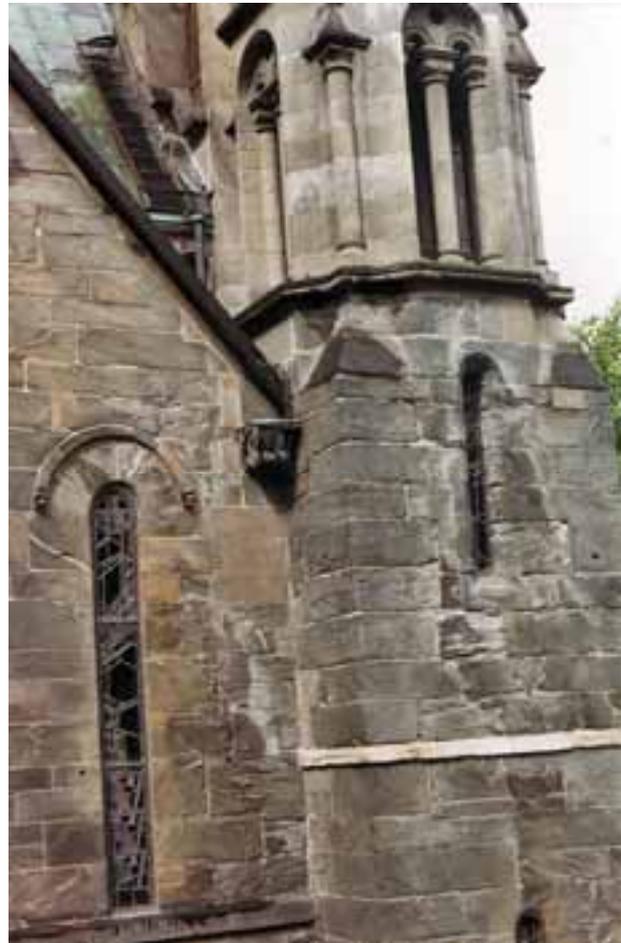
Fig. 13.8: *St. Mary's chapel. Corner between the gable and the north tower in which run-off collects. Note that the greenschist ashlars are very sound in the main waterway. Black crusts (and some other salts) have accumulated in zones beside the waterway, causing flaking and granular disintegration (photo: PS 6/93).*

The most distinctive run-off patterns can be found just below the corners between the gable and the towers (fig. 13.8). Here, water has effectively “cleaned” the ashlar in the central zone, while black crusts and other salt species have concentrated in the adjacent. This zone is characterised by flaking/exfoliation and granular disintegration, obviously caused by the actions of salts.

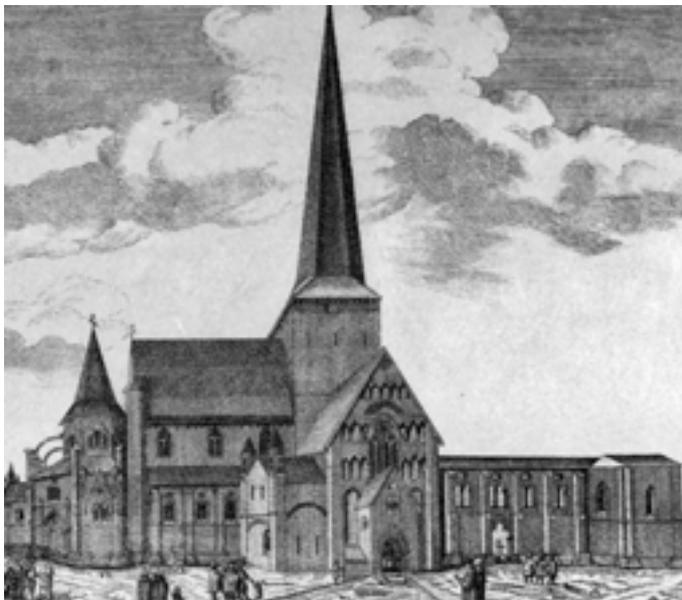
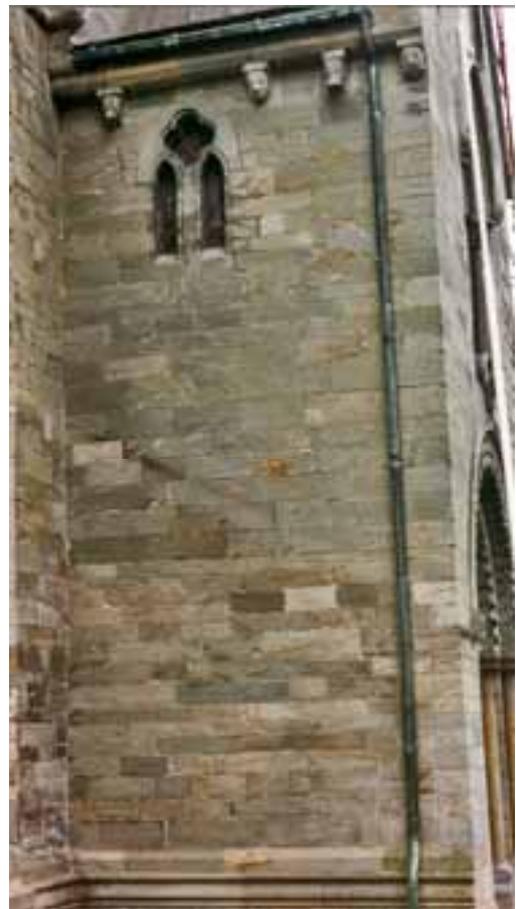
Fires did not always destroy stone surfaces, even when wooden structures burnt directly adjacent to the masonry. Quite often a slight brown coloration of stonework is the only feature to be observed today. An example can be found in the corner between the east wall of the north porch and the main north wall of the transept. According to the copperplate of J. M. Maschius from 1661 (figure 13.11), there was a pillory in the actual area - a wooden structure that may have burnt violently during a fire. Several ashlar were replaced during the restoration, but the remaining old stones show that the damage caused by the fire was very minor, indeed.

Fig. 13.11: Above: Copperplate by J. M. Maschius from 1661. The drawing is not correct, but a particular construction can be seen in the corner between the north porch and the main north wall of the transept. The construction is a pillory which later burnt, causing only minor damage to the masonry. Right: The only traces of the fire is brown discoloration (photo: PS 6/93).

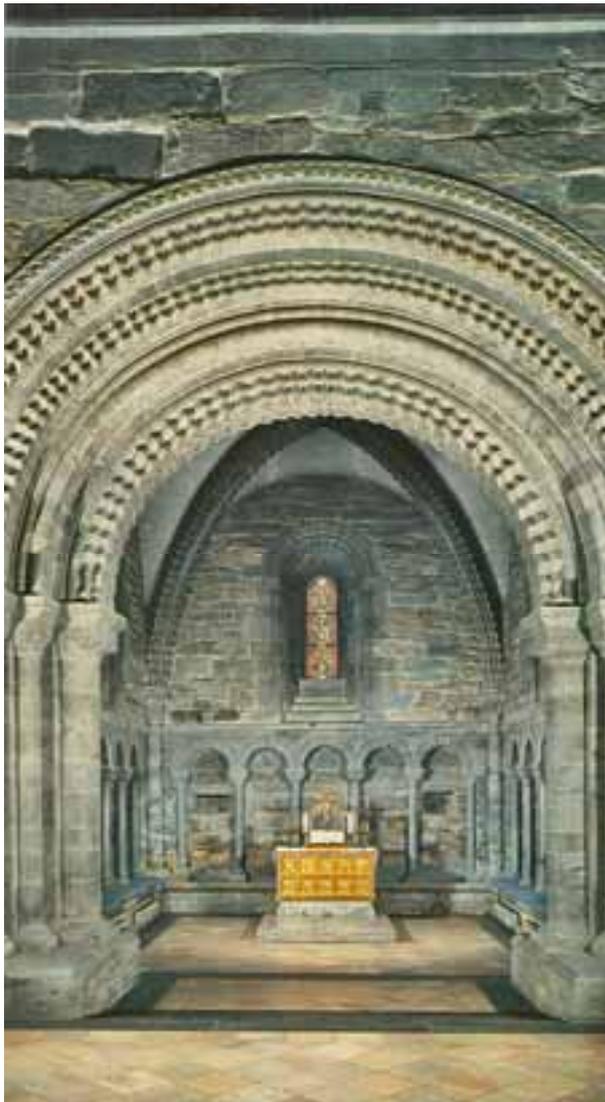
Using the Lectorium (fig. 13.12) as an example, the most active weathering occurs in the north-east corner. Studying the history of the chapel (table 13.1), it can be seen that moisture has been a problem since at least the 18th century. These moisture problems can be attributed to poor drainage of surface water, which may have collected on the layer of clay on which the cathedral is built. However, since the chapel is a cold corner of the church, condensation was probably very important before the installation of heating in the late 19th century. The chapel was heavily restored between 1880 and 1900. Major parts of the badly damaged walls were replaced, and several new columns and other decorations put in place where old ones were missing or damaged.⁵ The restoration, which included the use of Portland cement, explains why trona and sodium sulphates are the main salt phases found today. Trona occurs in the form of thick crusts along joints, while sodium sulphates are more evenly distributed on walls and decorations.

Fig. 13.12: The Lectorium has suffered dampness problems at least since the 18th century. Bases and capitals of the Romanesque blind arcade are still severely affected by salt weathering (photo: ARW).

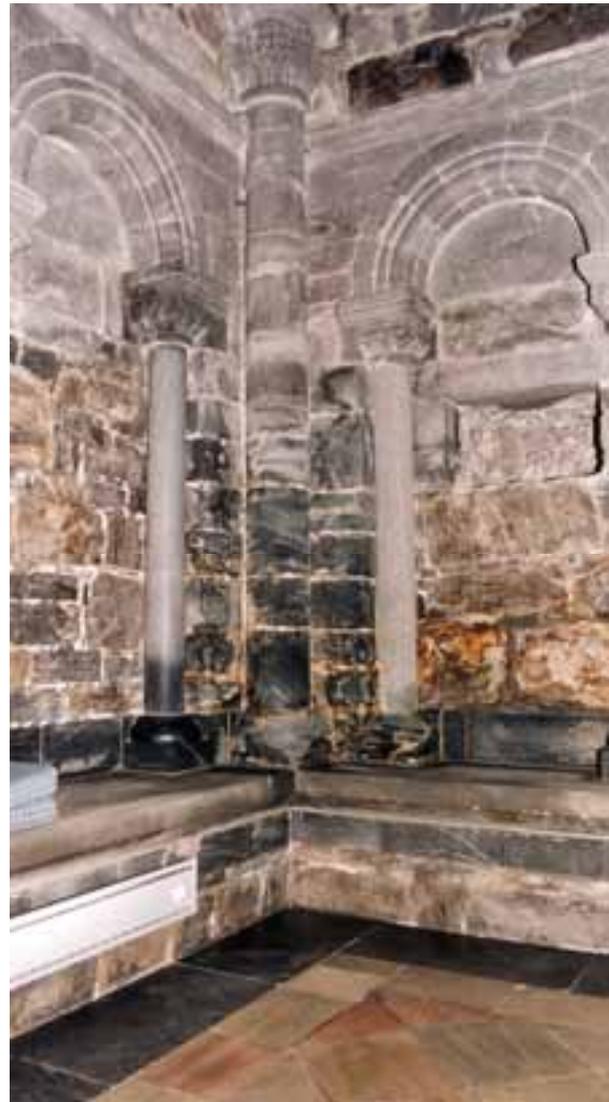
The cleaning routines in the cathedral may also play a role in the weathering. For several decades the normal way of removing dust and dirt has been to use soaking wet cloths - not only on the floor, but also on stonework and decoration.⁶ Summer condensation and wet cleaning may explain why the weathering is still developing. Whether these phenomena can explain the *initial* formation of large amounts of salt is, however, difficult to say.

Fig. 13.13: North-east corner of the Lectorium. During an event of summer condensation in August 1995, the corner became completely wet, causing most of the salts to dissolve (photo: PS).

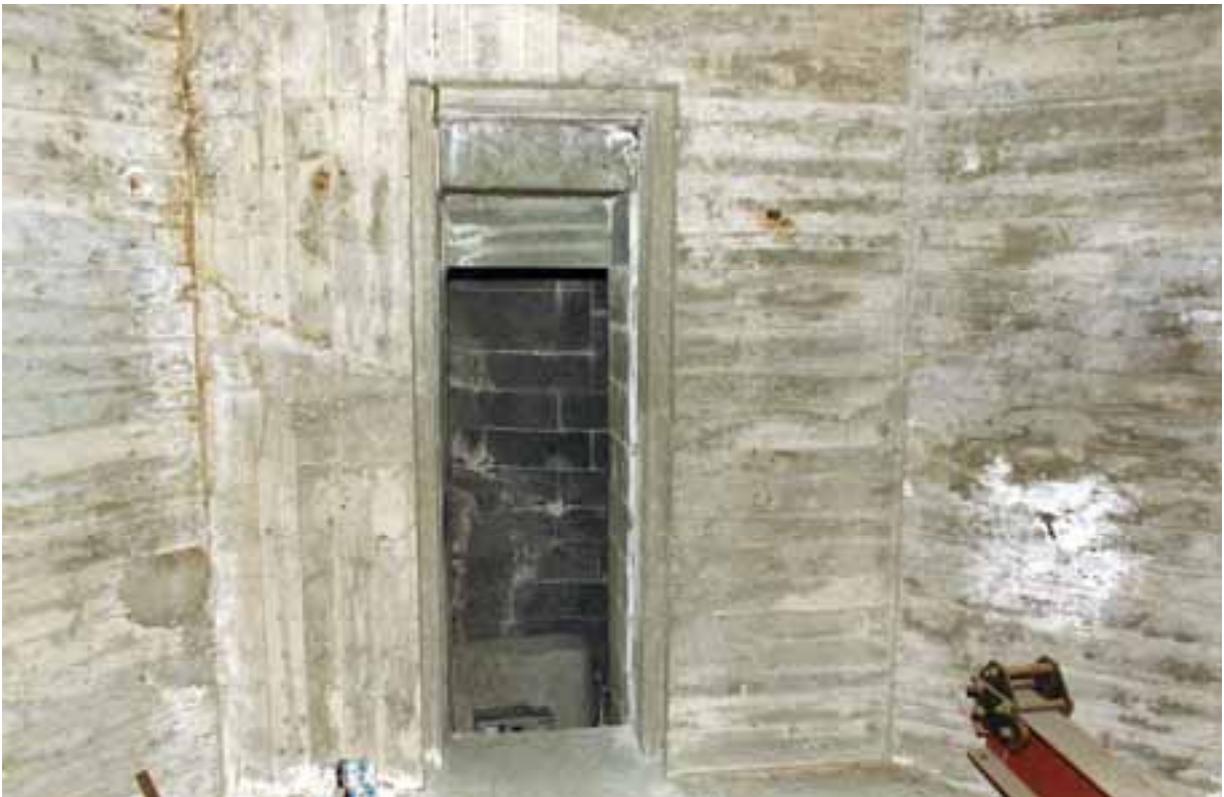
Fig. 14.3: *Interior of the concrete “bunker” above the belfry. The opening leads to the staircase of the turret which is severely damaged because of leaks and alkaline salts (photo: PS 6/91).*

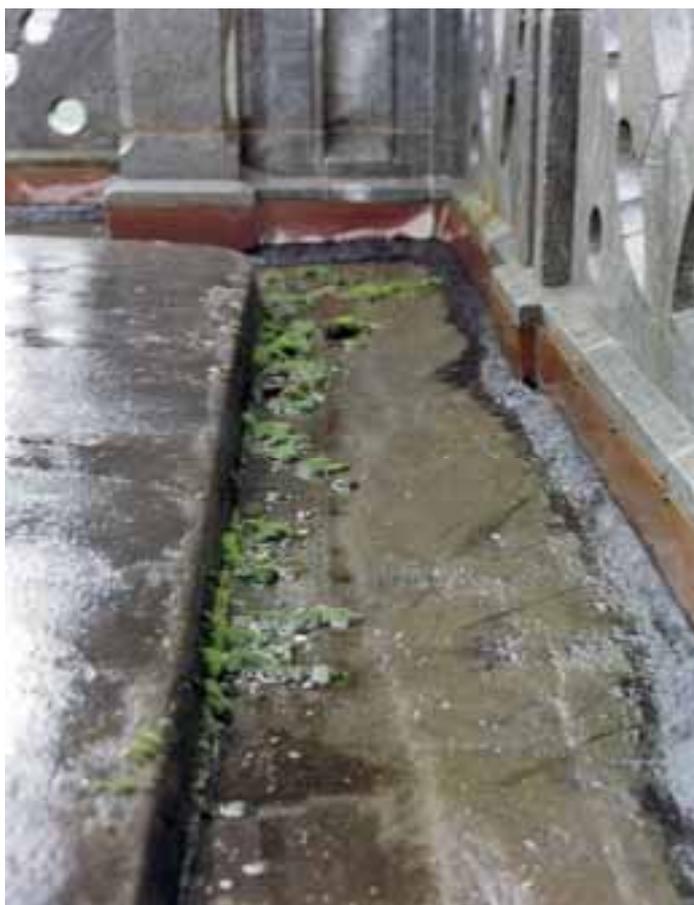
A major feature is the frequent leaks from joint fissures in the small towers, parapet, cornices and from fissures in the insulation of the platform. The platform has a drainage channel which leads to the one and only downpipe of the tower. Intuition and experience show that only one downpipe is insufficient, but a greater problem seems to be that the inclination of the channel is poor (fig. 14.4). Consequently, water often remains in the channel, causing growth of moss which may clog the downpipe.

Fig. 14.4: Drainage channel on top of the southern west tower on a rainy day. The inclination of the channel is insufficient, meaning that water remains and leaks develop through the mortar/asphalt covering (photo: PS 7/91).

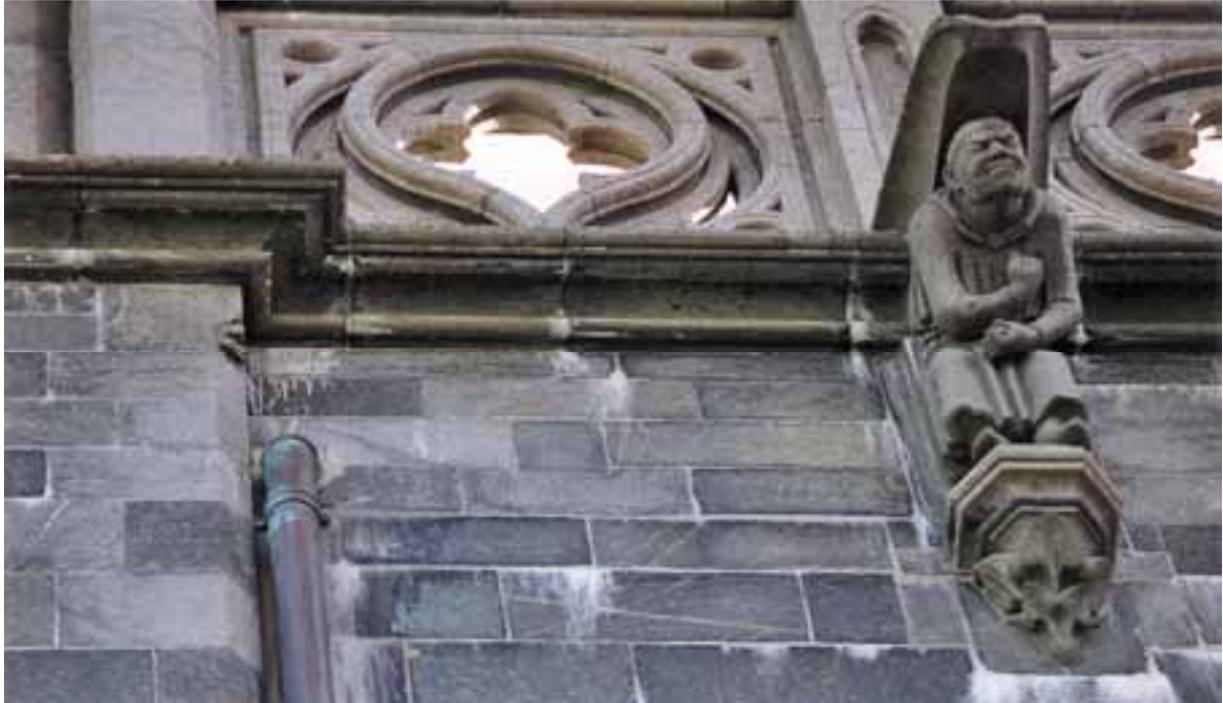
Joint fissures. The exposed small towers, parapets and cornices have extensive joint fissures, through which water infiltration can take place. The most problematic fissures seem to be those between stones in the cornice (fig. 14.5).

Calcite crusts. Such crusts unequivocally occur below joints and points of water infiltration, both on the small towers and masonry below the cornice (fig. 14.5).

Fig. 14.5: Cornice on the north side of the southern west tower. The picture shows the only downpipe of the tower, a fake stone gully and calcite crusts associated with joints. The joints in the cornice have all got fissures, through which water can infiltrate (photo: PS 5/96).

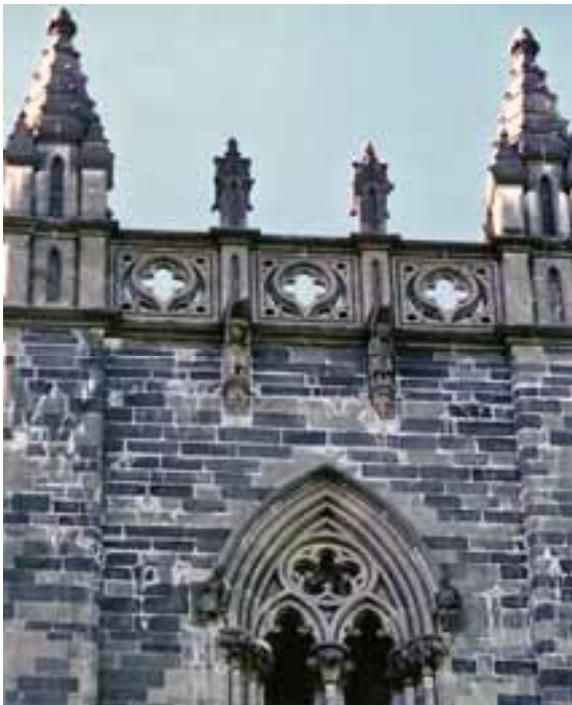
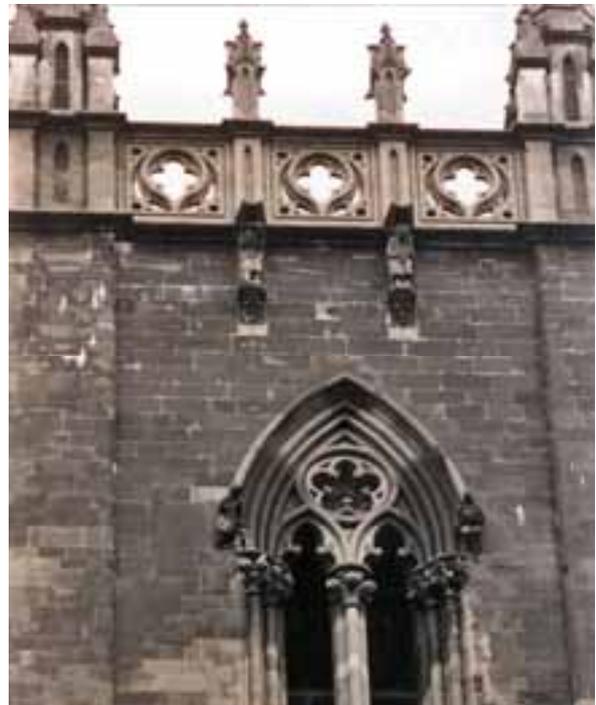
Fig. 14.6: The east wall of the southern west tower. Left: Large amounts of alkaline salts (white patches) prevail in dry spring weather (photo: PS 3/94). Right: Due to their hygroscopic behaviour, the salts have dissolved during a warm and humid day in late august (photo: PS 8/95).

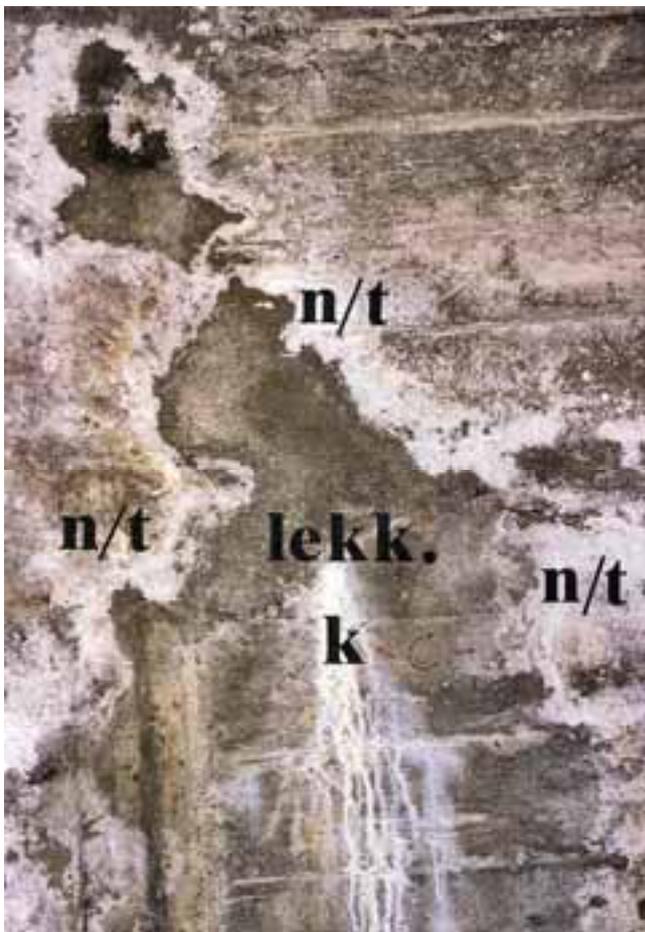
Starting with the “bunker” on top, it can be observed that leaks have led to the deposition of calcite crusts below fissures and cracks in the concrete. The numerous fissures indicate that the quality of the concrete is rather poor. Sodium carbonates tend to crystallise in an almost concentric manner around the calcite crusts (fig. 14.7). This is because of capillary forces and the fact that sodium carbonates are much more soluble than calcite. Needles, whiskers and loosely attached crusts of natrite prevail during wet periods, while in dry periods, e.g. spring and early summer, natrite dehydrates to form powdery efflorescences of thermonatrite. Whereas natrite quickly forms when water evaporates after wet periods, it normally takes quite some time (days, weeks) before complete dehydration to thermonatrite takes place.

Fig. 14.7: Wall of the concrete “bunker” of the southern west tower. A leak has brought large amounts of salts to the surface.

Explanations: lekk = fissure from which water is brought to the surface, k = calcite, n/t = natrite/thermonatrite (photo: PS 3/93).

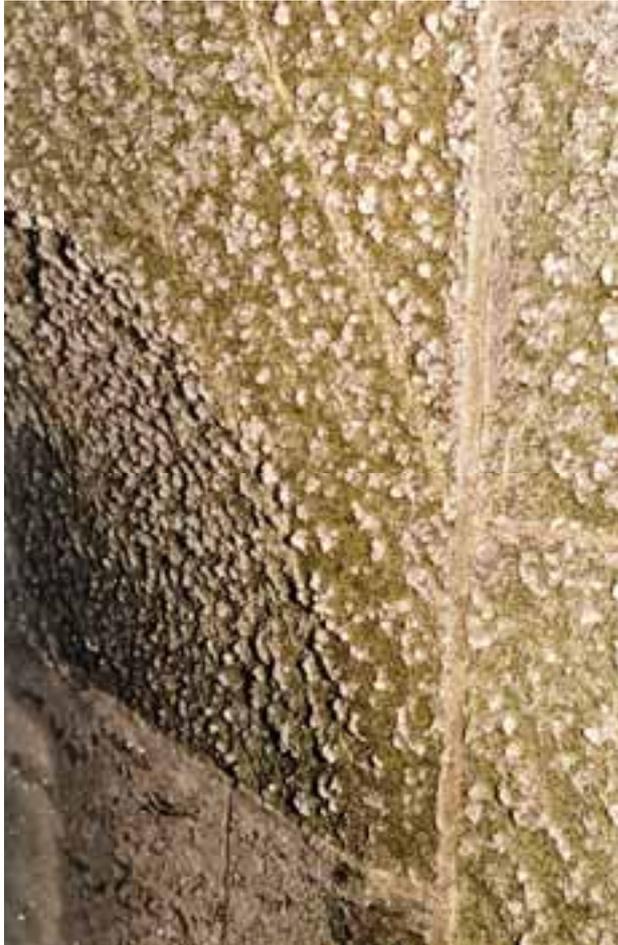
Fig. 14.9: Part of the wall in the staircase on a day with white frost. The white spots are not salts, but ice formed on dolomite grains present in the Grunnes soapstone. The matrix of the soapstone tends to weather more rapidly than the dolomite grains (photo: PS 12/96).

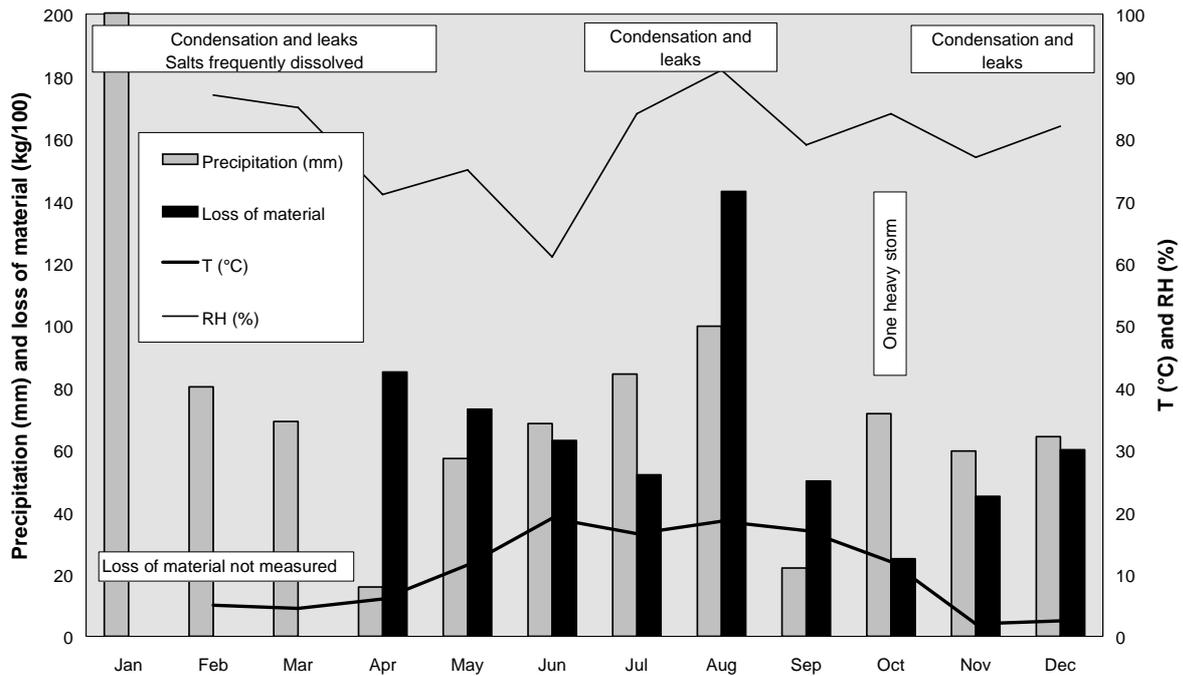
Fig. 14.10: Southern west tower, upper part of staircase. Loss of material pr. month compared with climatic conditions (mean monthly values). Note that the loss of material is high in - or just after - wet periods. This observation indicates that crystallization of natrite from solution (leaks, condensation) is the main weathering mechanism. Thermohygrograph readings, collection of material and some observations by Erling Refseth.

As can be seen in figure 14.10, the monthly loss of material was steadily decreasing during the fine spring and early summer, before rising dramatically during the wet August. Then it dropped strongly in the dry September and partly wet October, before once more increasing in November and December.

The largest material losses took place in, or just after, the wettest periods. This indicates that the most active weathering occurs when natrite crystallises directly from an evaporating solution.¹ However, in order to thoroughly understand the weathering mechanisms, several additional phenomena should be taken into account (see chapter 3). Above, we have concentrated on the pressure which develops when natrite crystallises, but not considered possible build-up of hydration pressure when thermonatrite eventually takes up water and forms natrite. This mechanism could - although unlikely - take place as a result of daily variations in relative humidity (dry days and humid nights). Hydration of thermonatrite has in fact never been ob-

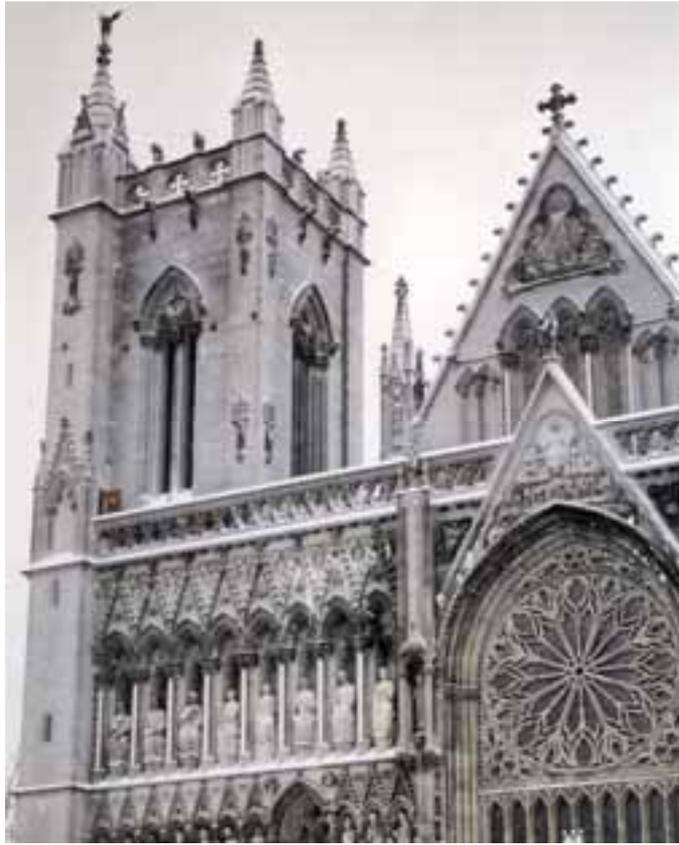
Fig. 14.11: Northern west tower on a day with severe white frost (photo: PS 12/96).

Although its concrete “bunker” is a little smaller, the northern west tower (completed in 1964) was built in roughly the same way as its southern counterpart (fig. 14.11). However, despite leaks and widespread occurrence of alkaline salts, the weathering takes place at a much lower rate in the northern tower.

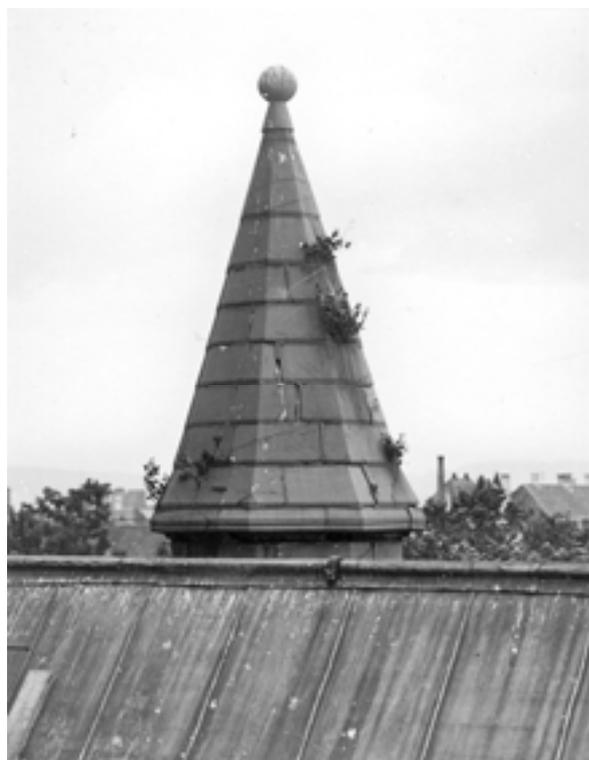
Water leaks appeared a few years after Schirmer's restoration. Photographs show extensive white crusts on the towers in the late 1870s. These crusts were removed around 1890, probably as part of the interventions undertaken in order to stop the leaks.⁵ The problems reappeared before 1926 when the joints in the stone capped towers had to be repointed because of the growth of bushes(!) and formation of joint fissures (fig. 15.3).⁶

Fig. 15.3: Bushes growing on the north tower of the chapter house before intervention in 1926. The repairs involved mainly repointing joints and removing white crusts (photo: ARW, no. 3006).

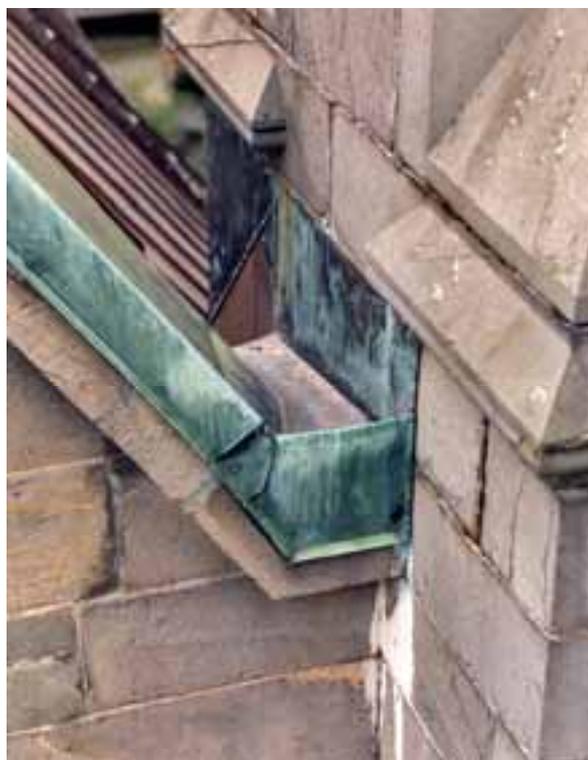
The next intervention followed in 1932 when copper was applied onto the gable copings, successfully preventing further leaks (fig. 15.4-5).⁷ Horizontal members and other parts of the masonry were repointed with Portland cement mortars.⁸ These measures were mainly undertaken in order to improve the poor condition due to "humidity" (i.e. salts) on the interior wall (fig. 15.9). Interior surfaces were subsequently cleaned by unknown means.⁹ The ventilation of the room was also improved since stagnant air was considered an additional reason for the poor condition.¹⁰

Fig. 15.4: Corner between the south tower and the gable of the chapter house. Note the copper construction applied in 1932, successfully preventing further leaks (photo: PS 9/95).

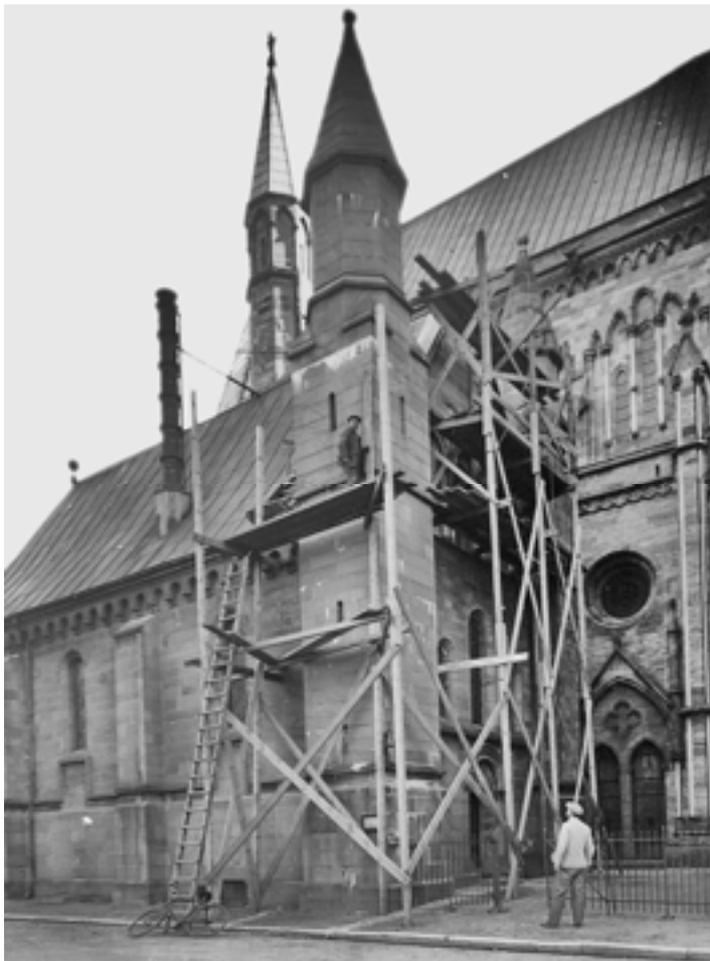
Fig. 15.5: The gable triangle of the chapter house under restoration in 1932 - a task involving removal of white crusts and application of copper cover on the copestones. (photo: ARW, no. 3856).

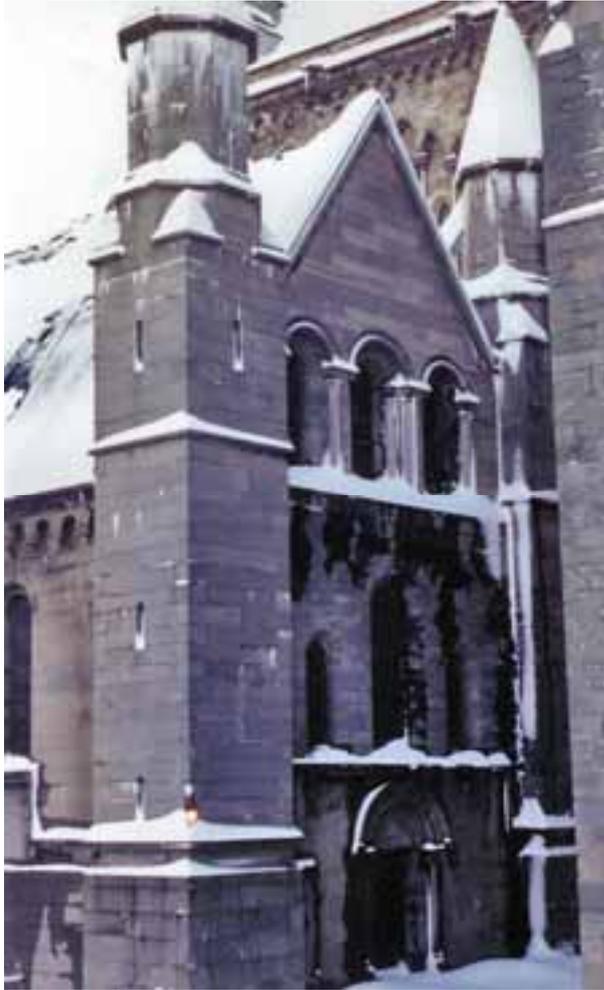
Acting as collectors of precipitation (fig. 15.6) and being without metal cover, the horizontal members, as well as the towers, must be regarded as the weak parts of the chapter house. Since the wall is practically never exposed to sunshine, it is one of the coldest parts of the cathedral. Hence, the interior surfaces are occasionally affected by condensation events, especially on warm, humid summer days. The interior wall has also been affected by soot from the central heating system (which is located in the cellar) due to via earlier ventilation openings in the floor(!).²

The present weathering situation is principally the same as before 1890, 1926 and 1948: The towers have developed joint fissures which have resulted in water leaks, extensive formation of calcite crusts (fig. 15.8) and moderate salt weathering on the interior walls of the northern tower's staircase. The joints in the broad sill below the upper group of openings have weathered away, and the interior west wall is almost completely covered by salts (fig. 15.11). Sheltered parts of the exterior wall suffer from flaking, delamination and the presence of black crusts. However, the description below will not focus on exterior weathering phenomena.¹² Instead attention will be paid to interior salt weathering.

Fig. 15.6: The chapter house today. Note the extensive white calcite crusts below the stone caps of the towers. This shows that the asphalt insulation from 1948 has been ineffective. Note also that thawing takes place from the broad sill (photo: PS 2/95).

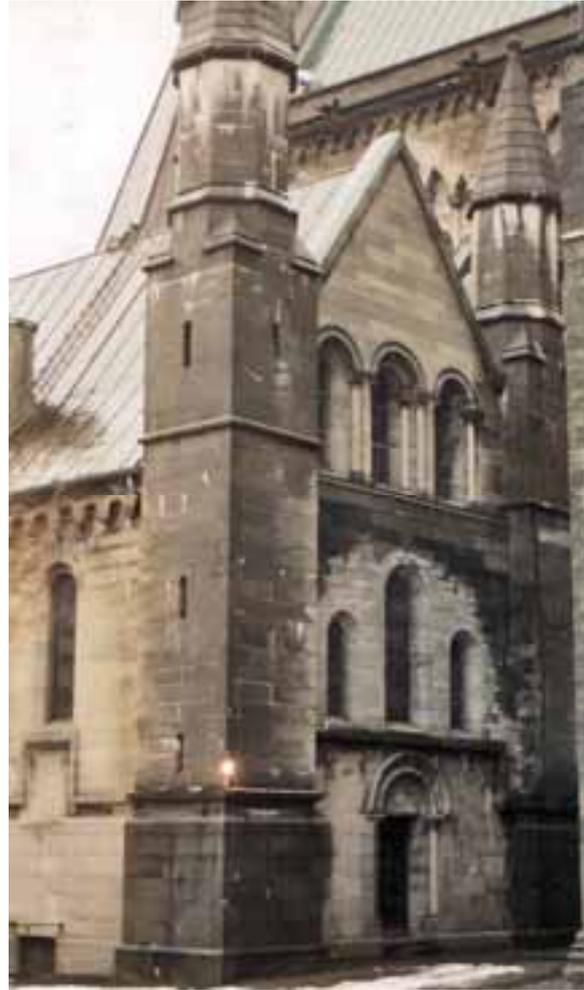
Fig. 15.7: The chapter house during an event of late autumn condensation. Note that condensation is restricted to unheated parts of the building. The location of the vaulting can also be seen (photo: PS 11/95).

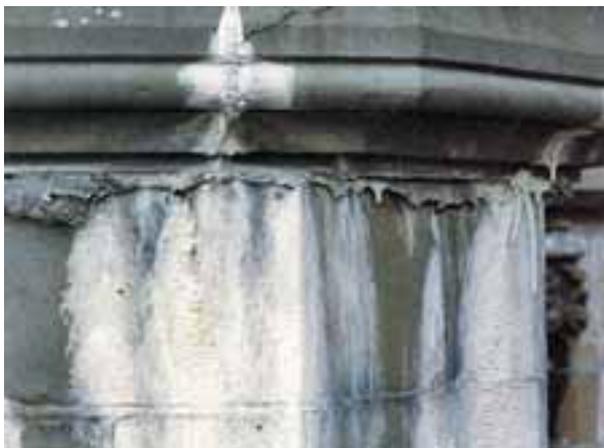
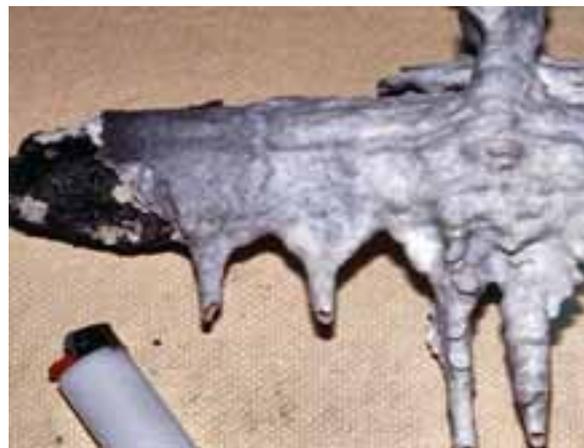
Fig. 15.8: Left: White calcite crusts on the southern tower. Note the layer of asphalt which has been pressed out. The layer was applied in 1948 (photo: PS 9/90). Right: "Stalactite" collected from just below the stone cap of the south tower (photo: PS 1/91).

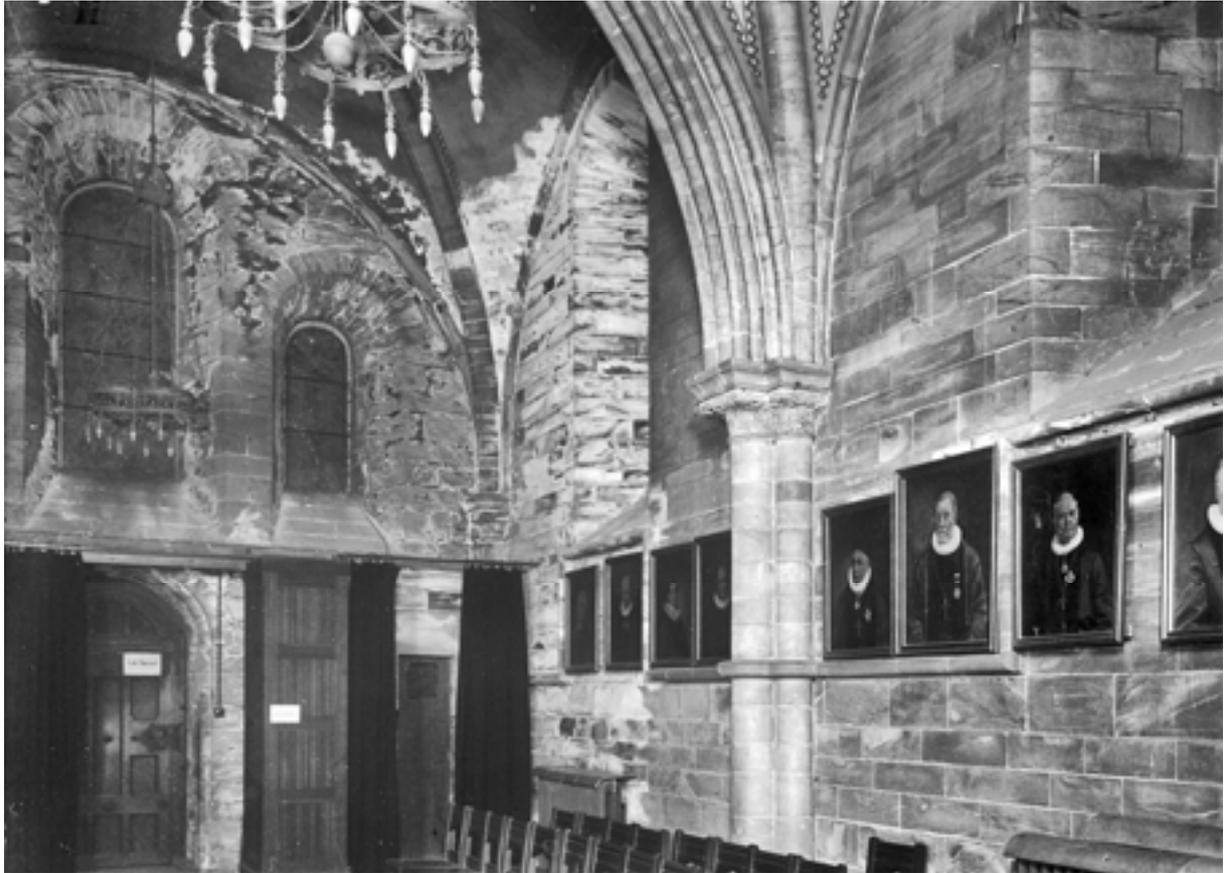
Fig. 15.9: The north west corner of the chapter house before cleaning of the walls took place in 1932. Note the extensive distribution of salts (photo: ARW, no. 3070).

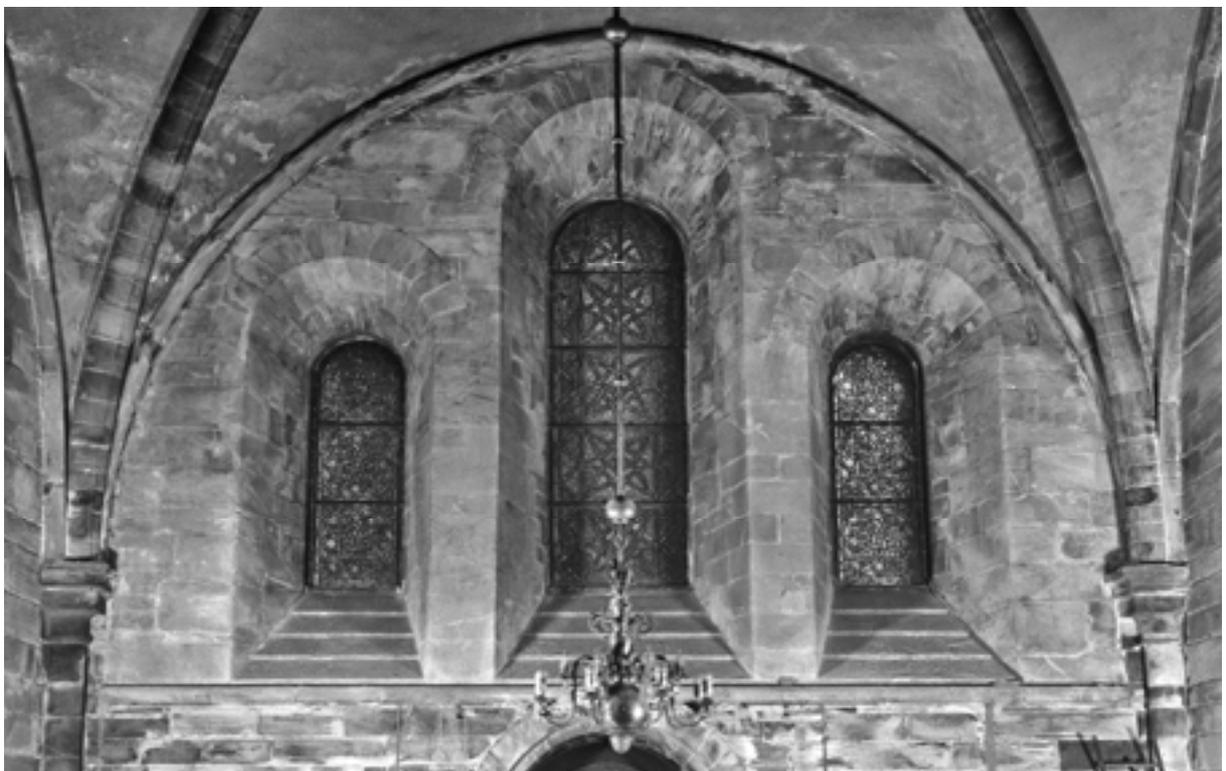
Fig. 15.10: The west wall of the chapter house, probably in the early 1960s. Note that the extent of salt efflorescences has been reduced since 1932 (photo: ARW, no. 7019).

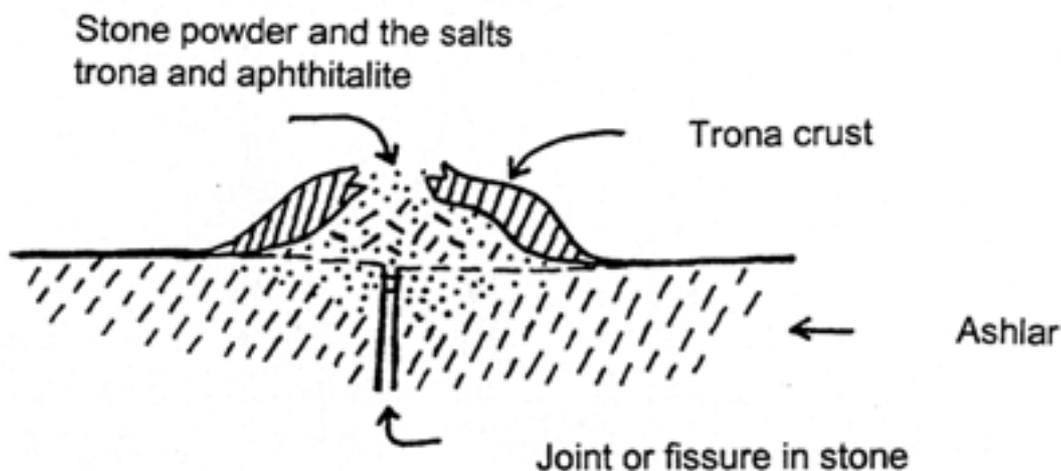
The salt system in the upper section is complex, but it includes two dominant species: trona and apthitalite. The crusts related to the pop-outs consist of these salts, as needle-like trona and small, hexagonal crystals of apthitalite. Trona is also present in efflorescences and sub-florescences on the vault and close to joints on the wall itself, whereas in the central, rather sound part of most ashlars, powdery thenardite and/or needle-like mirabilite are the most frequent species to be found.

Fig. 15.12: The west wall of the chapter house. Sketch of pop-outs consisting mainly of the salts trona and apththitalite. When the pop-outs break up (looking like small volcanoes) granular disintegration of the stones can be seen within.

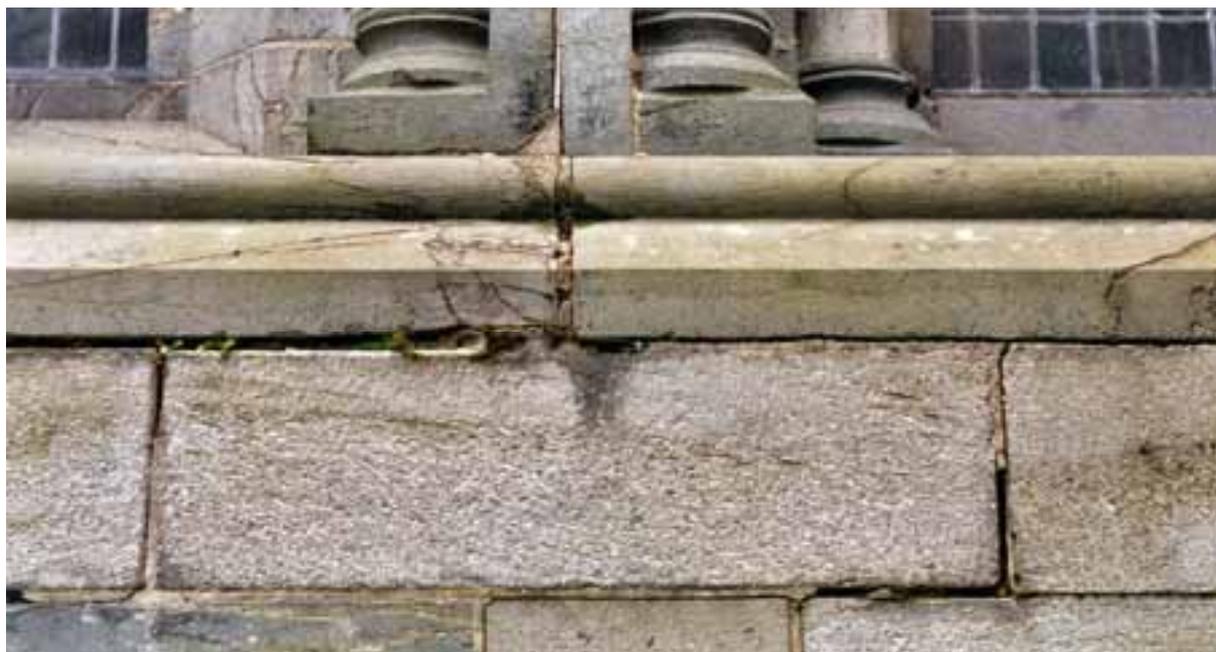
Water infiltration from the broad sill (fig. 15.13) and the towers seem to be responsible for this problematic situation, but water has not actually been observed running down the wall inside. Hence, slow water seepage in the joint system seems able to mobilise and transport the large amount of salt present. It should be remembered that the broad sill is affected by virtually every event of precipitation.

Fig. 15.13: The west wall of the chapter house. Open joints in the broad sill below the upper group of openings are the main reason why moisture enters the interior of the wall (photo: PS 9/95).

Since earlier conservation measures have failed, a new approach ought to be considered when planning future interventions. Water leaks should be eliminated as fast as possible. For this purpose it is probably necessary to apply lead or copper on the most exposed parts, i.e. the towers and the broad sill below the upper group of openings. Since water also penetrates open joints in the vertical part of the northern tower, it may be necessary to remove the joints which were applied during earlier repointing operations. Removal of the joints is a difficult measure and it will be treated on a more general basis in chapter 20. Another difficult issue is which type of mortar should be used for new repointing operations. Whether lime mortars can be used is probably dependent on the nature of the joint system, i.e. whether there is a lot of cement in the deeper part of the joints or not.

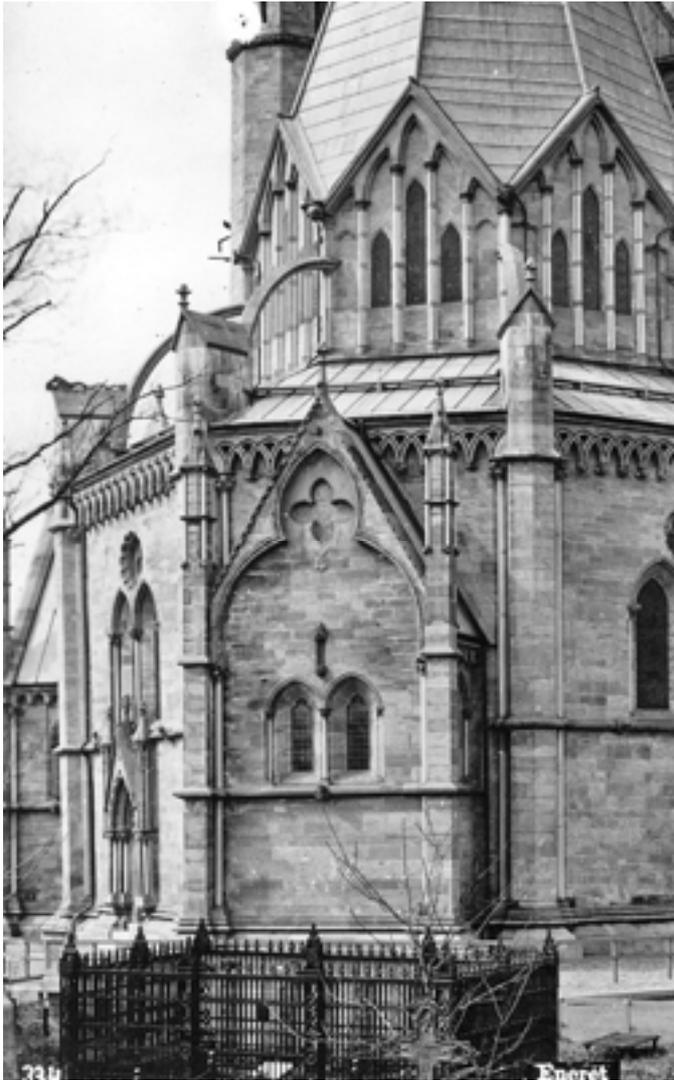
Fig. 16.3: *The octagon in the late 1880s. Note especially that the south pillar of the east chapel already has a slight dark cover - probably black crusts (photo: ARW, no. 334).*

The introduction of alkaline salts and chloride, as well as increasing air pollution, are important factors to keep in mind, especially because salts cannot be washed away by rain on large parts of the chapel. Studying photographs, we can see that black crusts appeared on the pillars by the 1880s (fig. 16.3). In 1905 the crusts were much more widespread - also appearing along joints around the windows.⁹ The following 50 years lack photos, but in the late 1950s the crusts seriously distorted the aesthetic appearance of the chapel. Now it is also evident that masonry above the windows is rather weathered, in particular along joints (fig. 16.4).
