The Stones of Nidaros

An Applied Weathering Study of
Europe's Northernmost
Medieval Cathedral

Dr. Ing. (Ph.D.) thesis no. 1997:92
Department of Architectural History
Norwegian University of Science and Technology
Trondheim, Norway

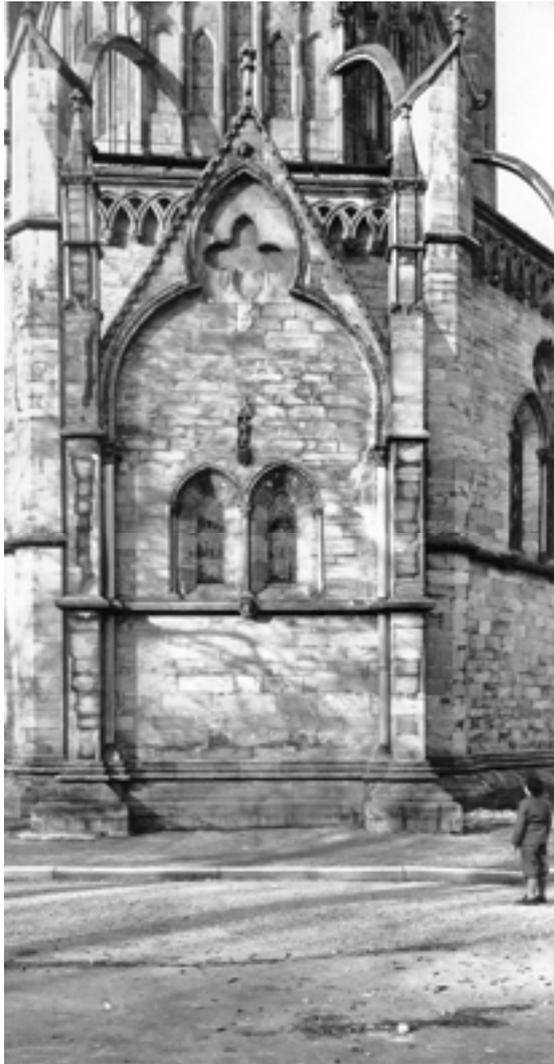
Fig. 16.4: The east chapel, probably in the late 1950s. Note the extent of black crusts on the pillars. (photo: ARW, no. 6721).

Before the restoration in 1974-76, there were distinct run-off patterns below the corner between the pinnacles and the gable (fig. 16.4). The black crusts beside the main waterways have largely disappeared, probably because run-off was eliminated after the restoration and the ongoing weathering of the masonry.

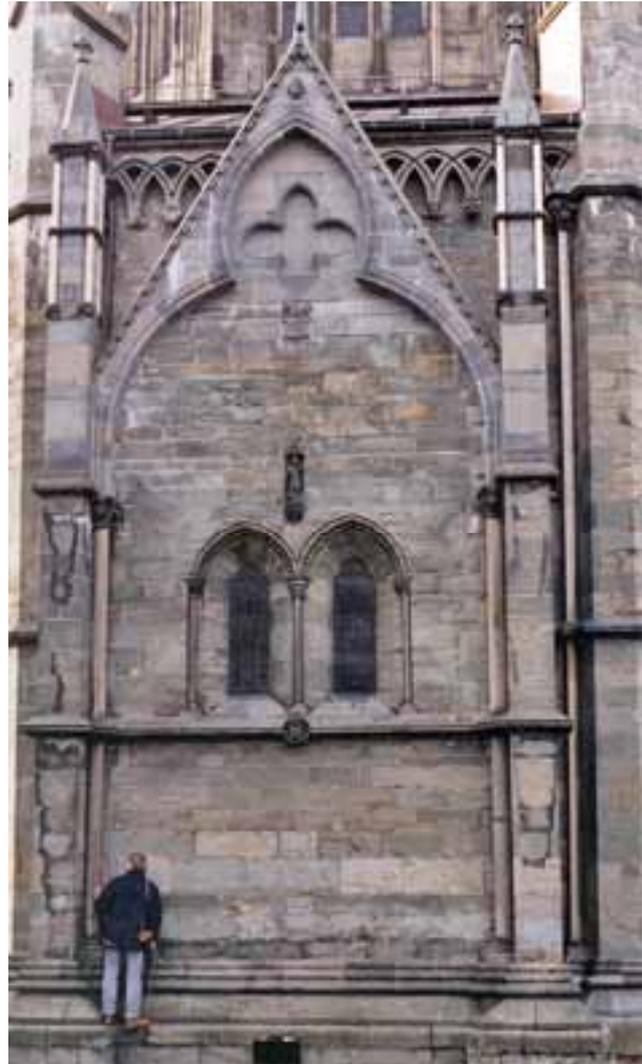
Fig. 16.5: The east chapel in February 1990. The upper part of the gable was replaced with new stone (in 1974-76). Note that the extent of black crusts has decreased since the 1950s (photo: Oddgeir Øfsti).

In 1975-76 the gable was rebuilt using new soapstone and serpentinite from Bubakk (fig. 16.5). Copings were made of Gullfjellet stone, while for the interior wall brick was applied. According to the masons who undertook the work, Portland cement mortar (1:3) without additives was used for all purposes during the restoration. From a 1996-perspective, the restoration must be considered extensive and “hard”, largely because of all the Portland cement applied and the fact that most of the old stones could have been saved. The restoration also destroyed important evidence of Valkendorf’s restoration in the 16th century.

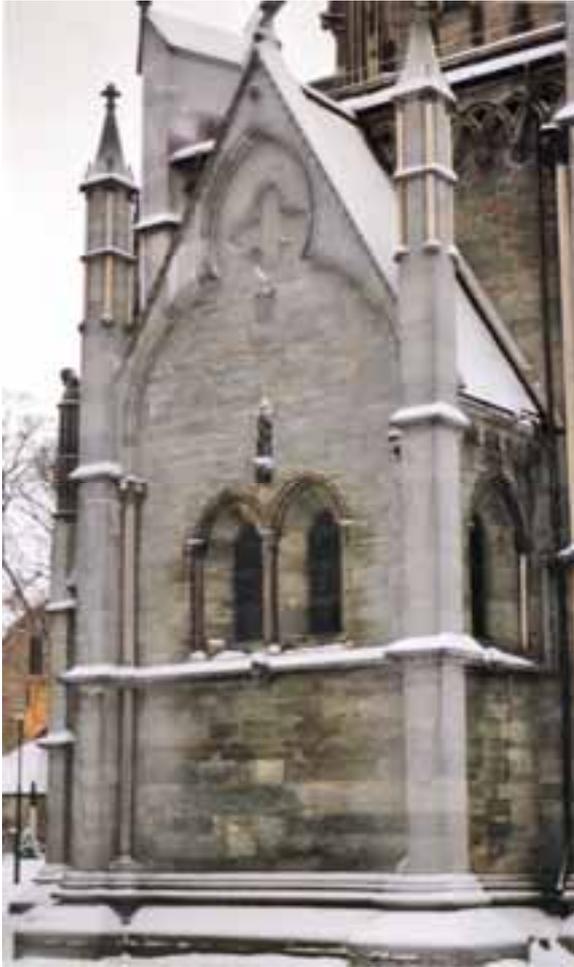
Fig. 16.7: The east chapel during a white frost event in December 1996. Only walls that are heated from inside remain relatively dry (photo: PS).

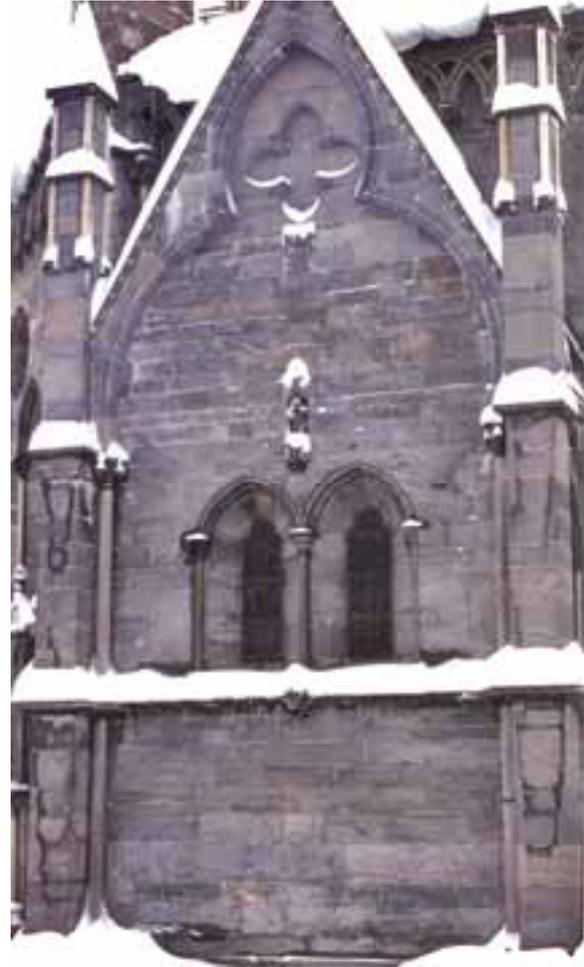
Fig. 16.8: The east chapel during a snowfall in February 1995. Note how snow affects projecting stonework and decoration. Some decorations are deeply weathered (photo: PS).

noted that several slightly projecting decorations are affected by snow and therefore subject to freezing/thawing events (fig. 16.8).

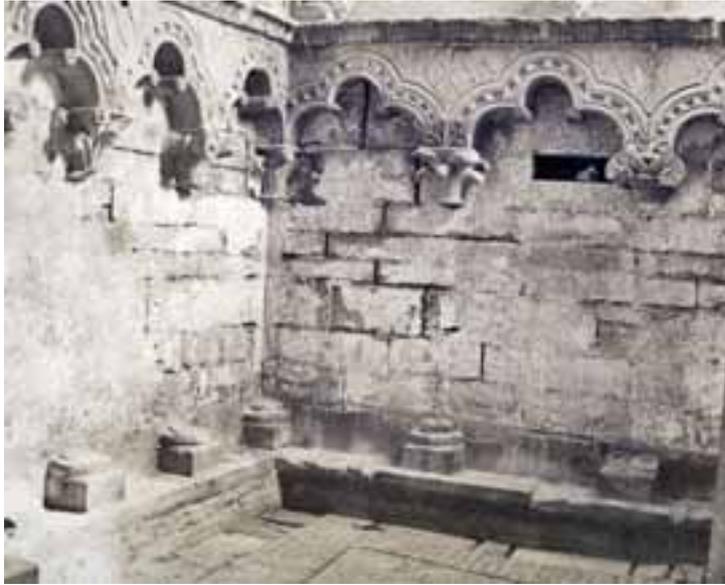
Fig. 16.10: Interior of the east chapel before restoration in 1871. Note the condition of the walls (photo: ARW, no. 27).

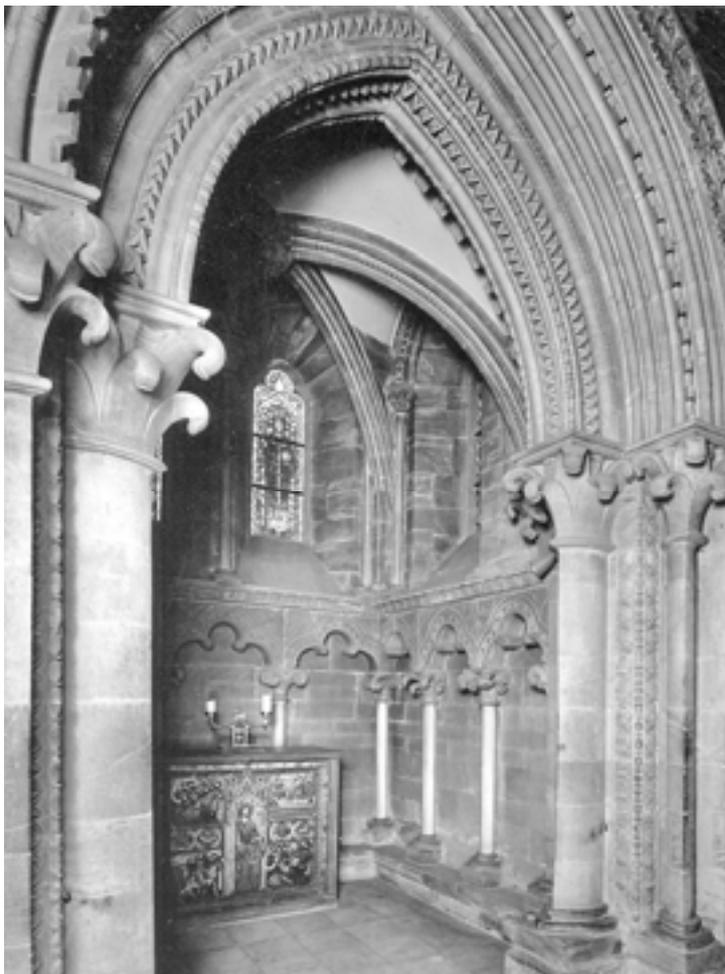
Fig. 16.11: Interior of the east chapel, probably in the 1940s. Except for slight salt weathering in the window arches and along the base, the condition is good (photo: ARW, no. 4538).

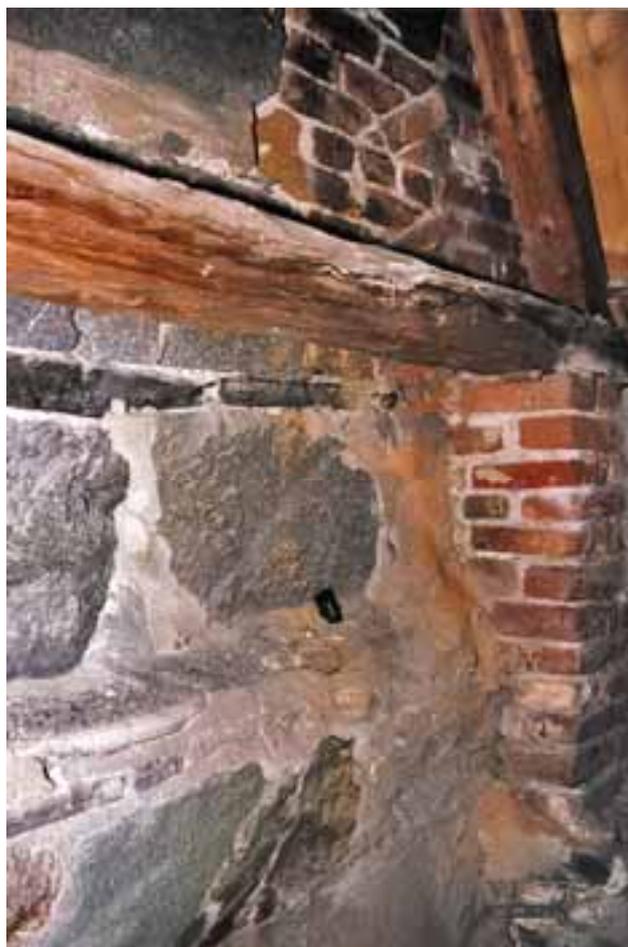
The large amount of salts in the upper section of the chapel can be verified by studying the reverse of the wall (on the loft, fig. 16.12). The weathering of medieval parts of this wall is characterised by deep granular disintegration - the surfaces of the greenschists and soapstones are reduced to a soft powder. This is unsurprising knowing that the stones have been subjected to fire and contain large amounts of gypsum and thenardite/mirabilite (especially in joints) as well as a little epsomite (related to old bricks and lime mortar).

Fig. 16.12: Loft of the east chapel in 1992. Note the stone powder which has accumulated due to intense salt weathering (photo: PS).

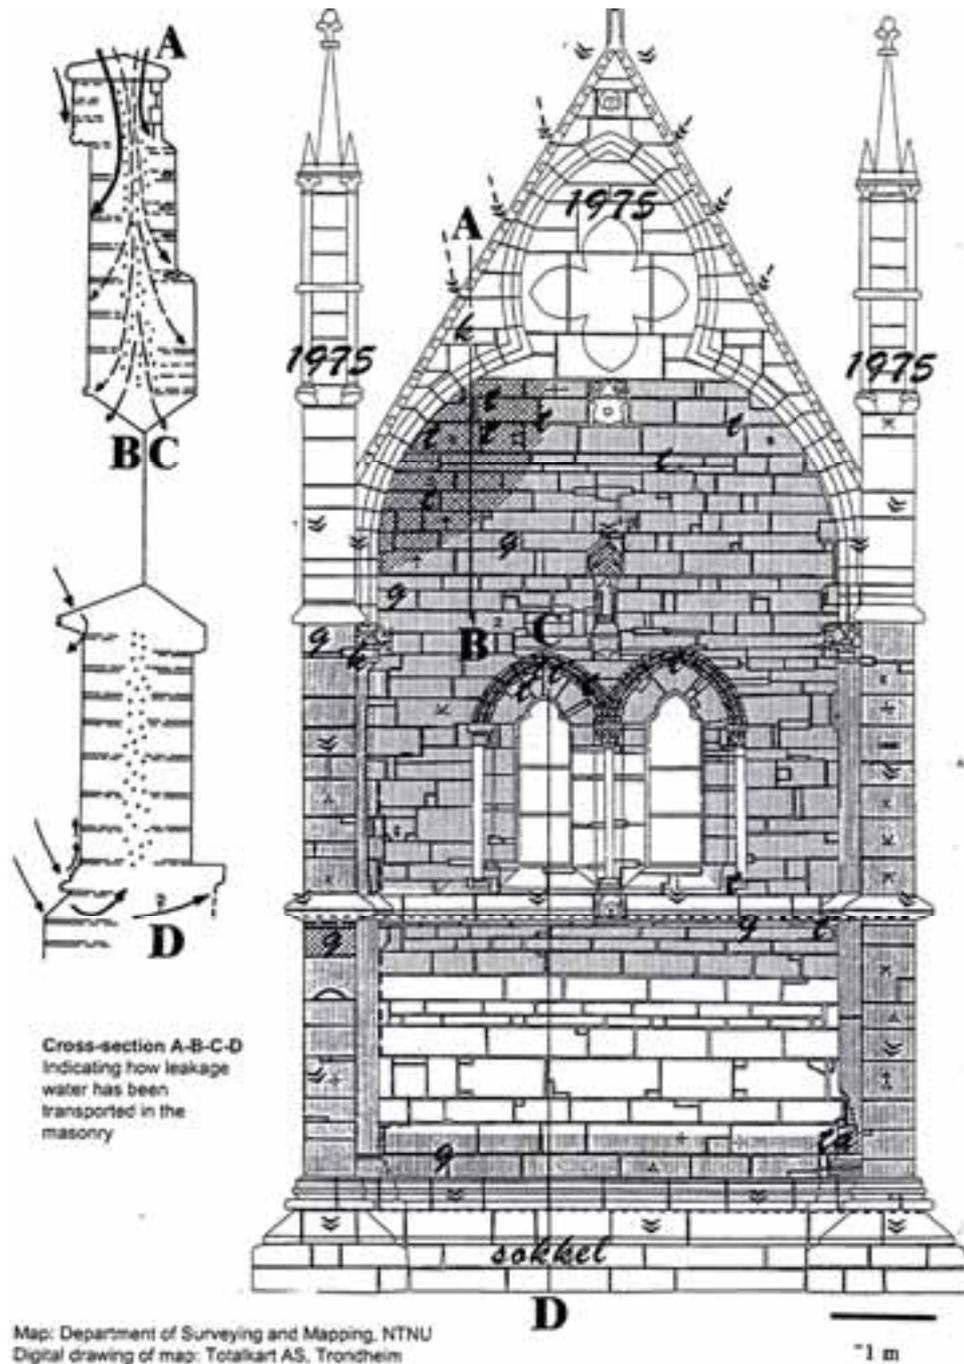
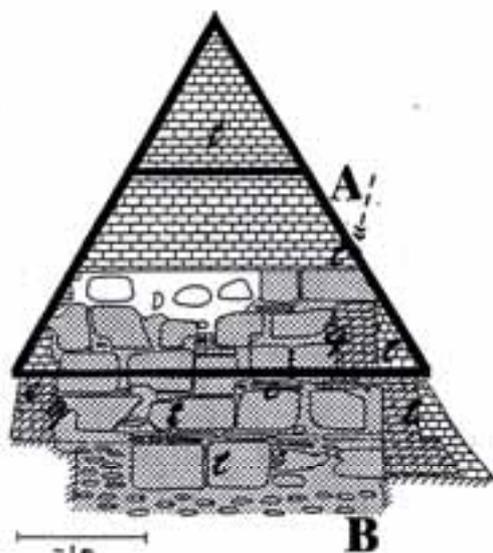
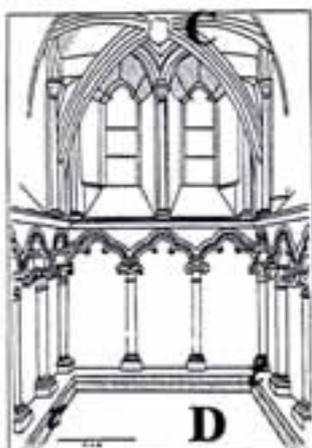
Nidaros cathedral
East chapel of the octagon

Fig: 16.13 (this and next page): General overview of the weathering situation at the east chapel. Note that only analysed salt species have been marked on the figure.

- 19.** New part from 1975. Little stone weathering, but joint fissures cause leakage. Partly exposed to rain.
- Medieval stonework, conserved 1871-73. Widespread delamination of greenschist most common weathering form. Not exposed to rain.
- Medieval stonework, conserved 1871-73. Active weathering and deeply weathered decorative details.
- Medieval stonework, cleaned or redressed 1871-73. Partly exposed to rain. Irregular gypsum crusts very widespread.
- New stone from 1871-73. Gypsum crusts. Not directly exposed to rain.
- 20.** Replaced base 1871-73. Widespread opening of joints.
- Small masonry crack. Probably caused by minor differential settlement between the buttress and the wall
- Certain points of water leakage.
- Areas affected by run-off.

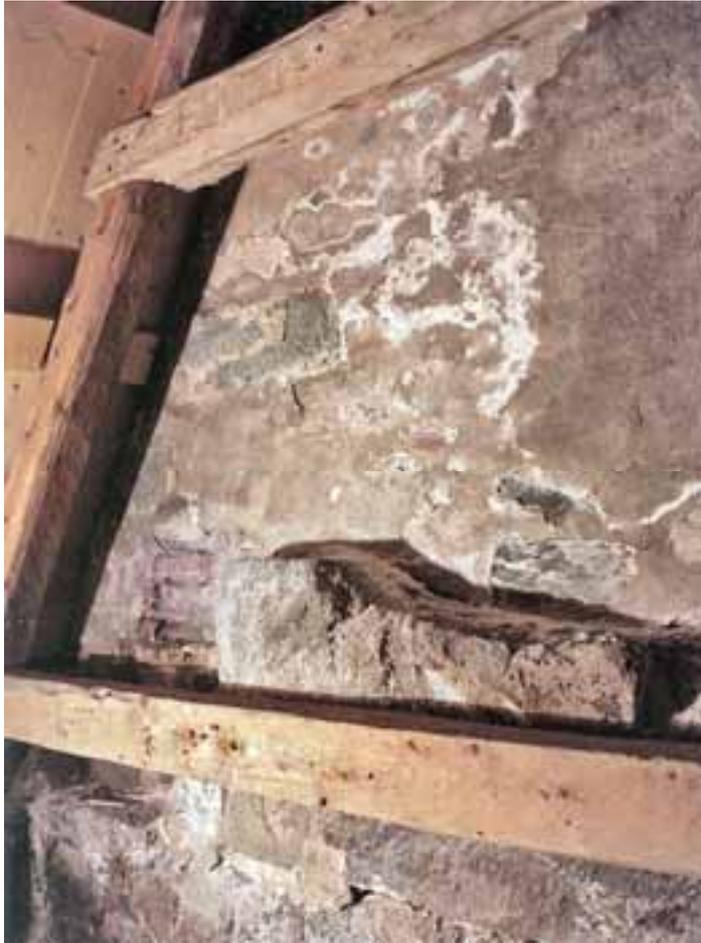
Fig. 16.16: *The loft of the north chapel of the octagon in March 1993. Large amounts of alkaline salts can be seen (photo: PS).*

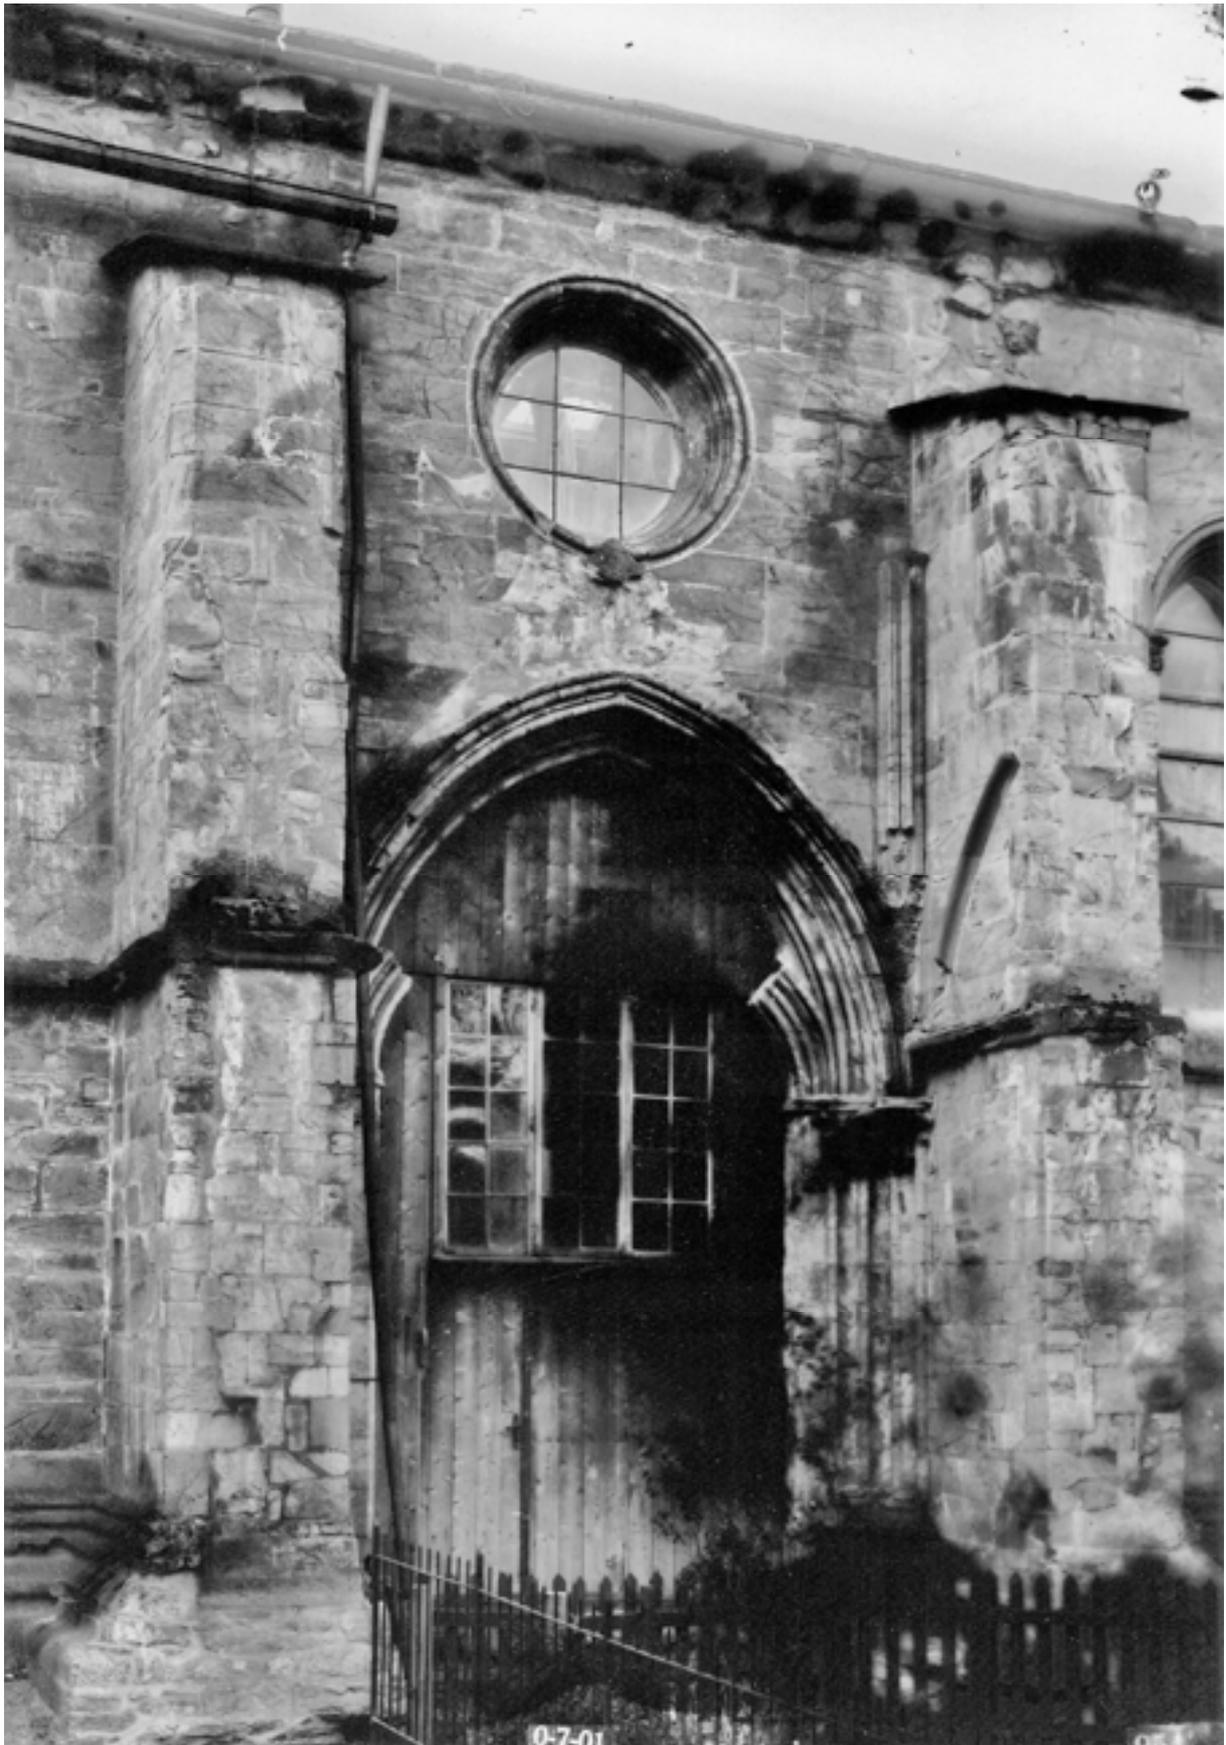
Fig. 17.1: St. Mary's portal before the restoration at the turn of the century (photo: ARW, no. 954).

The building of the chapel/porch in the 15th century involved removal of several parts of the portal, and although it was severely affected by the 1531-fire, the condition of the remaining medieval stone seems to have been astonishingly good before the restoration (fig. 17.1 and 17.8). Mouldings in the main arch were somewhat cracked and spalled, but the vertical sides were hardly damaged at all. The marble plates above the capitals, as well as the capitals themselves, had, however, lost the most exposed details.

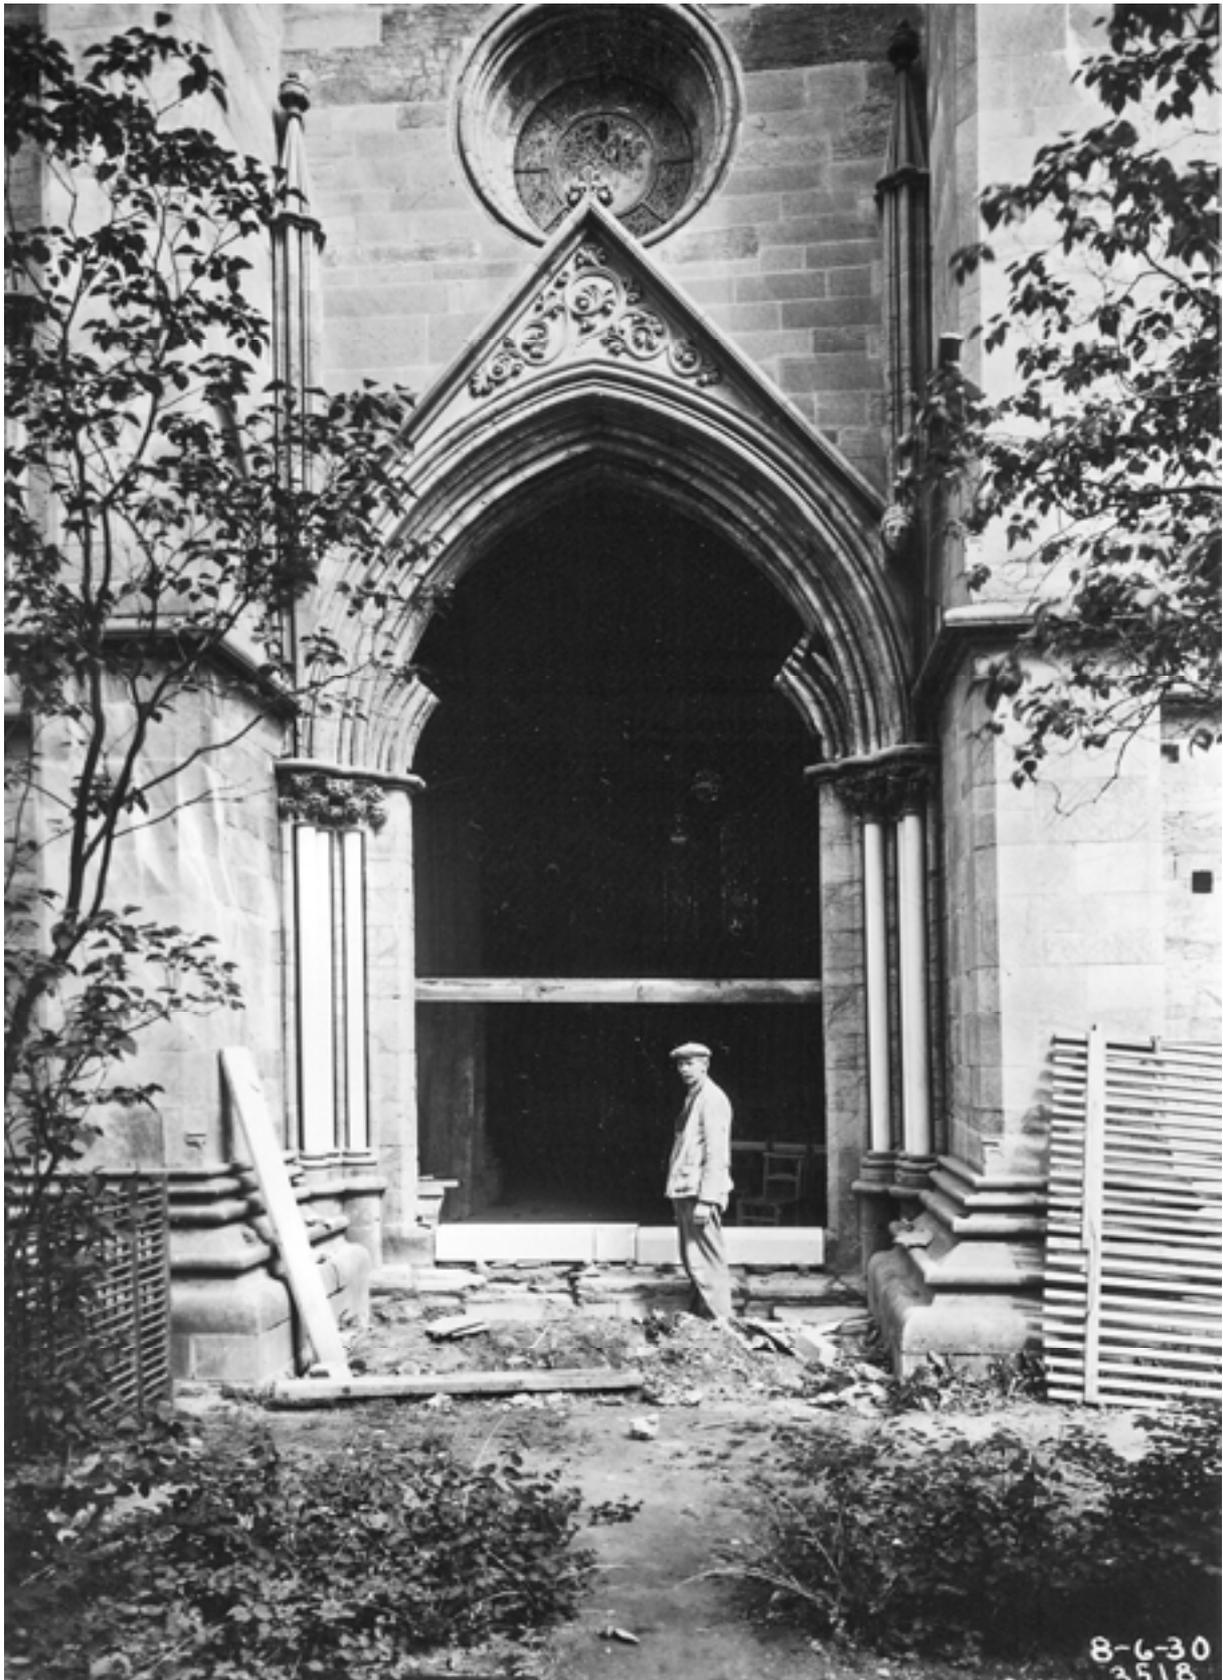
Fig. 17.2: St. Mary's portal in 1930, after the restoration of the nave's aisle, which took place at the turn of the century (photo: ARW, no. 3518).

before 1930. A photo taken at this time (fig. 17.2) shows that the condition of the medieval parts of the portal was good, except that there were some white spots (salts) on the arches just above the east capital plate.

After the reconstruction and repair of the gable and the pinnacles, new marble plates were inserted above the capitals. The capitals and several parts of the main arch were partly reconstructed. All medieval mouldings were cleaned, but the method is unknown. New marble columns were also put in place (fig. 17.2).⁷ As in the rest of the nave Bjørnå and Solerød soapstone and Portland cement or lime cement mortars were used for most of the measures mentioned above.

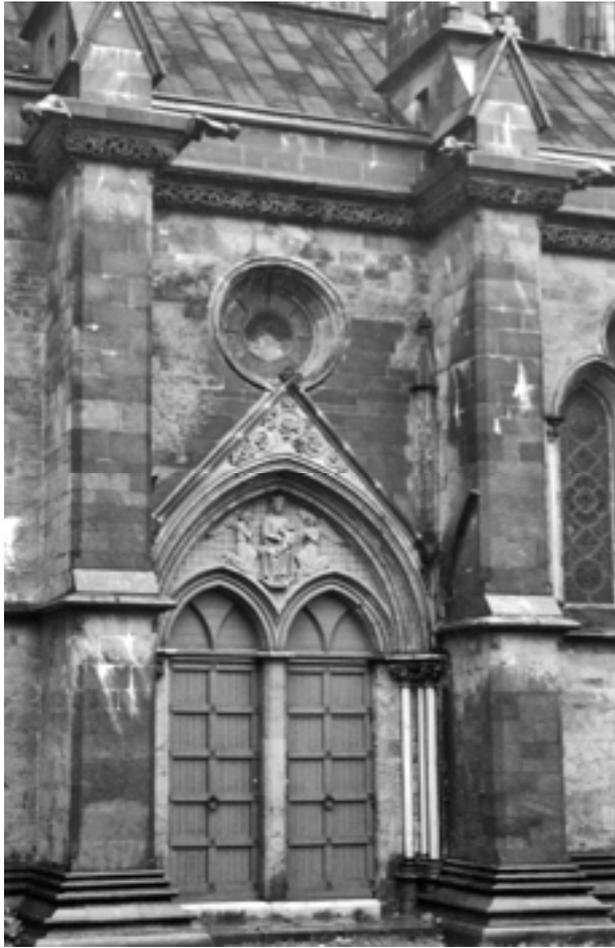
Fig. 17.4: *St. Mary's portal in the autumn. Picture taken during a gale in October 1992. Note the parts which are protected from rain, especially the east side beside the columns (photo: PS).*

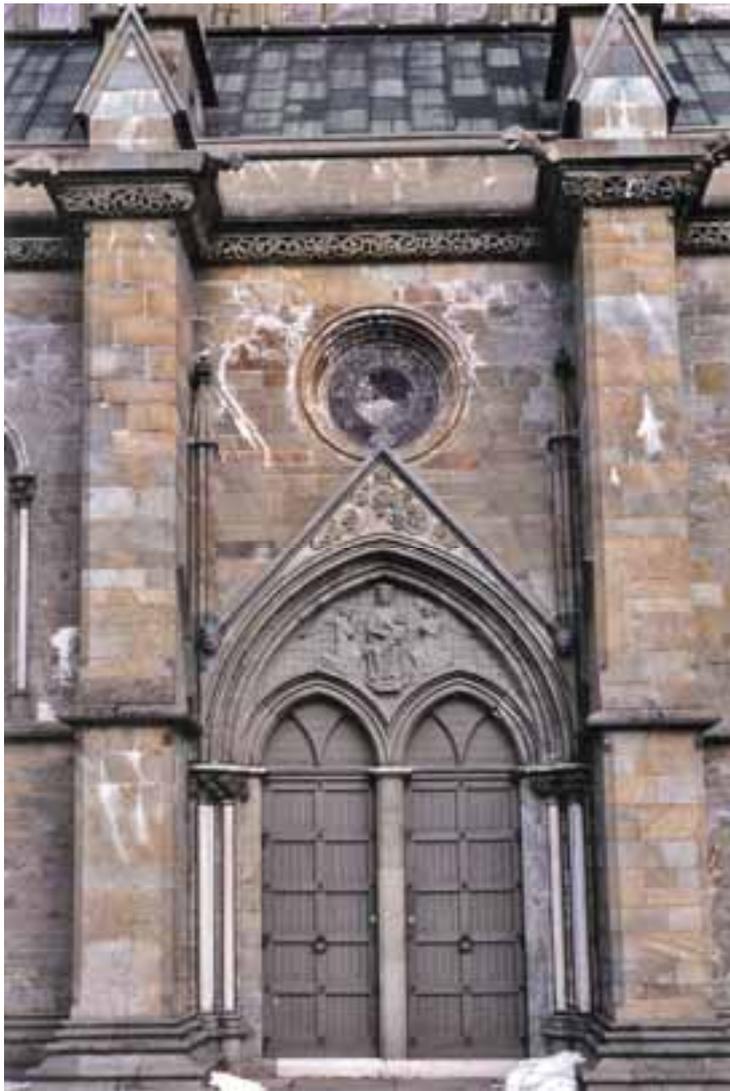
It is worthwhile to remember that the nave's gangways and parapets have been problematic since they were finished before 1930. In chapter 12 it was shown that the general situation of the nave is characterised by the occurrence of alkaline salts just below the parapets (fig. 17.6). Problems with leaks and salts can be traced back to cracks formed as a result of differential settlement after the erection of the west towers in the 1960s.

Fig. 17.6: *St. Mary's portal in spring (March 1994). The masonry has dried out and there are large amounts of salts below the parapet as well as beside the marble columns (photo: PS).*

The salts appear (as usual) in dry winter, spring and summer periods (fig. 17.6), tending to disappear in humid autumn weather and obviously during condensation events (fig. 17.5). They often reappear at different places during dry weather periods and sometimes they are even completely absent in very dry weather. This phenomenon is ascribed to the fact that lashing rain (fig. 17.4) is sometimes able to remove salts provided during particular events of water leakage or run-off. Hence, the salts may be transported down the wall to the portal itself.

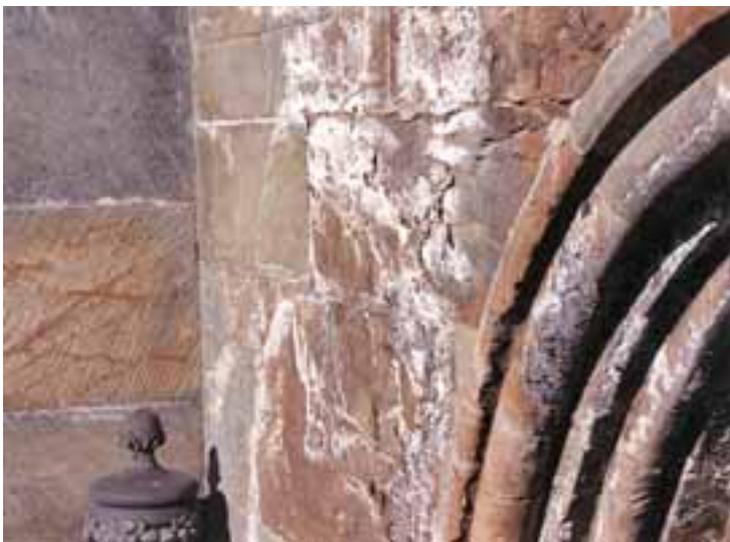
The weathering of the semi-sheltered area above and around the circular window is characterised by flaking and exfoliation. It is usually the outermost, burnt layers (brown colour) that tend to exfoliate, whereas the stone underneath shows granular disintegration (fig. 17.7). Between 1990 and 1997 some flakes have been lost and it seems for the first time that replacement stones also start to weather actively. Alkaline salts (sodium carbonates, apthitalite) originating from leaks in the gangway above, as well as from joint fissures in the cornice below the parapet must be regarded as the main cause of the weathering. However, it is not possible to rule out the action of frost (due to occasional severe leaks).

Fig. 17.7: *Dry spring weather. Efflorescences mainly of thermo-natrite and flaking of burnt medieval soapstone (photo: PS 4/94).*

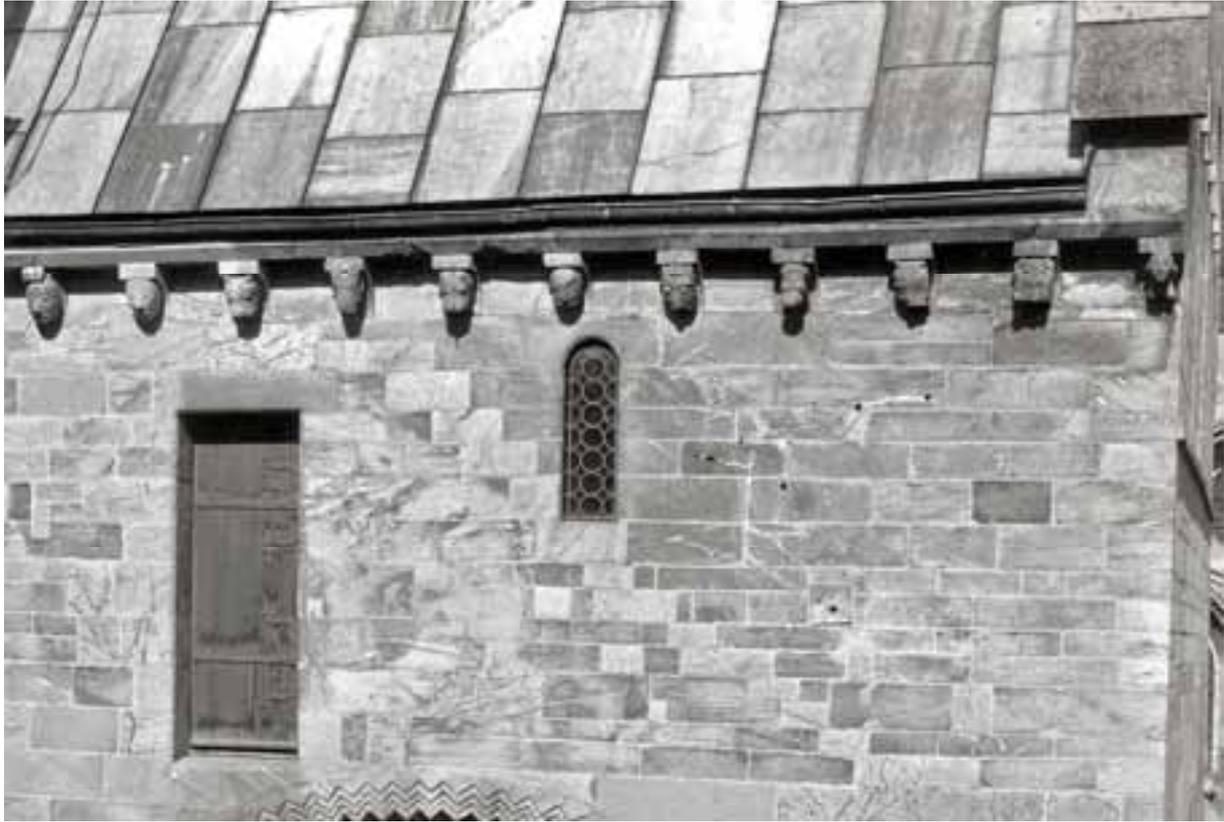
Fig. 18.4: *St. Olav's chapel in c. 1920. Note the distinct colour differences of the masonry. The darker colour (brown) is a result of fire, showing that there must have been an exterior wooden staircase which burnt in the Middle Ages. Several ashlar were replaced during the restoration in c. 1880. All the corbel heads, except the easternmost one, show distinct traces of fire. Note also the limited extent of black crusts on the masonry (photo: ARW, no. 2632).*

A photo taken in the 1920s (fig. 18.4) shows that very little has happened to the corbels since the restoration. Some black crusts have formed on ashlar below the easternmost part of the cornice, but not elsewhere. The reason why black crusts have accumulated in this particular area must be related to the frequently moist conditions here. The area appears, however, not to receive enough rain for the crusts to be washed away.

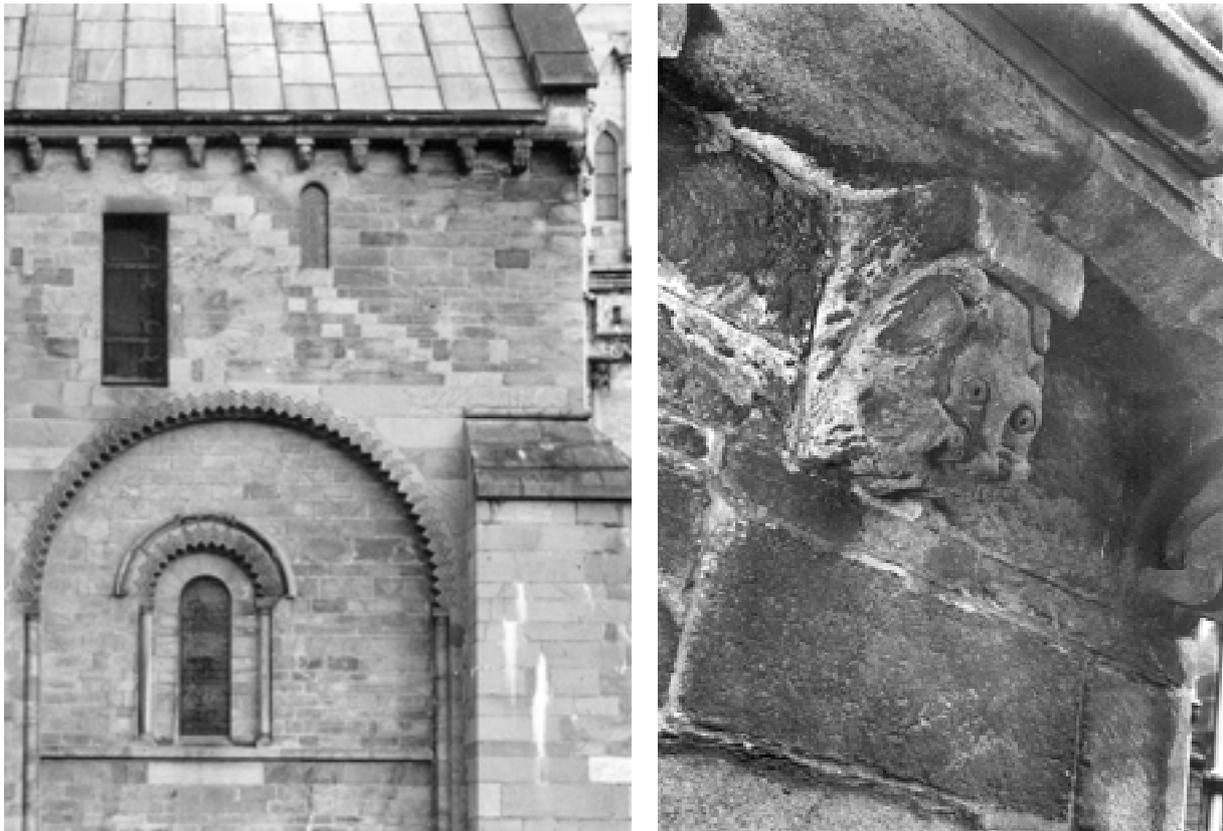
Fig. 18.5: St. Olav's chapel, probably in the 1960s. Left: The black crusts on the easternmost part are more widespread than in the 1920s. Note that the lower copestone of the gable appears to have an open joint. There is also a white calcite crust just below, indicating that water has been seeping through the joint system and affecting the easternmost corbel heads (photo: ARW, no. 7011). Right: Close-up showing white patches (salts) along joints and on the corbel (photo: ARW).

The extent and intensity of the black crusts increased towards the 1950s and 1960s (fig. 18.5). Now it is also evident that they cover some of the corbels themselves. A more important observation is that the joints (based on Portland cement) around the lowermost copestone of the gable are open and that white calcite crusts have formed just below.

Thus, it seems that run-off carrying alkaline salts has directly affected the easternmost corbels. Water may also have been seeping into the joint system around the beams above the corbels, carrying alkaline salts into the masonry (fig. 18.5). In this connection it should be noted that during the last five years occasional observations revealed a great deal of salt efflorescences on the masonry during dry weather periods.

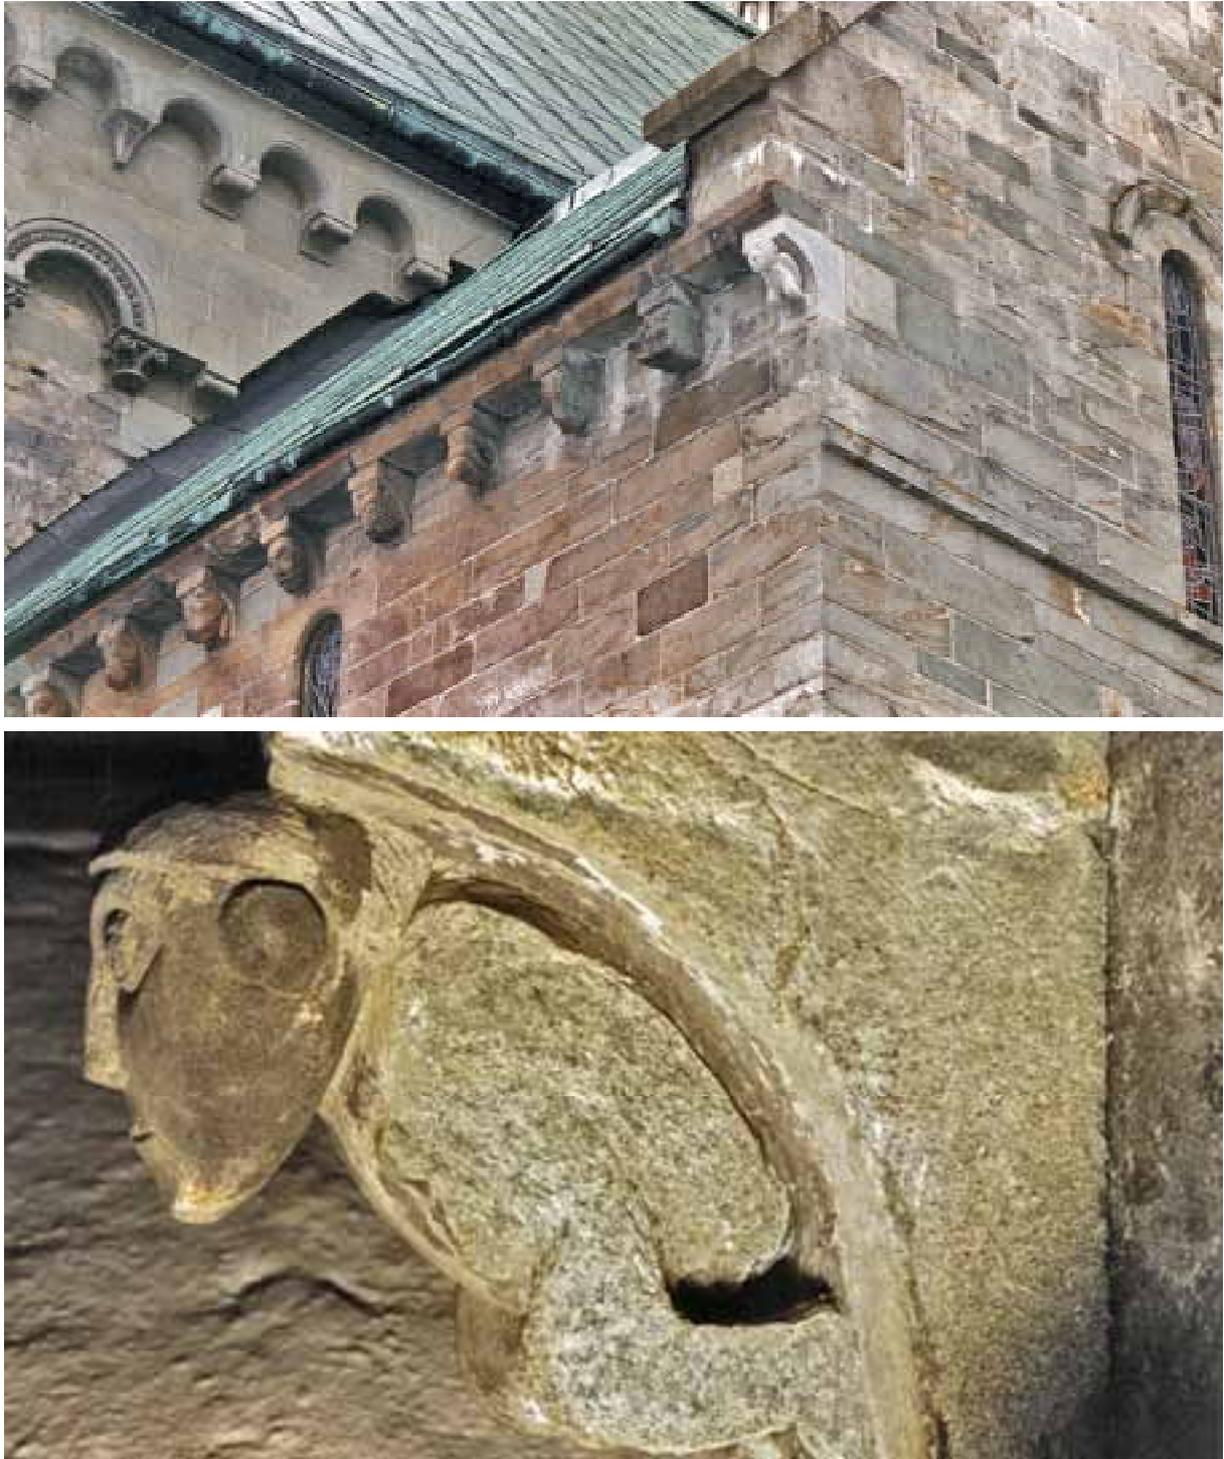
The two corbels next to the easternmost one had lost large fragments by 1990. Therefore, it is evident that the severe loss of material took place chiefly between 1960 and 1990. Since 1990 very little has happened (fig. 18.6).

Fig. 18.6: Top: St. Olav's chapel in September 1995. The gable was restored (stone replacement, repointing) in 1983, while the easternmost corbel was replaced by a copy in 1993 because it was strongly weathered. Note that the extent of black crusts has decreased since the 1960s and that there are some specific light traces beside the easternmost corbels. The traces originate from silicone applied onto the corbels in order to make plaster copies in the 1980s. Below: The original easternmost corbel has lost one side and is partially covered by black crusts. It can presently be seen in the museum collections (photos: PS).

In the early 1980s the copestones on the gable were in such a bad state that some of them had to be replaced. The joints were simultaneously repointed (Portland cement mortar), whereas plaster copies were made of the three easternmost corbels.⁶ 10 years later, in 1993, the outermost corbel was in such a bad condition that it was replaced by a copy carved in Bubakk soapstone.

It is certainly possible to propose less drastic solutions than to completely re-restore the roof. However, in order to let the corbels survive for a prolonged period of time, it is absolutely necessary to protect them far better from rain and snow than today. It is probably also necessary to remove remaining black crusts on parts of the corbels. Consolidating or even painting the corbels should also be considered.

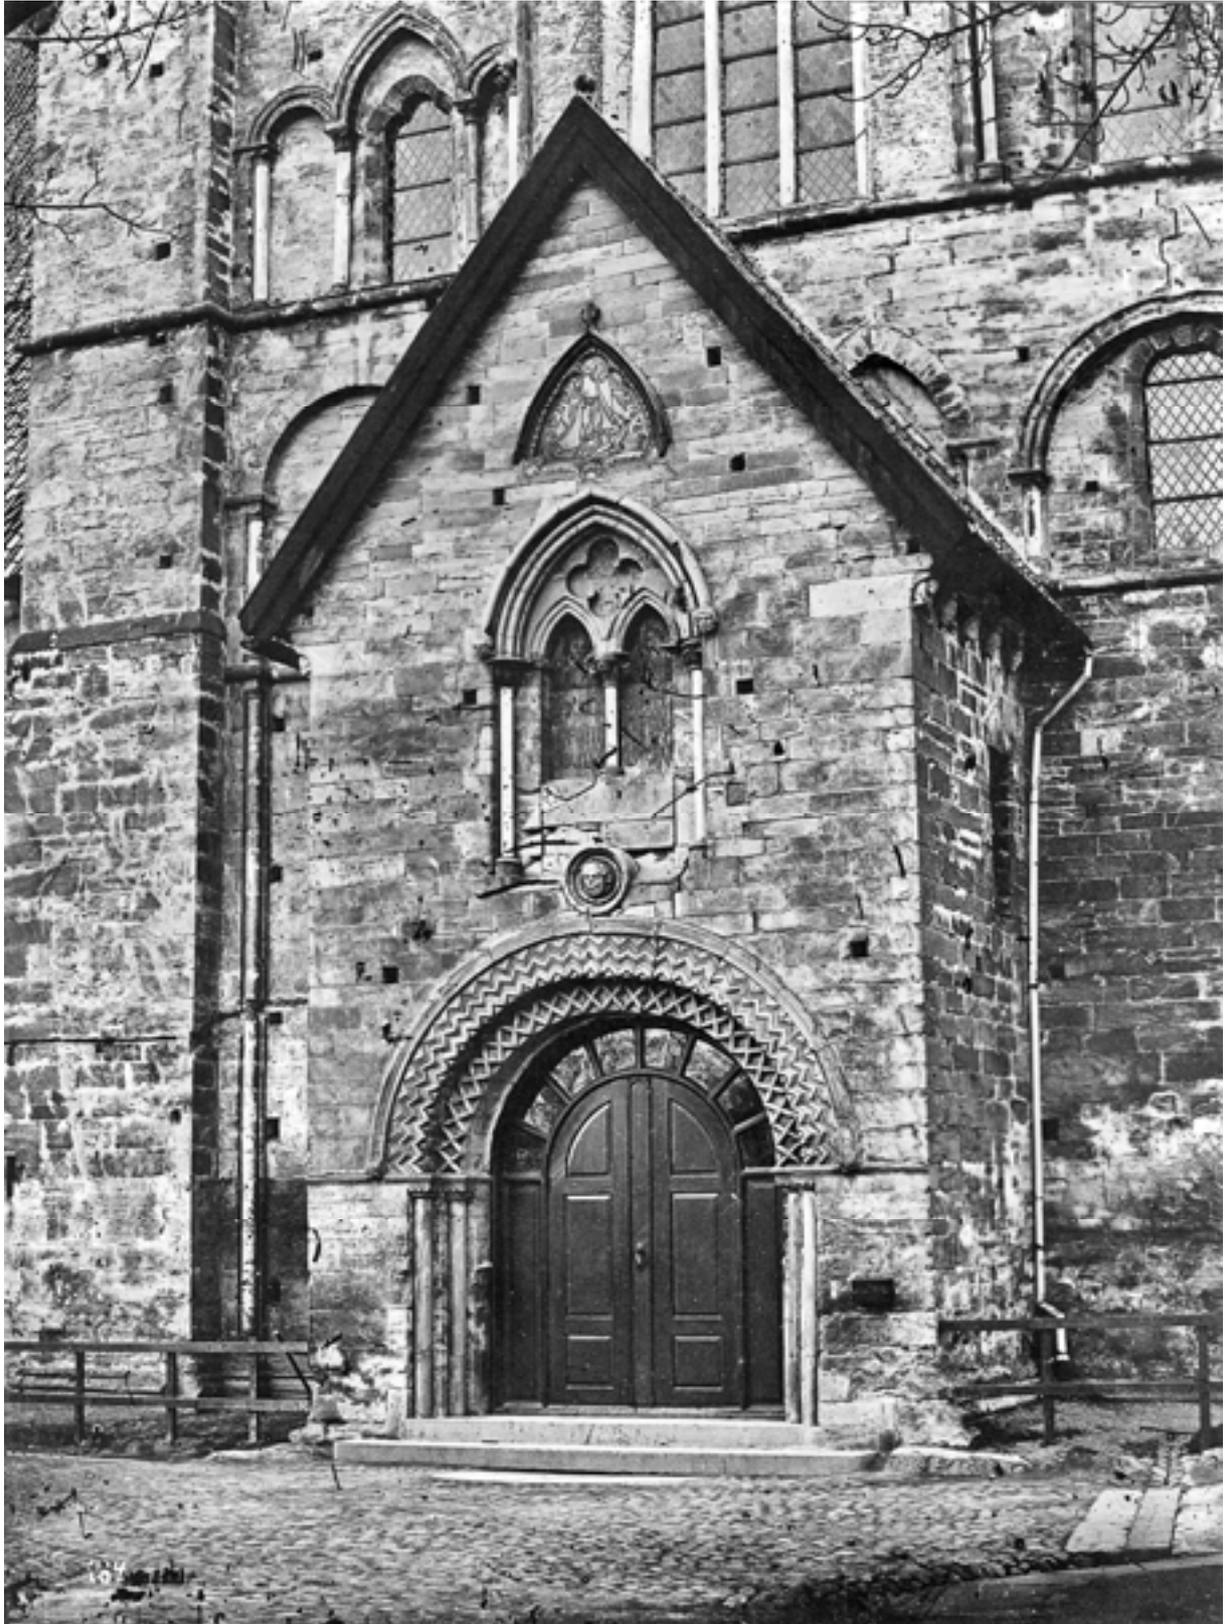
Fig. 18.7: St. Michael's chapel and the north porch. Condition before the restoration (c. 1870). Note that the tile roof, possibly constructed after the fire in 1719, is effectively protecting the Romanesque corbel heads from precipitation (photo: ARW, no. 184).

Otherwise, most of the issues mentioned in chapter 18.1 should be considered when interpreting the weathering situation and weathering rates. Even though the circumstances are more complicated than in St. Olav's chapel, there is little doubt that the change of roof design during the restoration (fig. 18.7) led to strongly increased weathering.
