The Stones of Nidaros

An Applied Weathering Study of
Europe's Northernmost
Medieval Cathedral

Dr. Ing. (Ph.D.) thesis no. 1997:92
Department of Architectural History
Norwegian University of Science and Technology
Trondheim, Norway

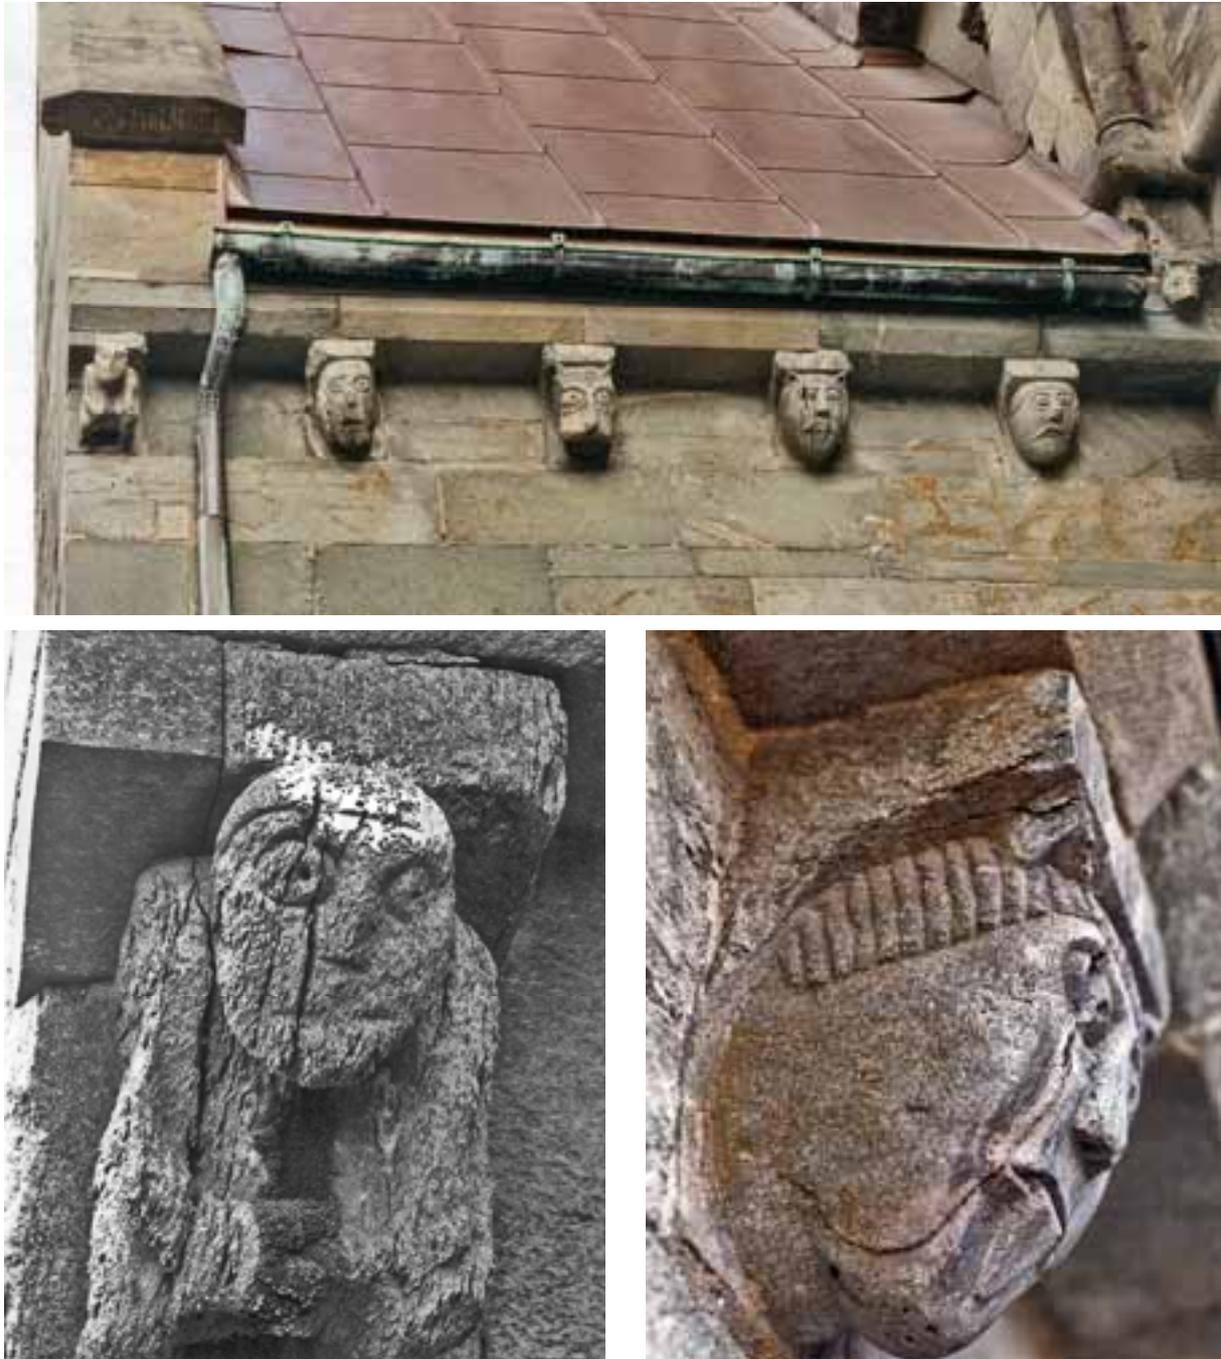
Fig. 18.8: Corbels in the western cornice of St. Michael's chapel. Top: The three outermost corbels are in a much worse condition than the other two (photo: PS 5/96). Left: The outermost corbel in 1961. Note the extensive delamination and the black crust below the head. The black crust has largely disappeared today, and the condition is otherwise slightly worse than in 1961 (photo: ARW, no. 7090). Right: Except for a major crack along a foliation plane, the second corbel from south is sound (photo: PS 5/96).

- The downpipes located in between the two easternmost corbels (see fig. 18.8) on each side may have had leaks affecting the corbels. In connection with this it should be mentioned that the copestones on the gable had to be repaired in 1984, mainly due to joint fissures and leaks.⁹

The most important feature of the present weathering situation is that the corbels in the western cornice are in a much worse condition than the corbels in the eastern cornice (fig. 18.8-9). Moreover, the most exposed corbels in the western cornice must be regarded as being hopelessly weathered when compared with the more protected ones (fig. 18.8). These features indicate that exposure to precipitation is the main factor governing the weathering rate.

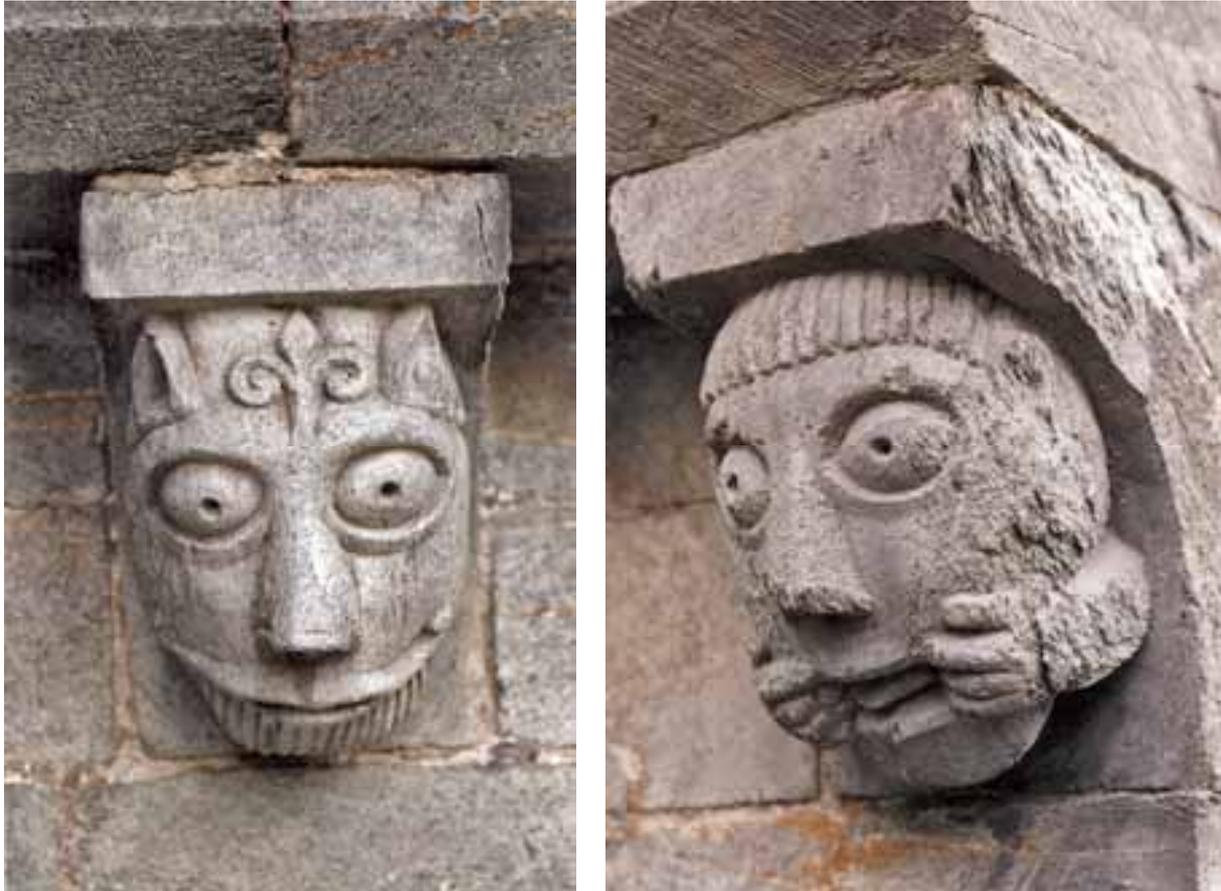
Fig. 18.9: Two corbels in the eastern cornice of St. Michael's chapel in August 1995. Left: The condition of the third corbel from north is excellent. Right: The outermost corbel just below the gable copings is quite good, but pronounced delamination has taken place at the most exposed places (photos: PS)

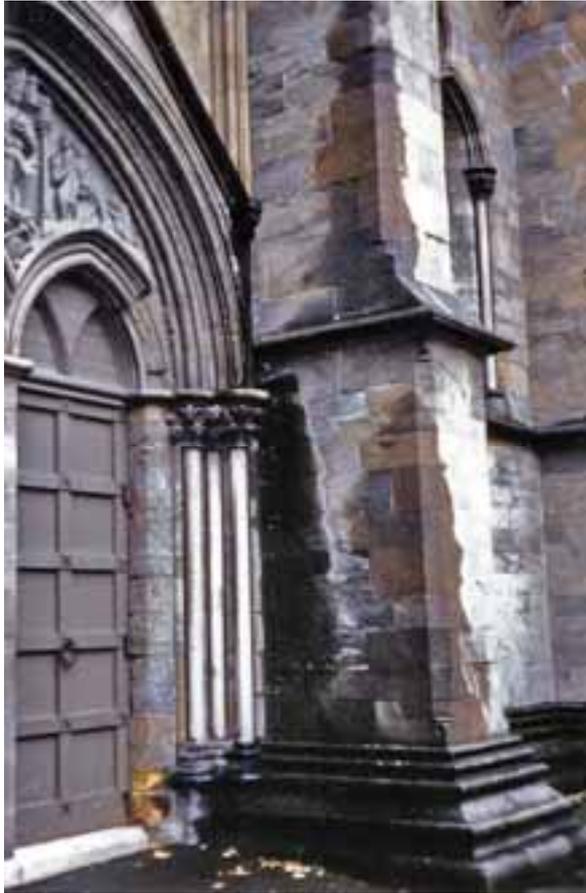
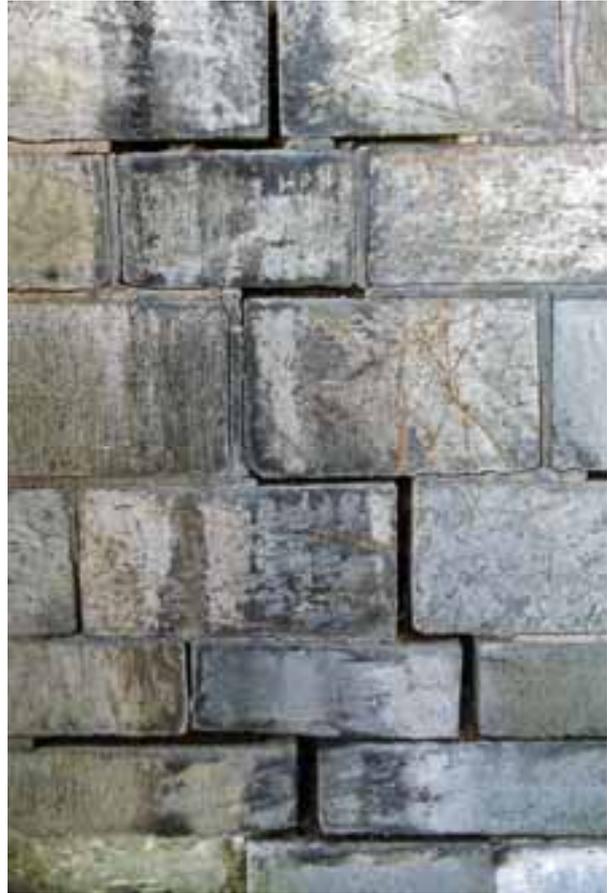
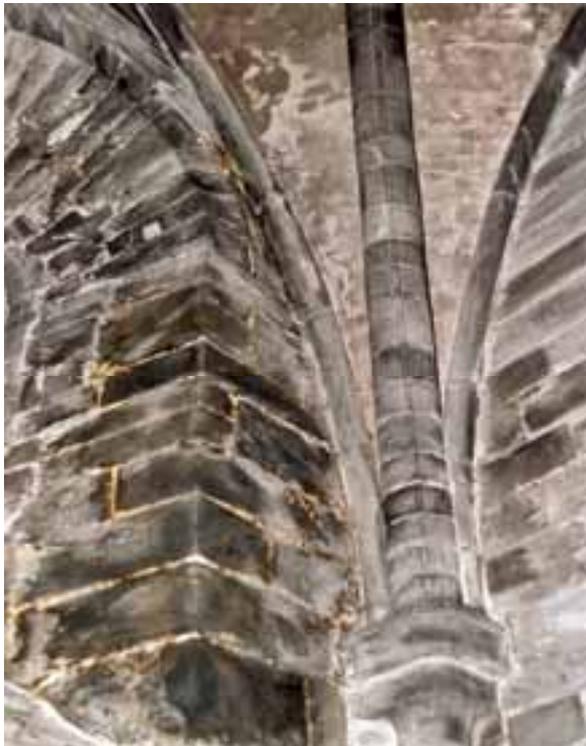
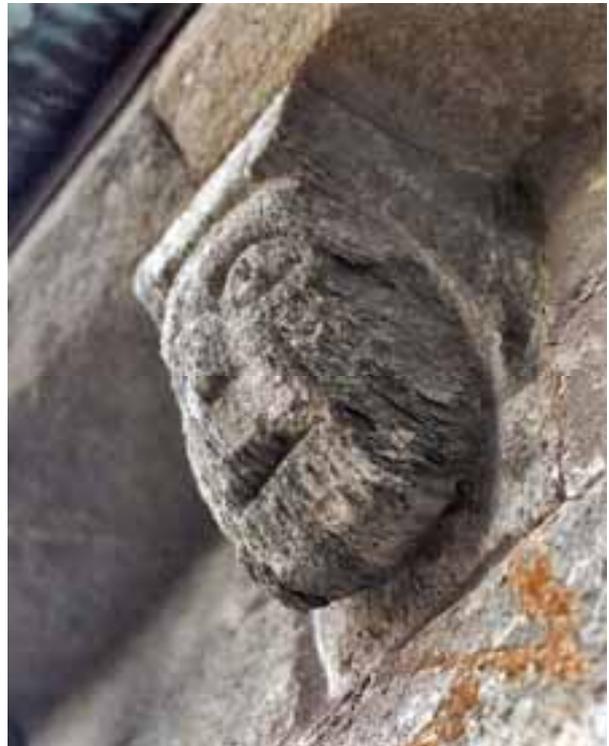
Fig. 19.1: Typical problems at Nidaros - water, open joints, indoor salt weathering and decaying medieval sculpture. Top left: St. Olav's portal (1995); top right: north turret of the choir (1991); left: chapter house (1995); right: St. Michael's chapel (1996) (photos: PS).

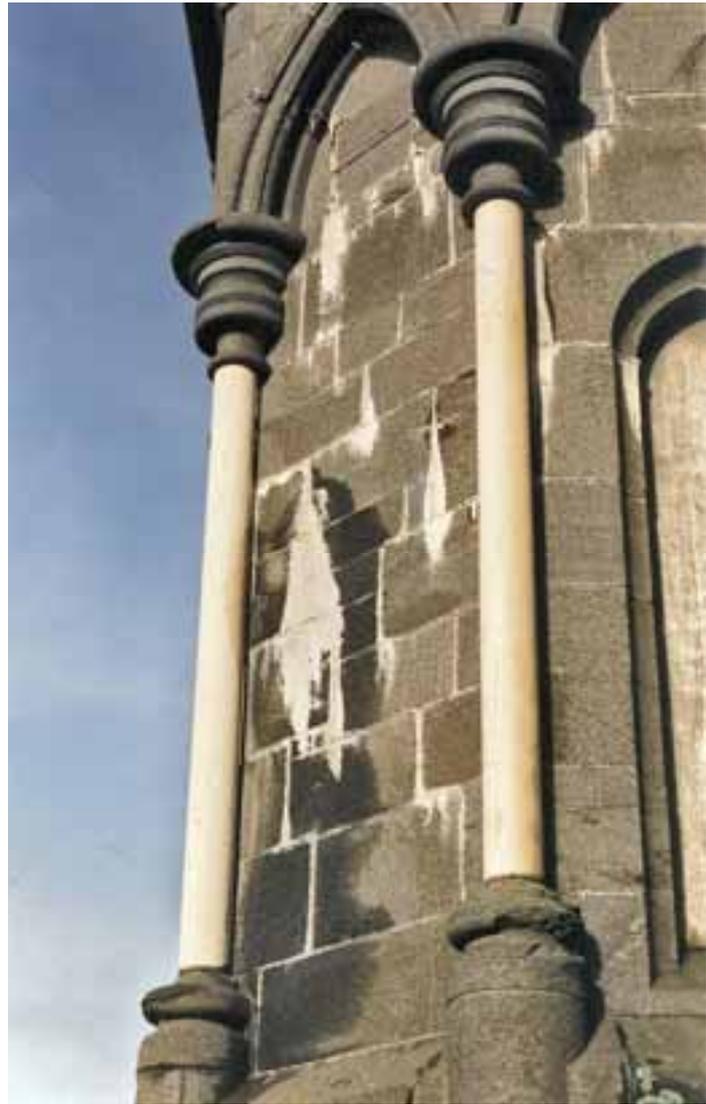
Almost without exception, the stone capped towers have major deposits of calcite below their cornices (fig. 19.3). The deposits are frequently so large that they seriously disturb the architectural character. Calcite crusts also prevail inside several towers, indicating the severity of the leaks. In addition, enormous amounts of soluble carbonates (natrite/thermonatrite, trona) have accumulated on the walls of the staircases immediately below the towers. Sulphates are not very frequent, and when they do occur, they mostly originate from the Portland cement as well (aphthitalite, some mirabilite and thenardite). Apart from a few exceptions, the salts are associated with extremely rapid weathering of ashlar. Grunnes soapstone is particularly vulnerable, but Bjørnå soapstone also shows serious weathering. Although leaks seem to be of particular importance for the weathering, effects of frequent condensation events should also be considered. Such phenomena have been observed, especially in the southern west tower.

Fig. 19.3: White calcite crusts on one of the central tower's small towers. Even though the weather was fair when the picture was taken, moisture arising from condensation runs down along the crusts. Generally, condensation - in addition to leaks - must be regarded as a significant cause of the white crust-problem at Nidaros (photo: PS 3/96).

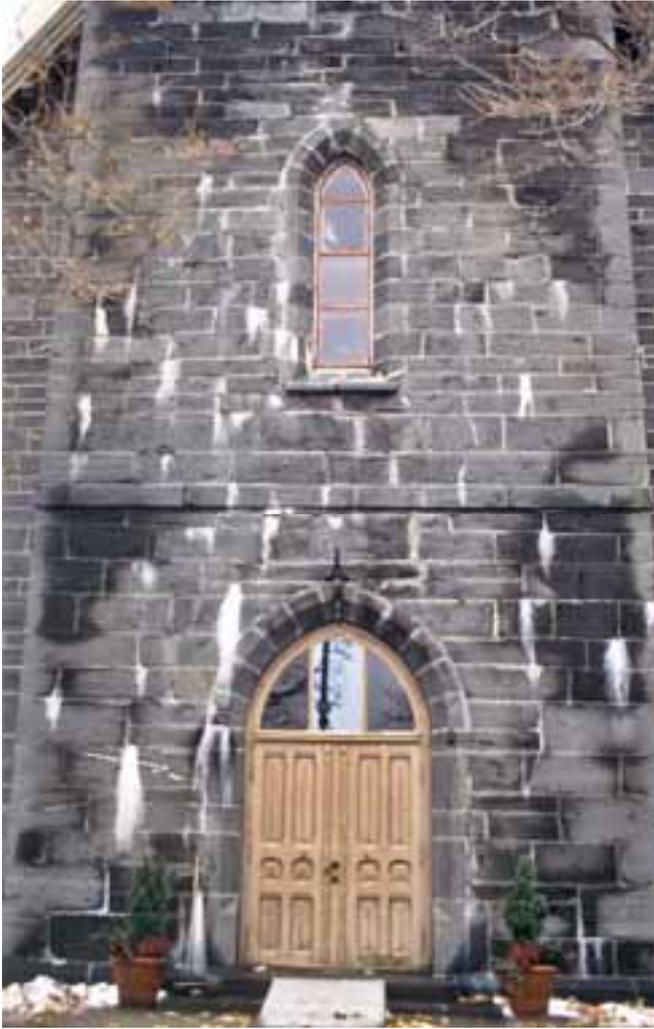
Fig. 19.4: White calcite crusts at the west tower of Orkdal church near Trondheim. The tower was built with local greystone and mortars containing Portland cement towards the end of the 19th century (photo: PS 10/94).

Nidaros cathedral is not the only building in the Trondheim region that suffers weathering problems due to the combined effects of the use of Portland cement mortars, joint fissures, leaks, condensation and alkaline salts. According to my investigations similar problems can be found at the Baroque tower (1740) of St. Mary's church,⁸ the towers of Neogothic stone churches such as Ilen (1889), Melhus and Orkdal (1893),⁹ and at Gulfossen stone bridge (1922) (fig. 19.4-6). The problem is also widespread in other parts of Europe.¹⁰

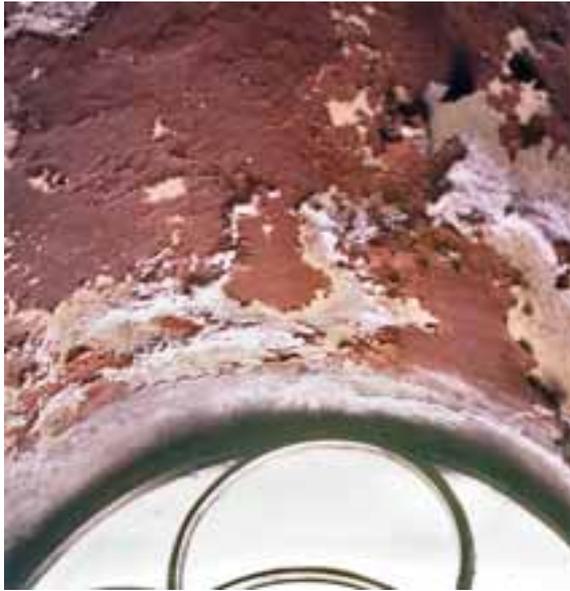
Fig. 19.5: Salt weathering problems at the west tower of the Neogothic Ilen church in Trondheim. Right: Although most calcite crusts seem to have been removed from the masonry, there are still numerous remains, seen as white patches. Above: Inside the tower there are enormous amounts of alkaline salts, sometimes giving rise to significant weathering problems (photos: PS 1994 and 1995).

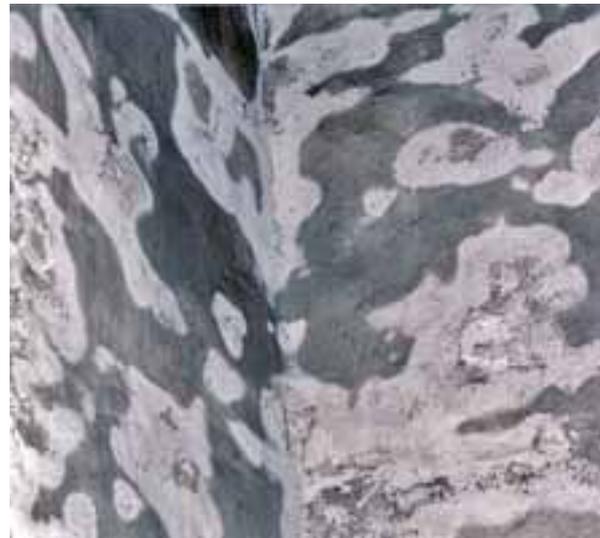
Fig. 19.6: Strange pattern of alkaline salt efflorescences inside the 18th century tower of St. Mary's church in Trondheim. Plaster containing Portland cement applied at the turn of the century has apparently led to moisture problems (photo: PS 6/96).

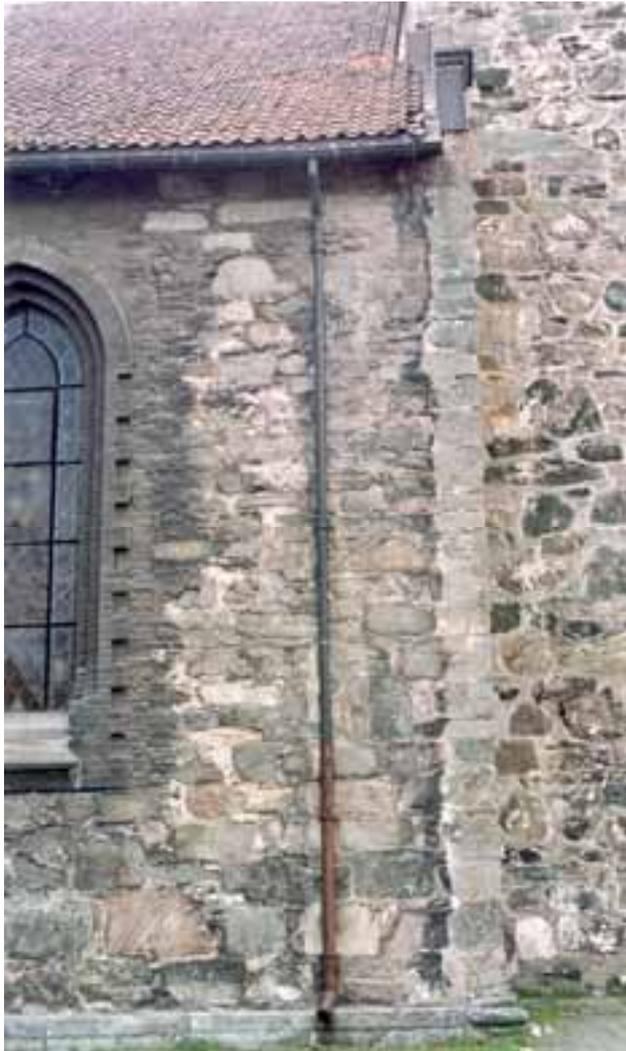
Fig. 19.7: Black crusts at the north wall of St. Mary's church in the city centre of Trondheim. The crusts prevail on lime mortar joints and whitewash around the windows, but are washed away at the corner of the wall (photo: PS 6/93).

A similar pattern can be found on several buildings in the city centre of Trondheim. The north façade of St. Mary's church has for example more black crusts than the south façade (fig. 19.7). However, the actual process of black crust formation is very complex in this particular case. Although it is unconfirmed, there is information indicating that plaster and whitewash were removed by *sulphuric acid* in the 1950s!¹²

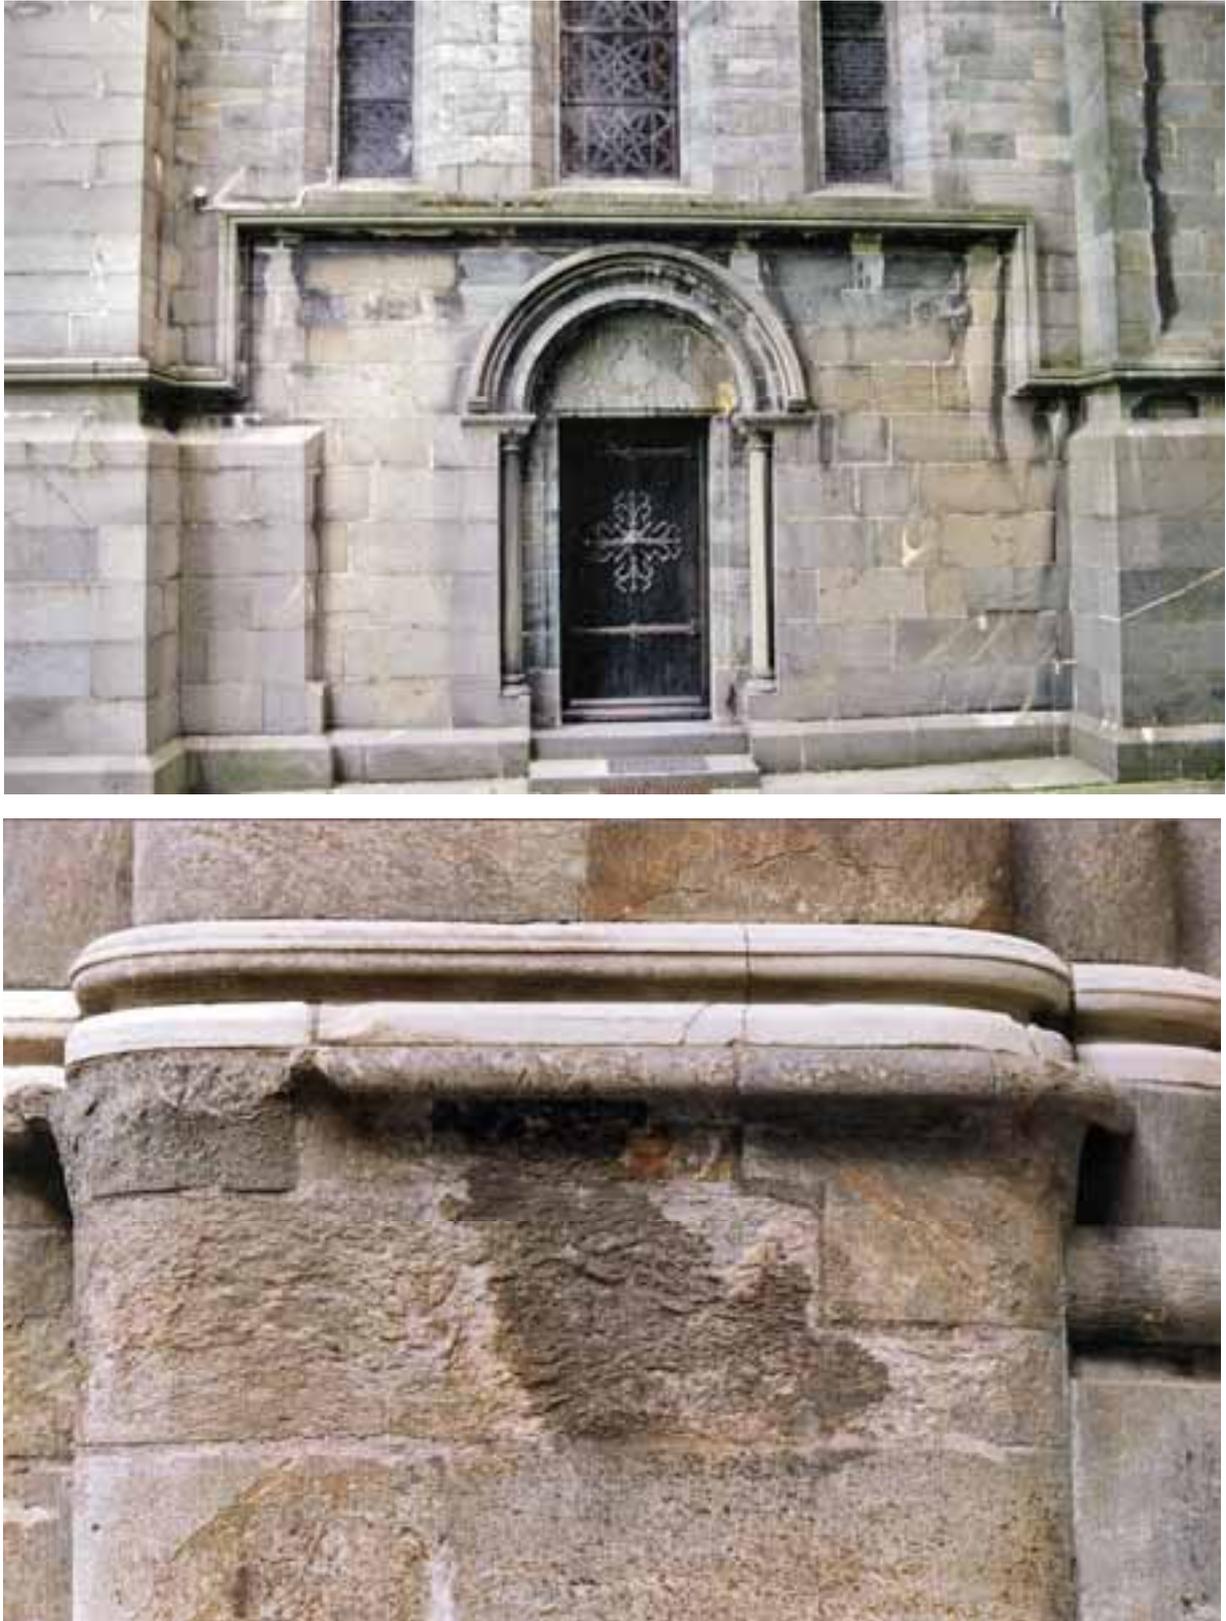
Fig. 19.8: Two different forms and origins of gypsum crusts at Nidaros cathedral. Top: At the west wall of the chapter house “normal” black crusts caused by air pollution prevail on the hard Hovin sandstone below the string course. Below: At the base of the King's porch on the south side of the choir grey gypsum crusts prevail on the sheltered part of a rather weathered Grytdal stone. An important reason why it is assumed that the crust originates from sulphides in the stone is that there are no other gypsum/black crusts nearby the area in question (photos: PS 1992 and 1996).

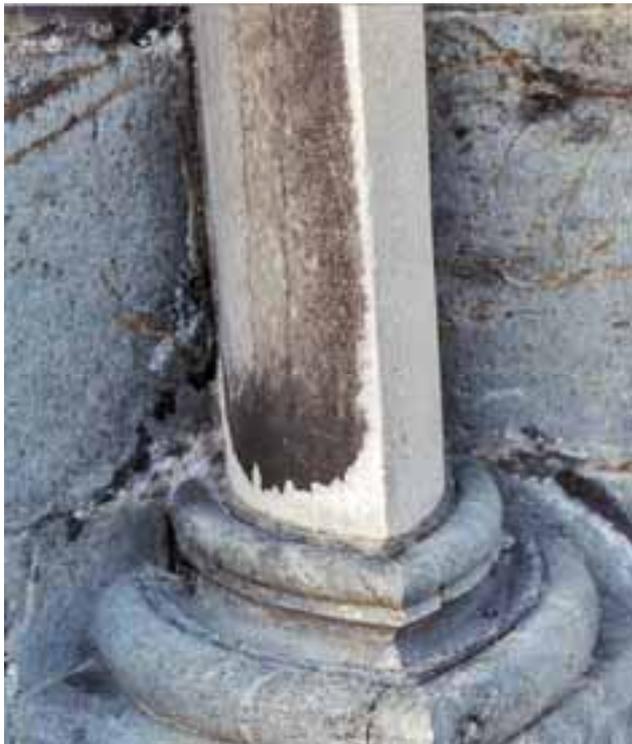
Fig. 19.9: North-east side of the octagon. Typical occurrence of black crusts on marble columns. The crusts are extremely thin and accumulate on sheltered sides and especially right above the zone of water splash (photo: PS 1997).

The presence of calcium is a prerequisite for the formation of gypsum. Calcite/dolomite in soapstones, greenschist, mortars and whitewash are key sources, but nowhere is the availability of calcium as great as in the marble columns of the cathedral fig. 19.9). Depending on actual exposure conditions, marble columns may be completely covered by black crusts. However, the general pattern of distribution - widespread black crusts at the eastern ends and little at the western areas of the cathedral - also repeats when marble columns are considered.¹⁶

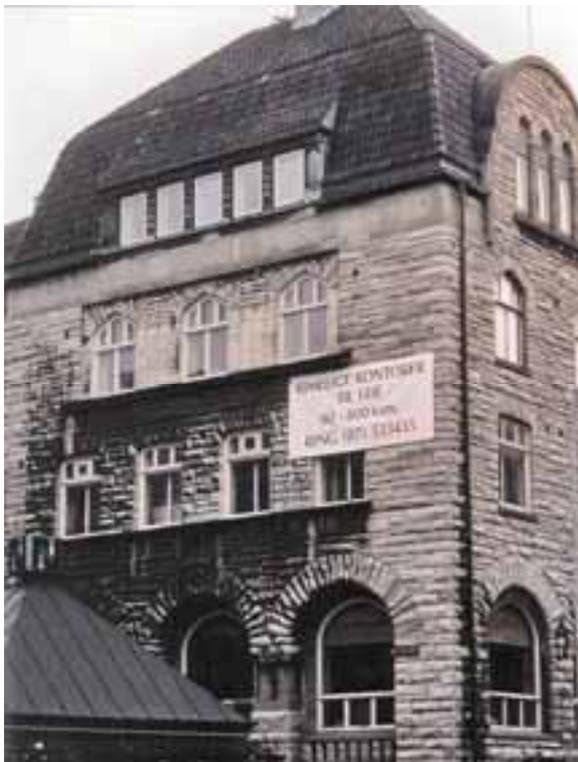
Black crusts have also formed at the two marble buildings in downtown Trondheim (located in Søndre gt.). Built at the turn of the century, the buildings are typical representatives of Norwegian rubble architecture.¹⁷ One of the buildings (*Gildevangen hotel*) was cleaned a couple of years ago, but the other one (formerly *Trondheim Handelsbank*) still shows large deposits of black crusts below projecting elements (fig. 19.10).¹⁸

Fig. 19.10: Large areas with black crusts below sills on the north side of former Trondheim Handelsbank in the city centre (photo: PS 5/94).

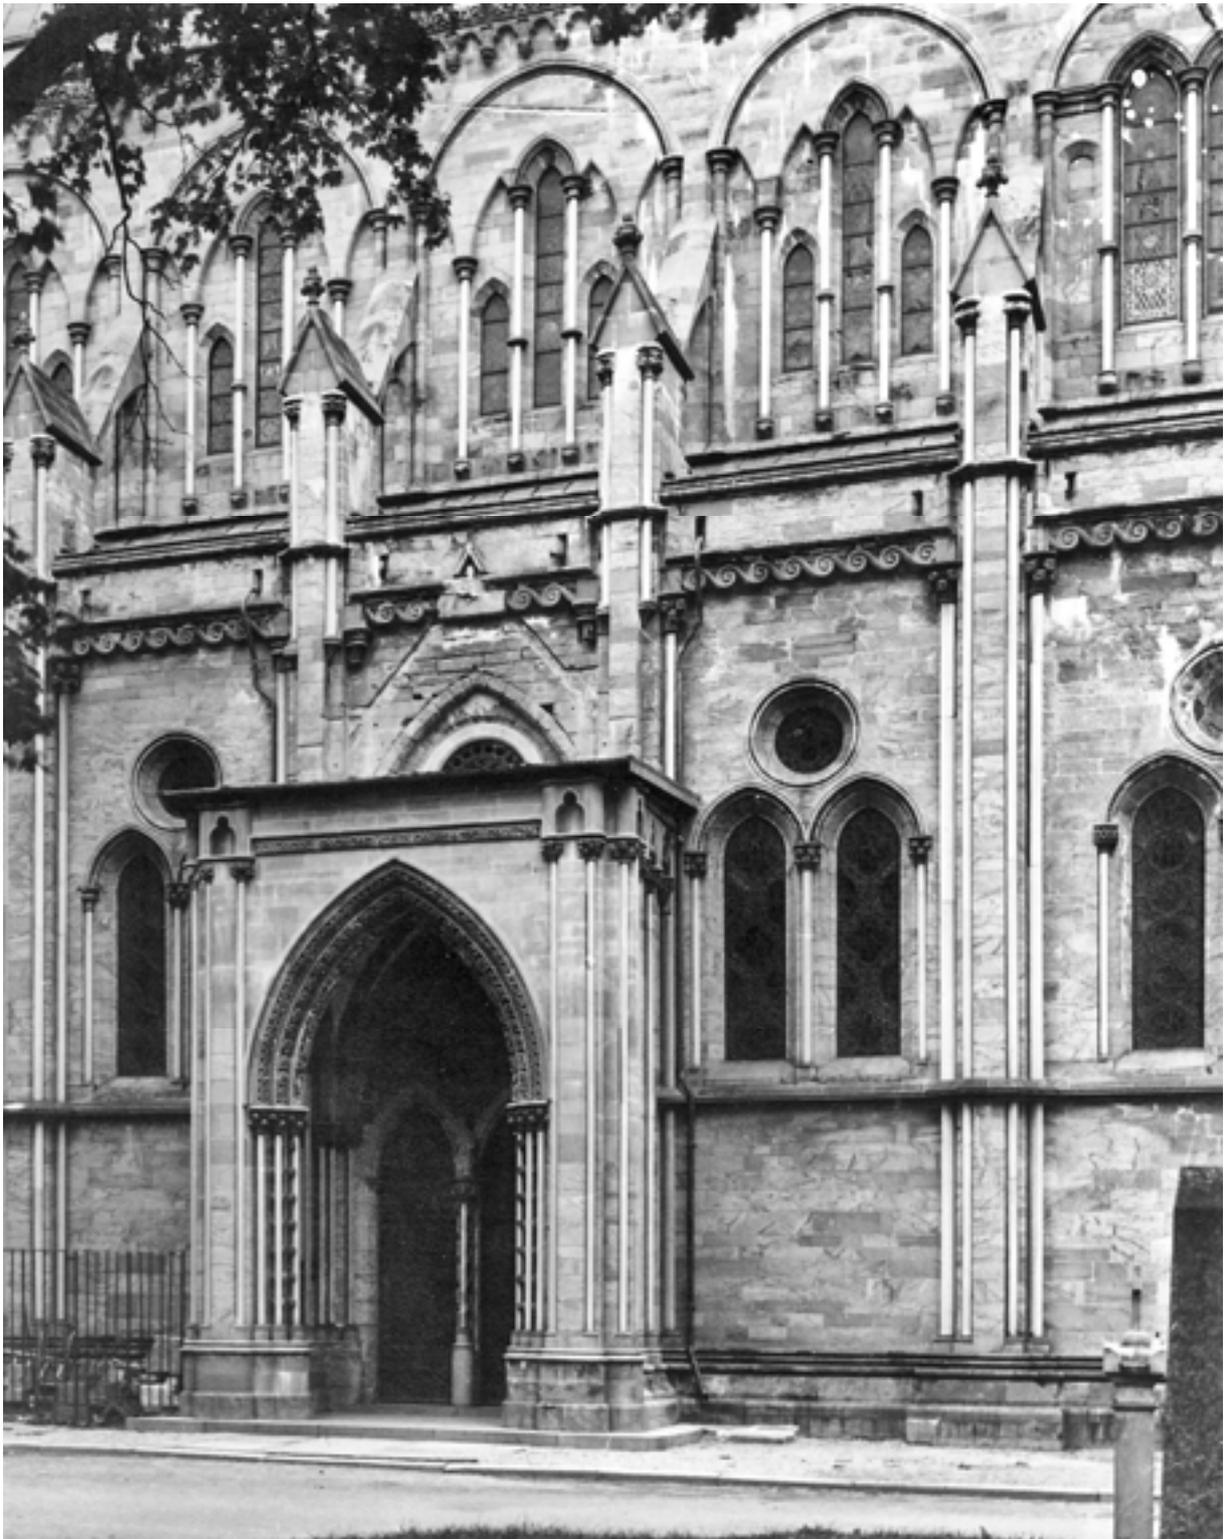
Fig. 20.1: In the 1950s the King's porch had to be partially demolished in order to secure the structure. Today the same problems as earlier have reappeared. Will it be necessary to once more demolish the porch? (Photo: ARW).

The greatest stability problems are without doubt to be found in the choir, including the King's porch which, in a worst case scenario, may be close to collapse. The eventual fulfilment of this scenario is strongly dependent upon whether the steel construction installed above the choir's main vaults in 1986 has been able to prevent the walls from inclining further outwards (chapter 5.3). In order to control the subsequent evolution, *the most urgent measure ought to be following up earlier measurements of deviation from the plumbline as well as of crack development.*² Moreover, recent investigations show that *the structure of the King's porch is so seriously damaged that comprehensive investigation, involving experts on structural behaviour of large masonry buildings, is absolutely necessary.*³

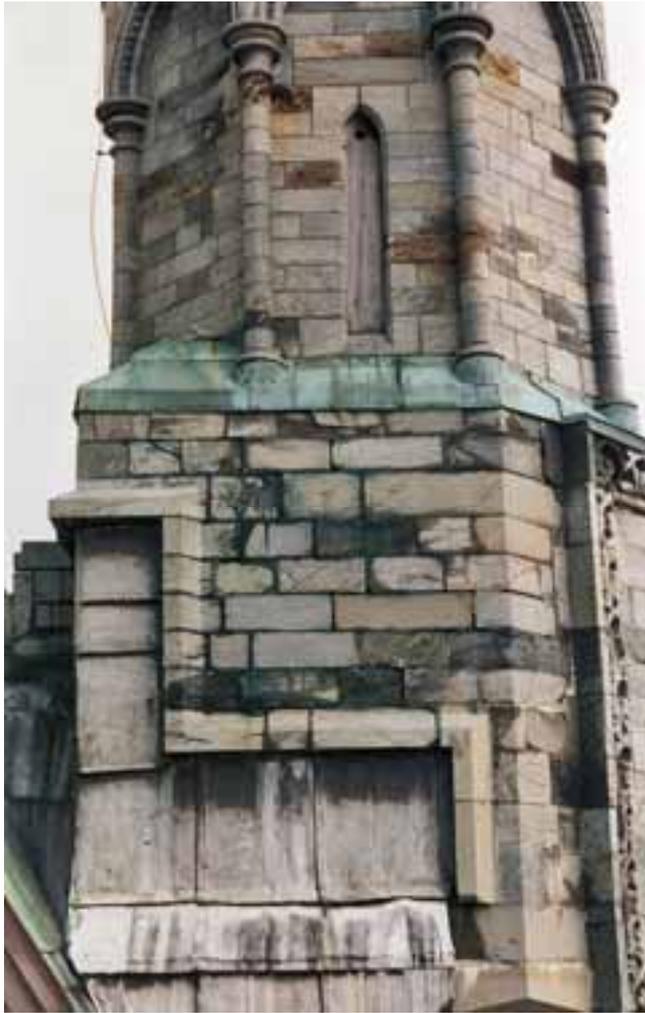
Fig. 20.4: For decades, copper and lead have been applied in order to prevent water leaks at the south turret of the choir of Nidaros cathedral. As can be seen, the copper cover is so poorly designed that water leaks nevertheless occur through all the open joints below (photo: PS 3/96).

Weather beaten architectural elements may also be protected by plates of copper, lead or zinc - traditionally a widespread solution to weathering problems even at Nidaros (fig. 20.4-5). In this case metal coverings may protect the stones themselves, but an equally important aspect is that they will prevent water leaks through joints/joint fissures which may be difficult to repair using mortar. Stone capped towers and cornices, which are notorious with regard to water leaks, are the primary candidates for such measures, but also stone capped gables, flying buttresses and parapets should be considered. However, due to complex architectural design, involving sculptured details, it is not always possible to apply metal coverings. Moreover, if such measures are used, one has to remember that they will change the architectural character of the cathedral. The risks of severe staining (e.g. copper salts) should also be considered.

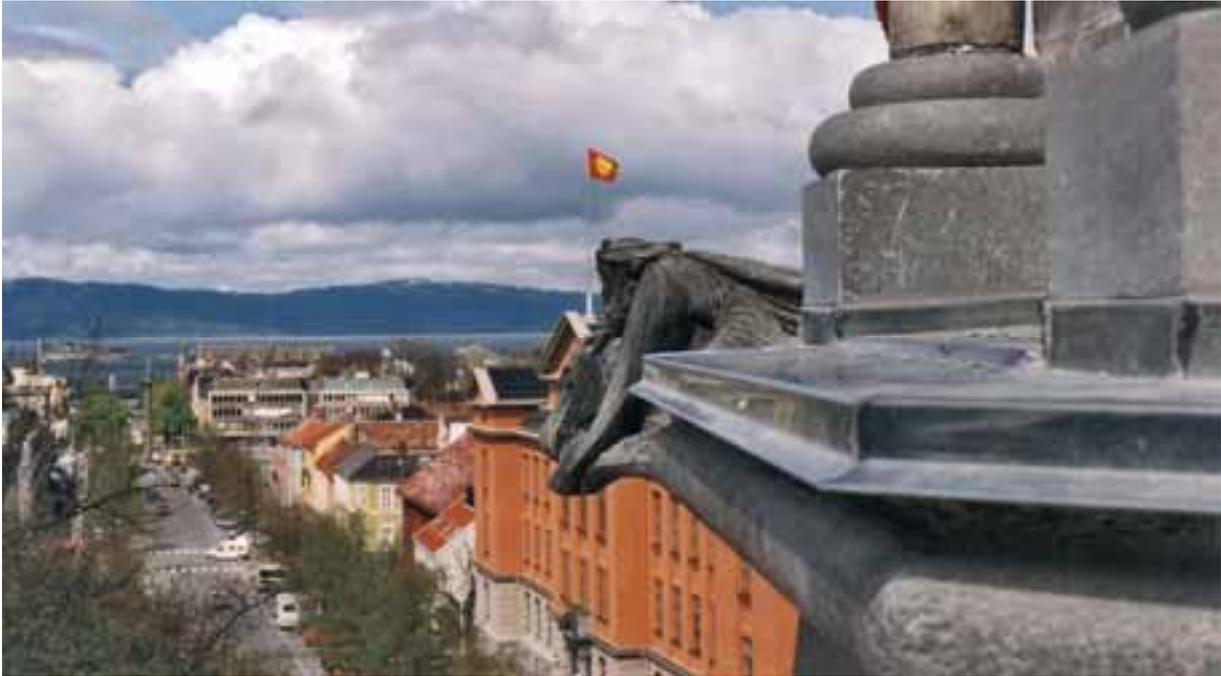
Fig. 20.5: During the recent restoration of the west tower of the north transept, zinc was applied in order to prevent water leaks from projecting cornices and rapid weathering of Bjørnå stone. It has not yet been verified whether this solution is sufficient (photo: PS 6/96).

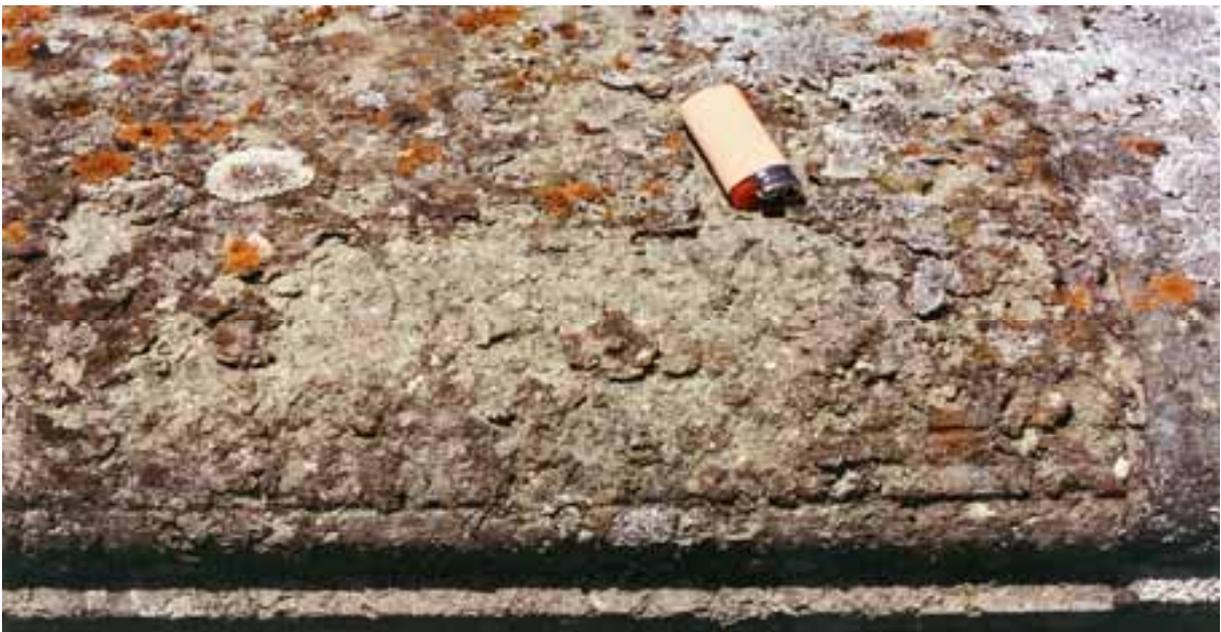
Fig. 20.6: Strongly weathered copestone of serpentine-rich soapstone from Bubakk at the southern west tower. It may seem that lichens enhance the weathering rate, and the question is whether they should be removed or not. Removal by mechanical means is out of the question in this case. Moreover, given the low porosity of soapstone, it is to be expected that biocides will be ineffective (photo: PS 6/93).

Most severely exposed elements at high elevations show intense growth of lichens together with flaking, pitting etc. (fig. 20.6). A relevant question is whether such growth should be removed in order to slow down the weathering rates. Removal might be undertaken by mechanical means, implying that flakes of stone will be lost simultaneously, or by applying

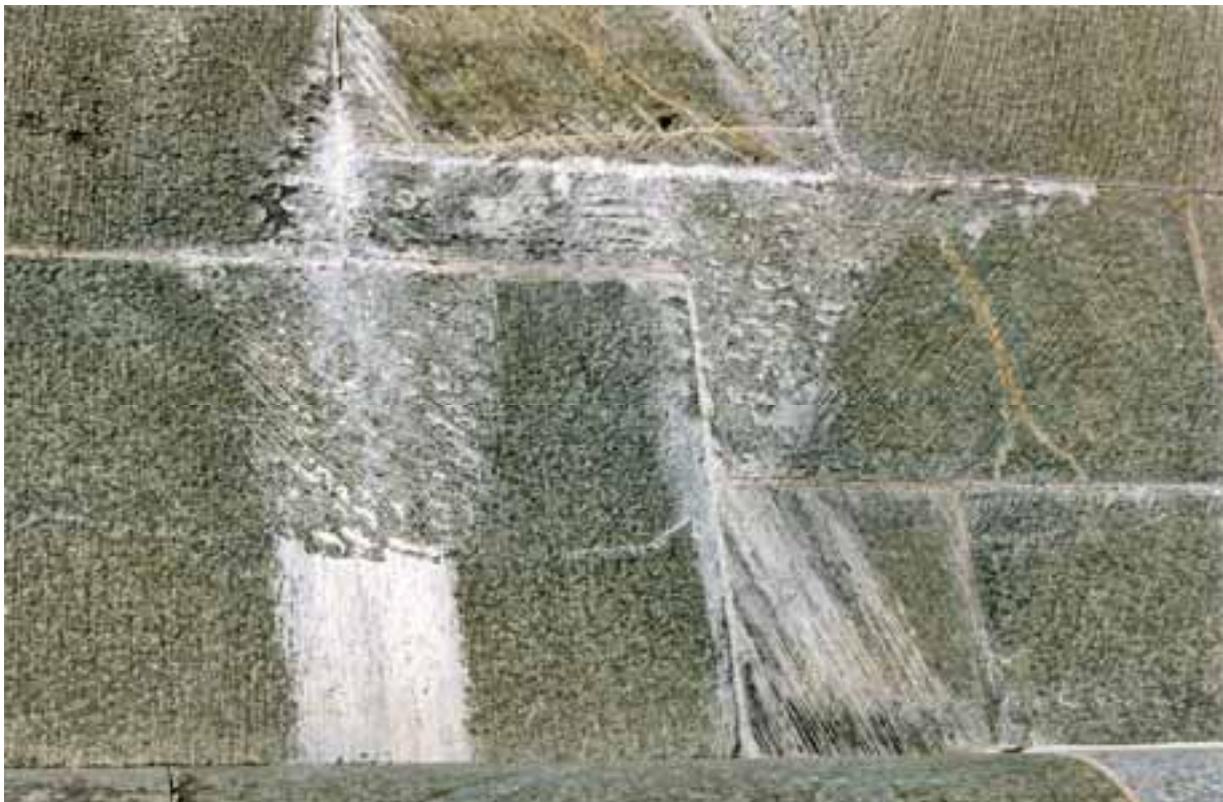
Fig. 20.7: An attempt at removing white calcite crusts with chisels was made on a buttress of the nave some years ago. As can be seen, the attempt was unsuccessful, implying that other methods should be sought (photo: PS 5/96).

One of the most characteristic features of the cathedral as a whole is white calcite crusts. Being excellent indicators of former and present water leaks, the crusts are not causing any particular harm to the stonework, but they may seriously distort the architectural character of many façades. They are on the other hand most significant from the perspective of age values and have become true historic documents of the “Portland cement cathedral”. Should they be removed or not? It is relatively simple to remove calcite crusts by chemical means (for example by diluted acids), but it may be difficult to assess the consequences of such treatments. Mechanical means are not particularly effective, insofar as underlying stonework will have to be redressed in order to completely remove the white patches (fig. 20.7). Perhaps modern means such as micro air abrasive cleaning and laser cleaning should be tested?¹²

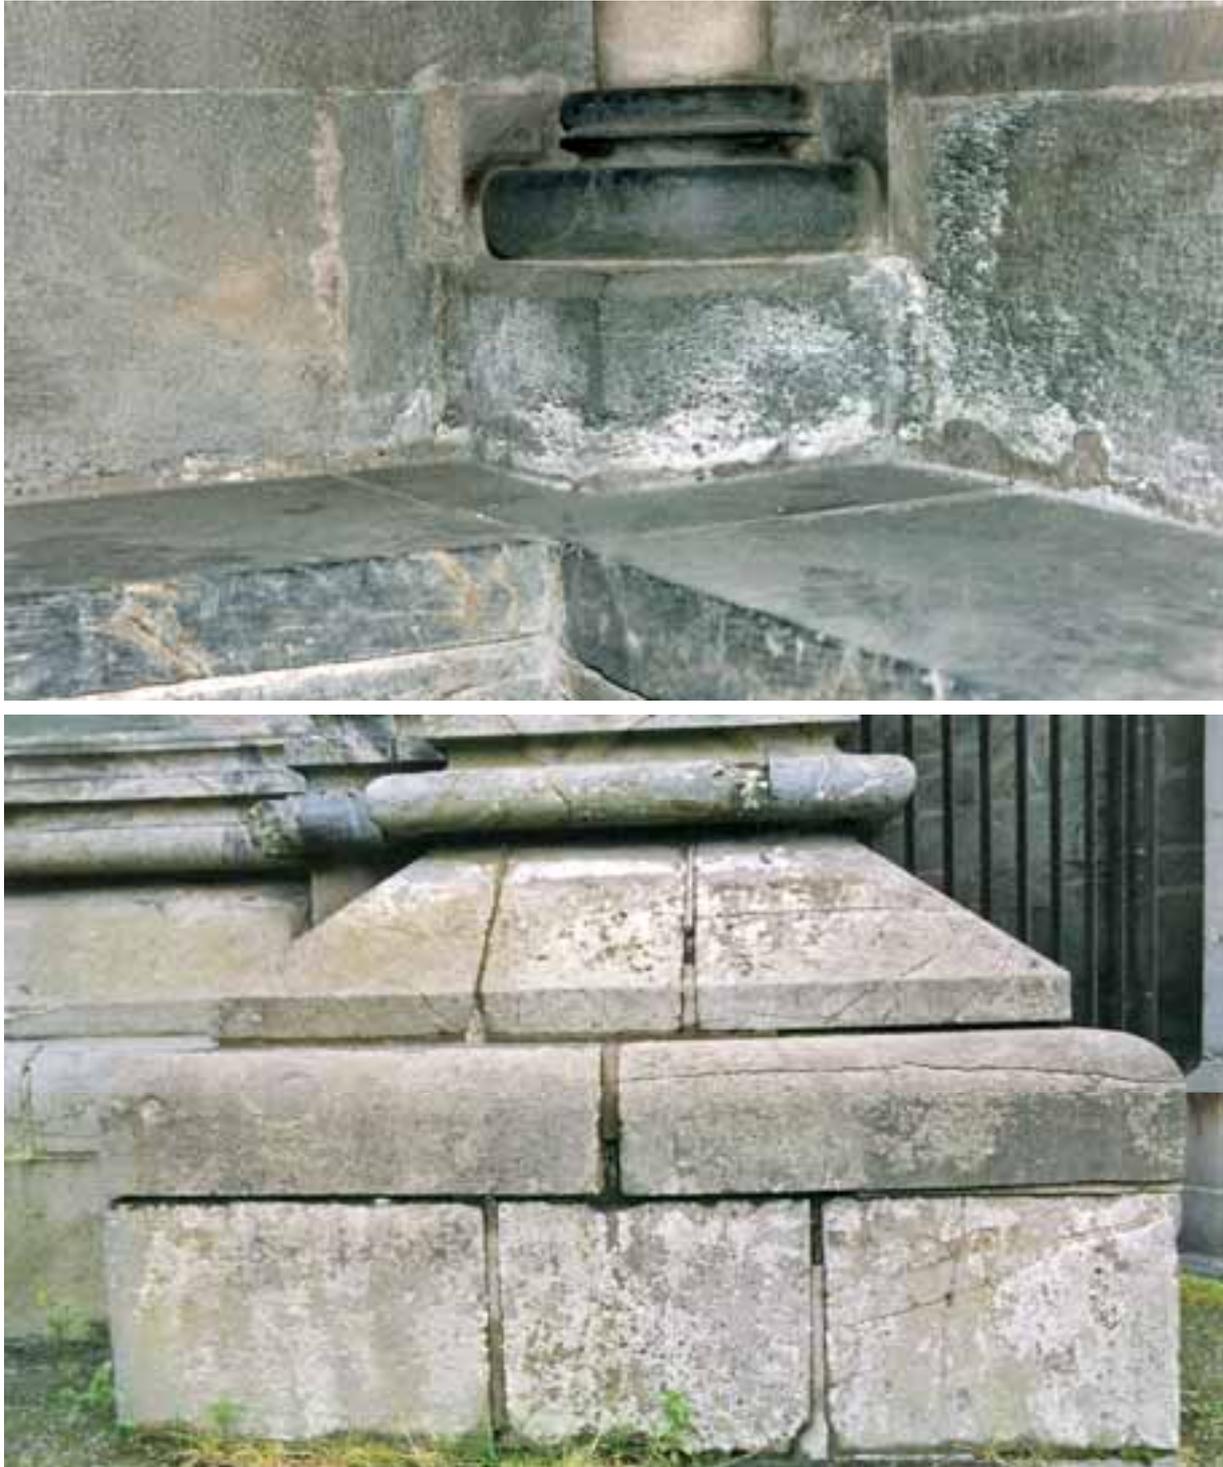
Fig. 20.8: The salt weathering proceeds very slowly along the base in the octagon (above), but in order to reduce the rate even more, joint fissures in the exterior base (below) should be repaired (photos: PS 1993 and 1990).

Salt weathering problems in the zone of rising damp are restricted to the transept and the octagon. The weathering proceeds so slowly in the octagon that there is no need for specific *direct* conservation measures. However, in order to reduce the weathering rates even further, *it would be wise to repair the numerous joint fissures in the exterior base, from which the moisture originates* (fig. 20.8).

Another wise idea would be to keep downpipes in good repair, preventing rain water channelling directly onto bases with joint fissures. The downpipes are at present not connected to the closed drainage system around the octagon. Perhaps they ought to be re-connected?

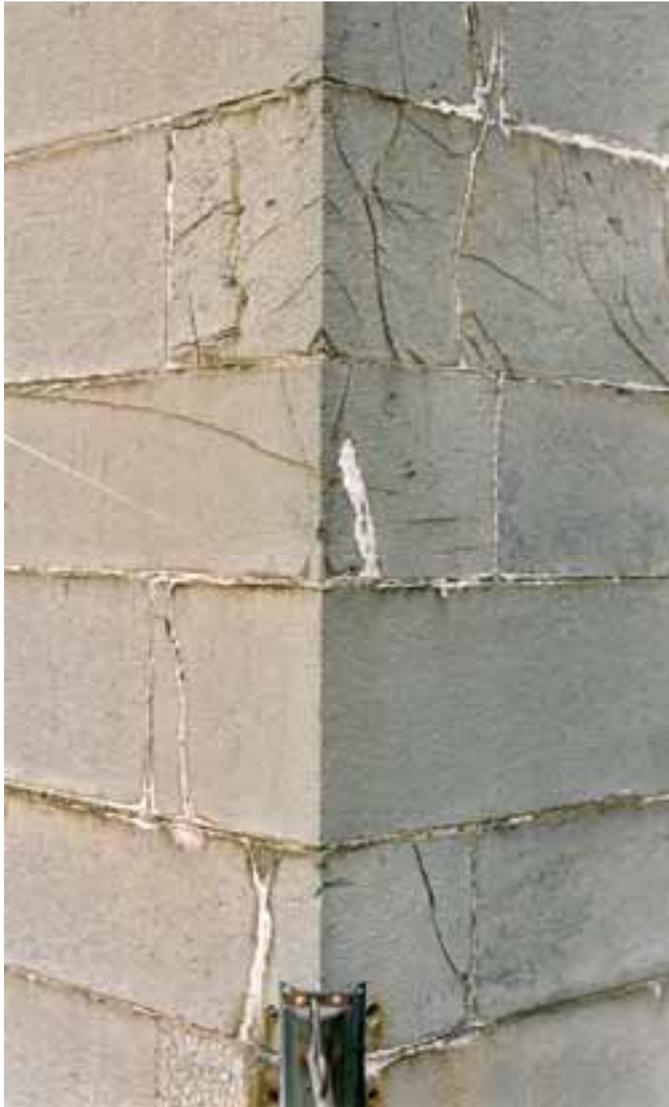
Another difficult issue is how to repair joint fissures at strongly exposed, damp walls full of Portland cement and alkaline salts. Examples include the north tower of the chapter house (fig. 20.10) and several other towers. The greatest problem in such situations is not how to select a suitable mortar, but how to prepare the joints before re-pointing operations commence. It is extremely difficult to remove old Portland cement mortars without damaging the soft stone, not least because the cement tends to bind very tightly to the ashlar (on one side only).

Fig. 20.10: On the north tower of the chapter house virtually every joint has thin fissures through which moisture can penetrate. Repairing such joints is will be very difficult and represents a major challenge for The Restoration Workshop (PS 9/95).

If successful in removing old cement joints to a reasonable depth, it appears that lime mortars represent the best option for re-pointing. If this seems difficult in practice, other mor-

tars fulfilling the criteria mentioned above should be tested. As a general rule: *If the mortars have to be based on smaller or larger quantities of Portland cement (to give hydraulic properties), ensure that low-alkaline cements are used!*
