The Stones of Nidaros

An Applied Weathering Study of
Europe's Northernmost
Medieval Cathedral

Dr. Ing. (Ph.D.) thesis no. 1997:92
Department of Architectural History
Norwegian University of Science and Technology
Trondheim, Norway

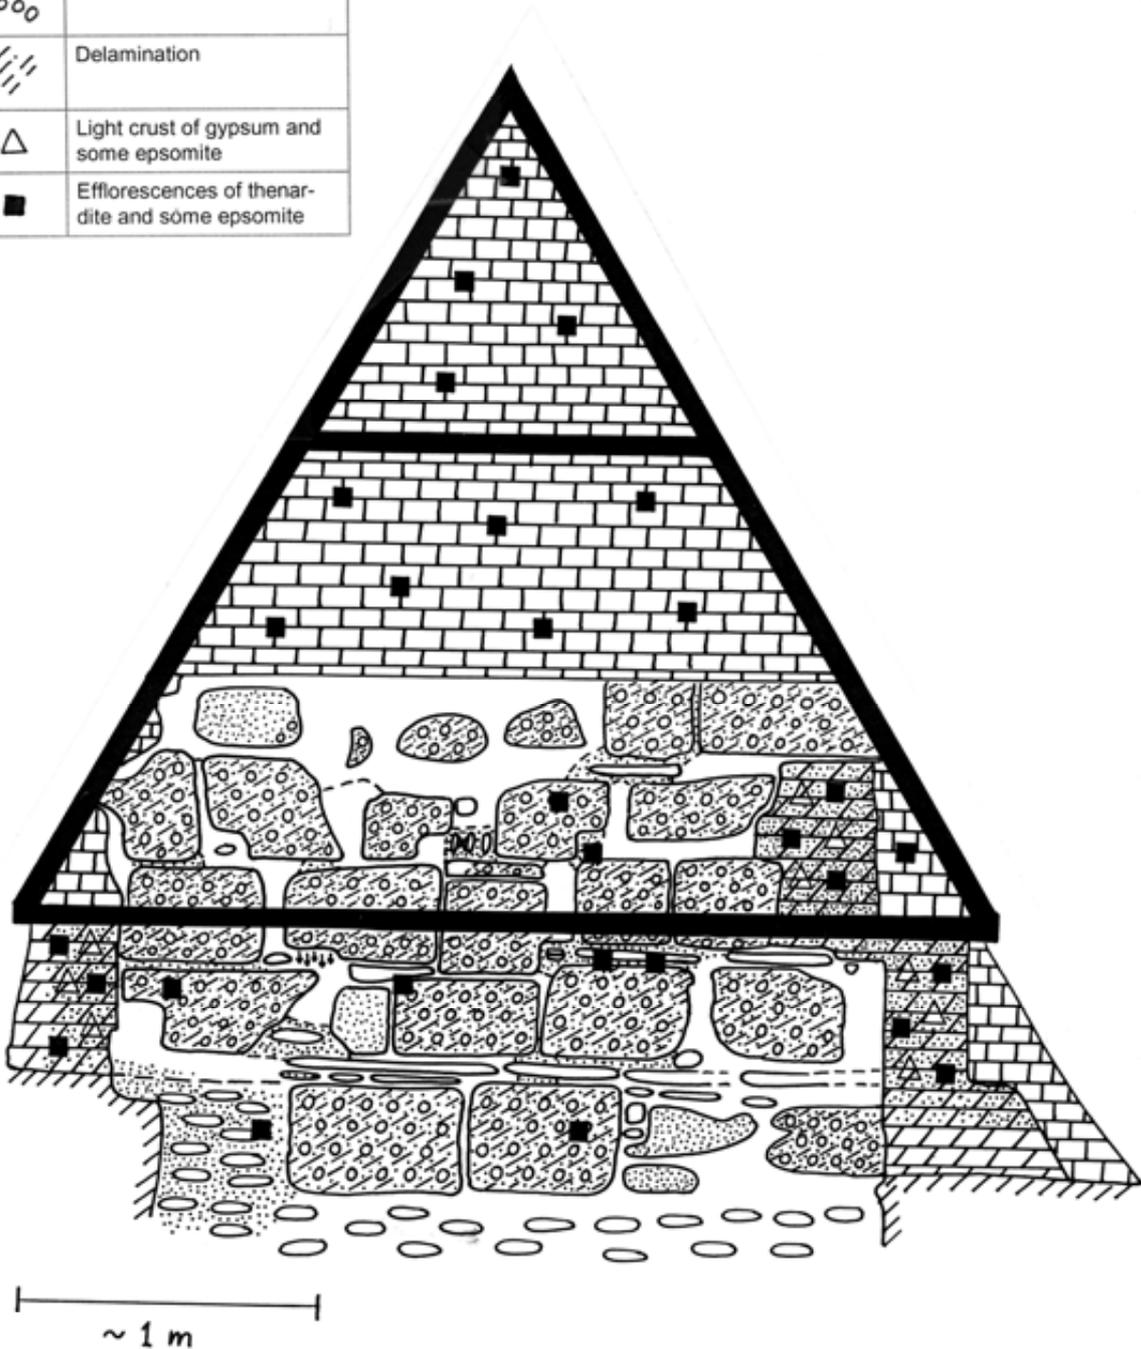
Nidaros cathedral
East chapel of the octagon, gable wall on the loft
Weathering forms and salts
Survey: Per Storemyr 1992-93

Efflorescences of thenardite and some epsomite

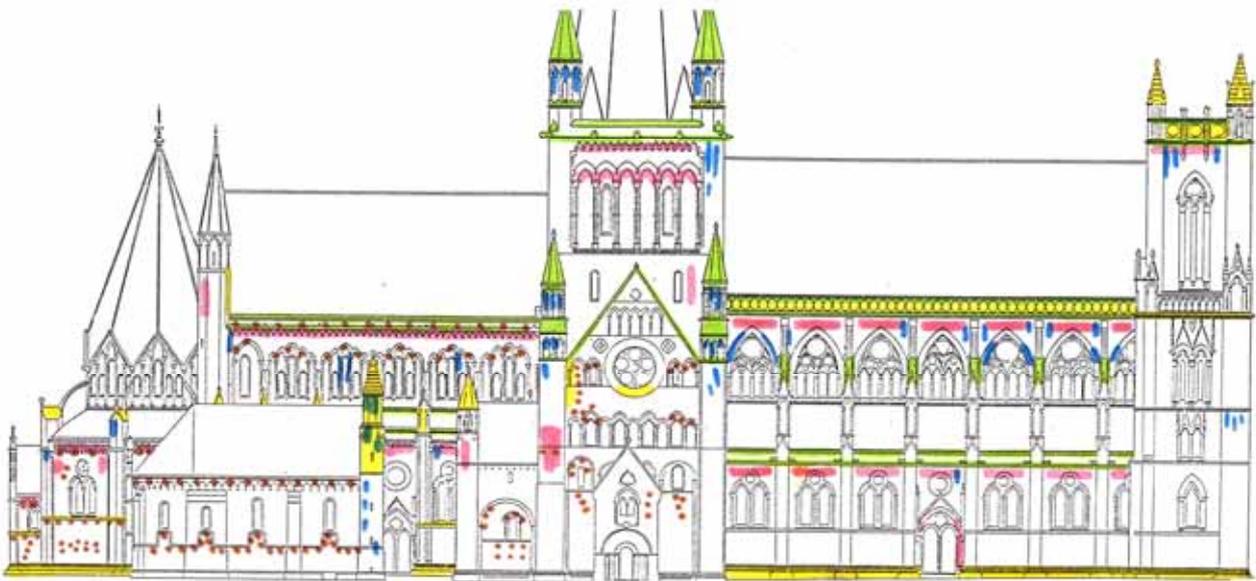
Weathering

- *Strongly exposed to precipitation*
Joint fissures, loss of carved details, surface disintegration, lichen and moss.
- *Strongly exposed to precipitation*
Joint fissures, lichen and moss. Little stone disintegration
- *Usually sheltered from precipitation, affected by leaks*
Salt weathering, white calcite crusts
- *Affected by leaks*
White calcite crusts
- *Usually sheltered from precipitation, affected by run-off*
Black gypsum crusts
